1. Calc. No. RPP-CALC-56856
Rev. 0

4. Job/Project Name/Number	5. Calculation Title/Subject	6. Date
T2R29	Estimated Waste Volume Remaining in Single Shell Tank 241-C-112 after Hard Heel Retrieval	4/9/2014

Calculation Title/Subject: *Estimated Waste Volume Remaining in Single Shell Tank 241-C-112 after Hard Heel Retrieval*

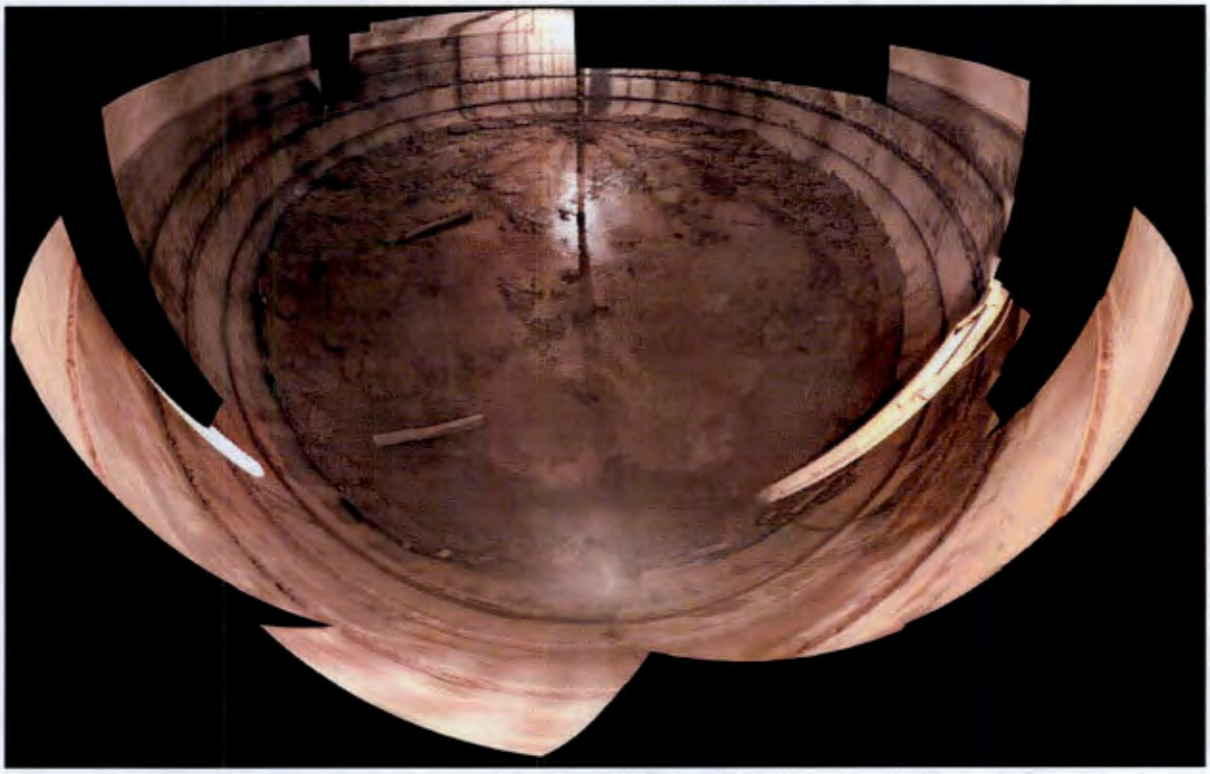
Figure 6-1. Tank 241-C-112 Panorama View.

The volume displacement was done on January 28, 2014. Following the volume displacement the tank was rinsed with water to remove as much soluble waste from the liquid as possible and final tank videos were obtained February 3-4, 2014 from both risers 3 and 6. The volume of waste observed appears to be consistent with volume displacement measurements and may be lower.

Figures 6-1 to 6-6 show still photographs of waste remaining on the tank bottom. A drawing of waste residuals using the camera CAD measurement system per TFC-ENG-FACSUP-CD-22 will be developed for the retrieval data report and final residual waste volume calculated.

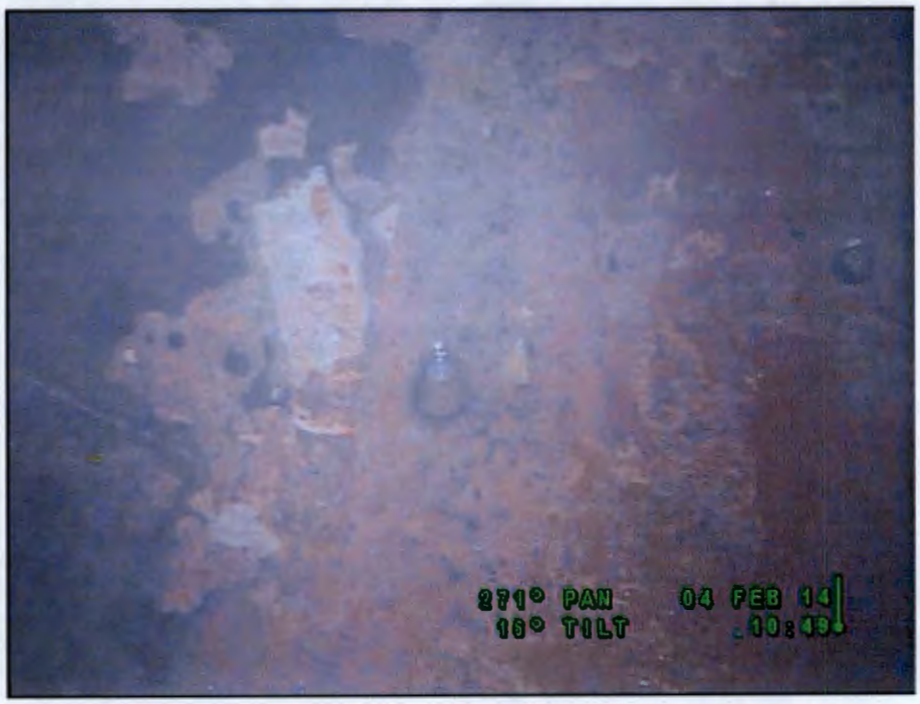
Figure 6-2. Tank 241-C-112 from Riser 6.

The Enraf plummet contacted the tank bottom at 11.69 inches. Based on tank drawings (BPF-73550), the Enraf should have contacted the tank bottom surface at 12.0 inches. This indicates that the distance from the top of the riser to the tank bottom is greater than shown in WHC-SD-WM-CN-078. As a result, a value of 0.31 in. was added to the tank C-112 Enraf readings listed in Table 6-1 to correct the Enraf measurement.

Figure 6-3. Tank 241-C-112 Enraf Plummet from Riser 6.

Subsequent video clearly shows that the tank bottom was clear under the plummet when it was raised.

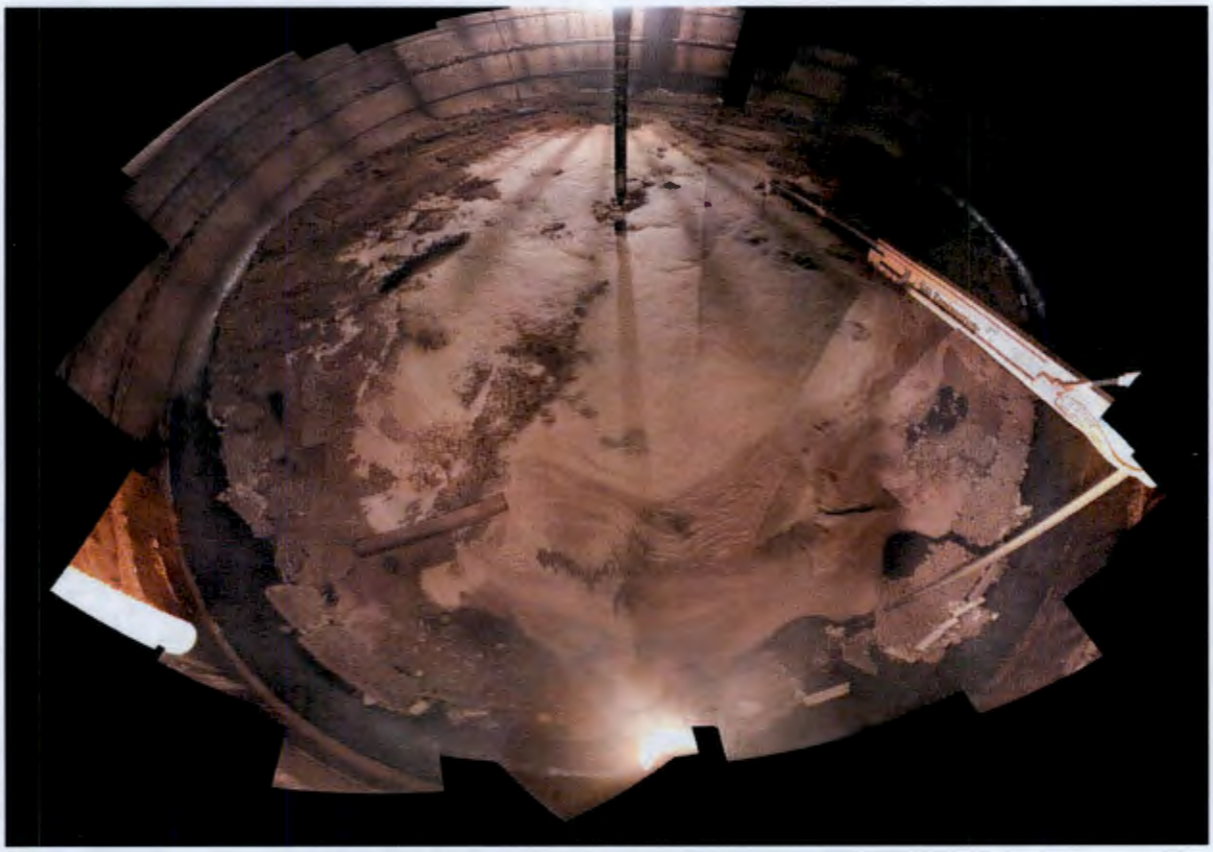
Figure 6-5. Tank 241-C-112 Tank Stiffener Rings and Wall.

Figure 6-6. Tank 241-C-112 Composite.

The volume of waste on the stiffener rings was calculated by estimating the average depth of the waste on each of the stiffener rings and multiplying by the surface area of each of the rings (97.6 ft^2). The average depths of waste on the stiffener rings were estimated based on video observation and comparisons with video estimates before and after the retrieval. Figures 6-1, 6-5, and 6-6 show photographs of the rings after completing retrieval. Only ring 3 shows a significant amount of waste on the ring. In general the tank rings were clean compared to previous C-Farm tanks retrieved. Table 6-2 shows the estimated depth and volume of waste remaining on each of the stiffener rings.

The waste on the walls was also determined by estimating an average depth and multiplying by the surface area between each stiffener ring. Figure 6-5 shows photographs of the tank walls. The tank walls appear to be mostly clean, but some waste was observed on the tank walls between the stiffener rings. Because of the thin layer of waste on the tank walls, a uniform, nonporous layer is assumed. The waste volume was calculated as follows, assuming a thickness of ~0.0625 in. on half the tank wall between stiffener rings #1 and #2, rings #2 and #3, and rings #3 and #4.
