RPP-RPT-43704, Rev. 0A

Hanford BY-Farm Leak Assessments Report

J. G. Field, J. M. Barton, B. N. Hedel, L. A. Fort — Washington River Protection Solutions, LLC
M. I. Wood — CH2M HILL Plateau Remediation Corporation
Richland, WA 99352
U.S. Department of Energy Contract DE-AC27-08RV14800

Date Published
February 2011

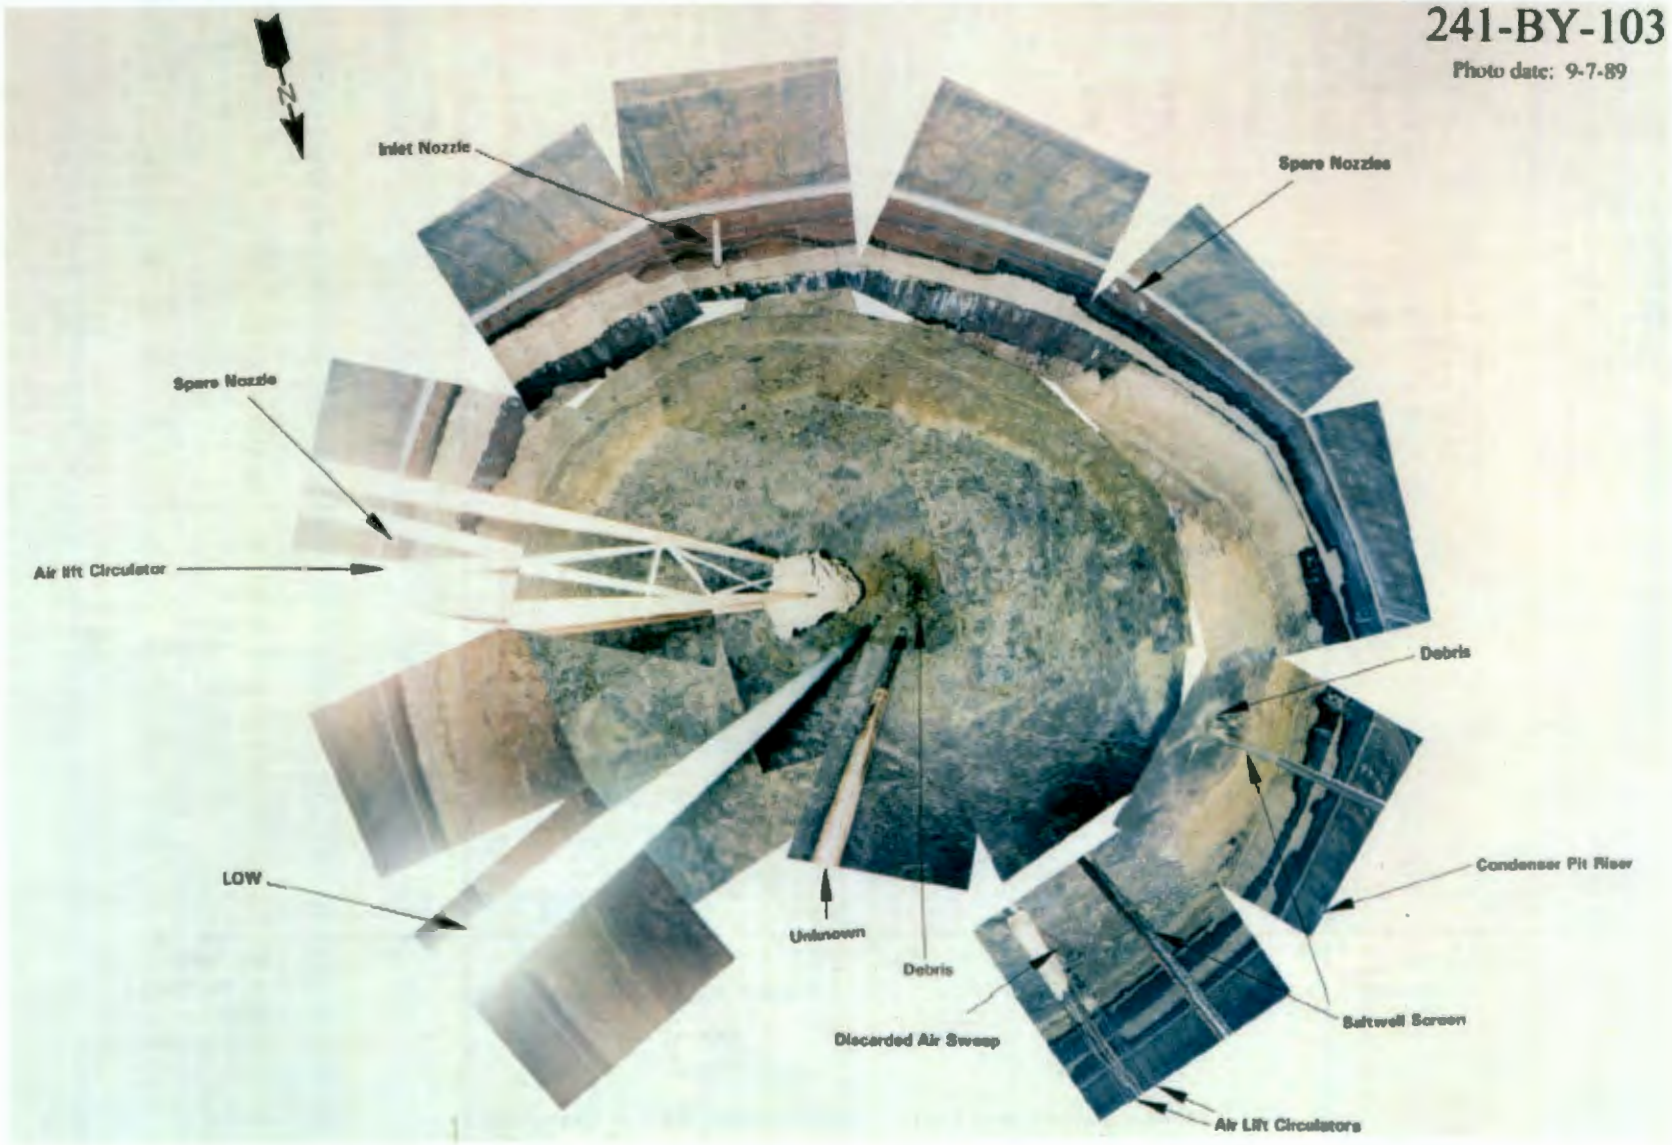
Figure B.1-4. Tank 241-BY-103 Waste Surface Photo Mosaic

An intrusion of ~1,100 gal occurred January 12 to 13, 1980 (OR-80-6). The intrusion was attributed to a rapid snow melt. Excavations around tank pump pits and risers in support of saltwell pumping provided runoff water a pathway into the tank's pump pit, then directly into the tank through the pit floor drain. No intrusions were observed after excavating around the tank before the rapid snow melt in 1979.

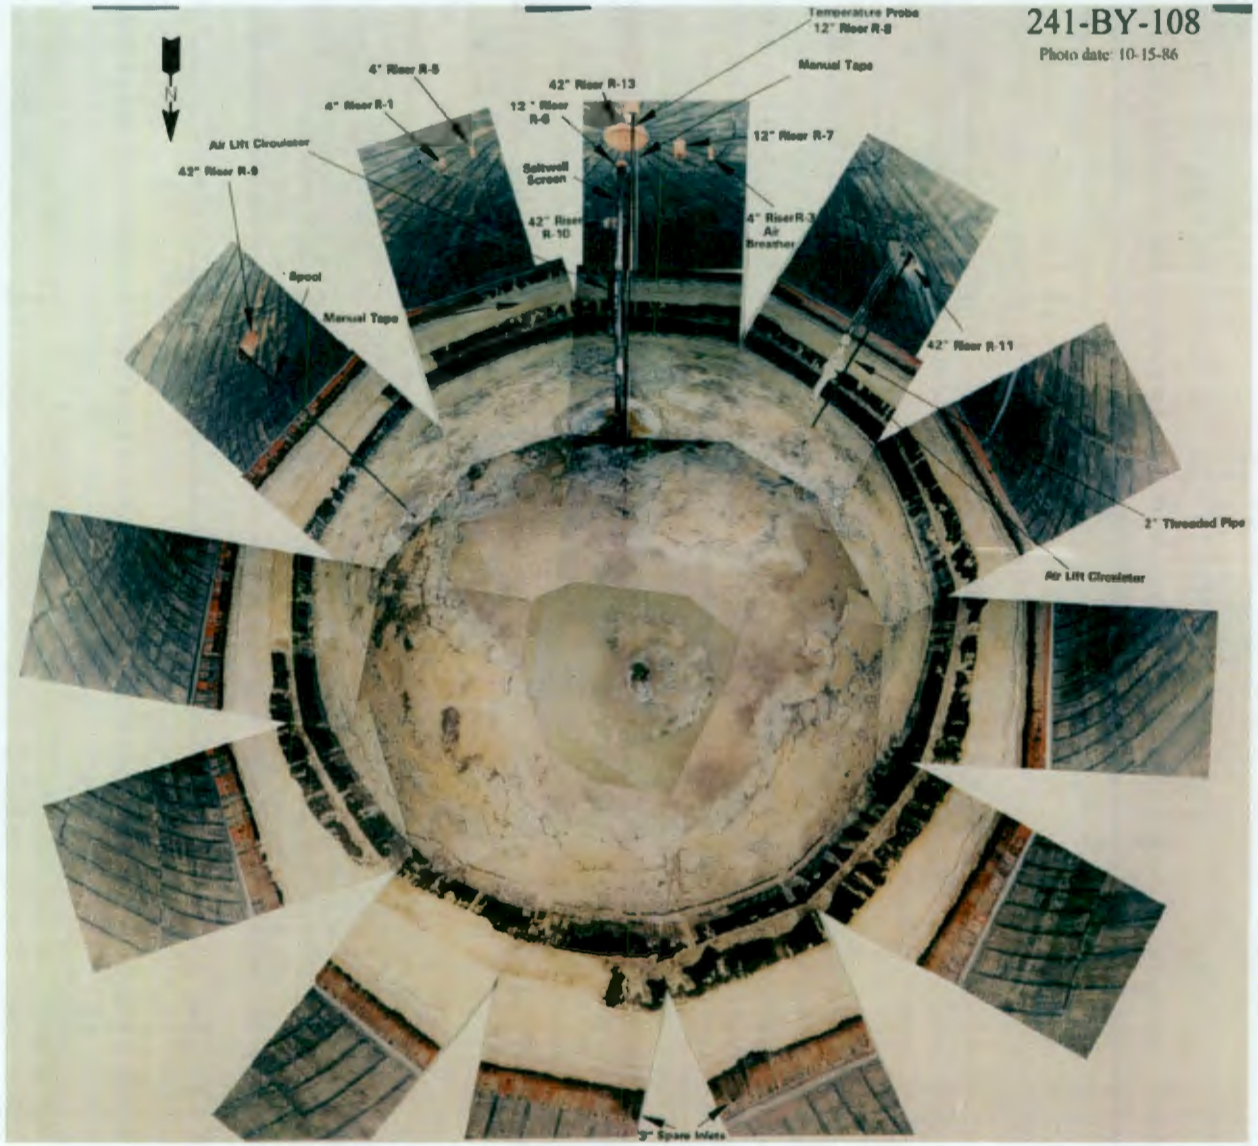
Figure B.5-4. Tank 241-BY-108 Waste Surface Photo Mosaic

B.5.1.2 Interim Stabilization. Tank BY-108 supernatant P-10 pumping was completed May 1972 (SD-WM-TI-356). Jet pumping to interim stabilize the tank began on January 9, 1984 and was halted December 9, 1984 due to failure of the jet pump (HNF-SD-RE-TI-178). 1986 photographs showed an uneven crusted surface of saltcake and a pool of liquid around the saltwell casing (Figure B.5-4).
