CONTRACT NUMBER DE-AC27-08RV14800 - WASHINGTON RIVER PROTECTION SOLUTIONS LLC SUBMITTAL OF HANFORD FEDERAL FACILITY AGREEMENT AND CONSENT ORDER INTERIM MILESTONE M-045-91I DELIVERABLE

RPP-IQRPE-50028, Single-Shell Tank Structural Integrity Assessment Report, Revision 0.

RPP-IQRPE-50028
Revision 0

Single-Shell Tank Structural Integrity Assessment Report

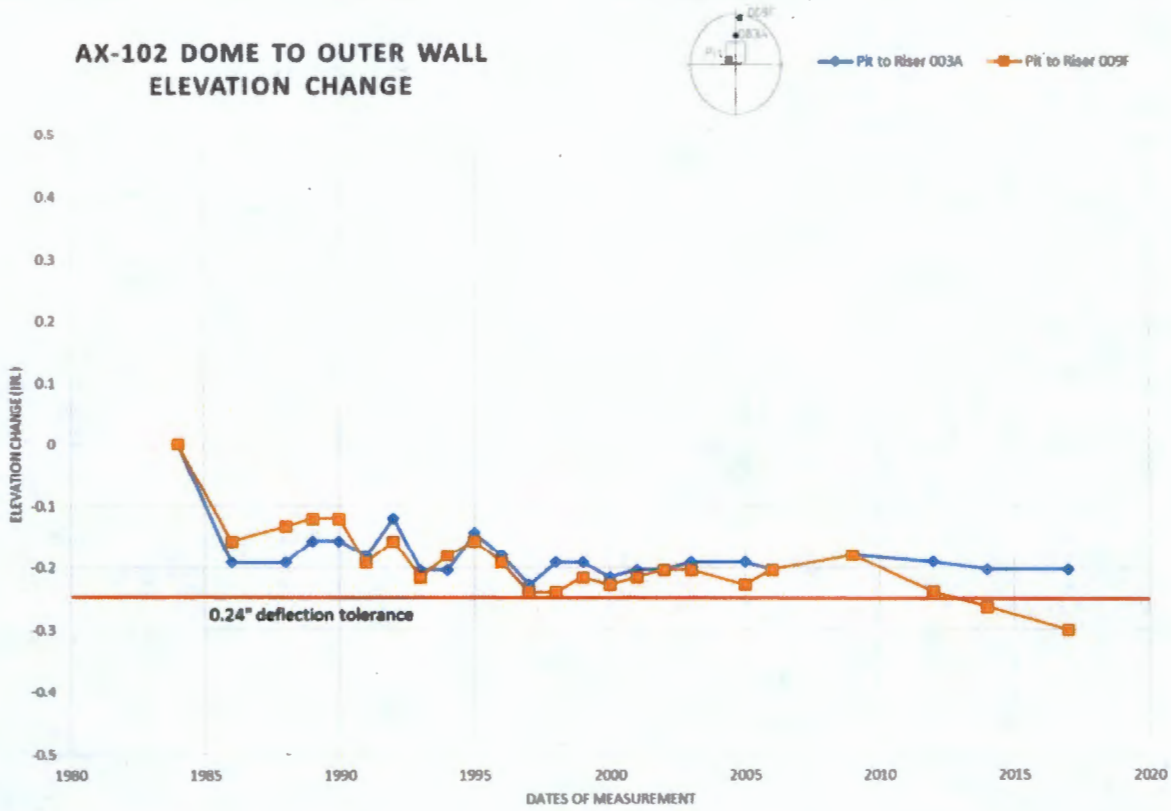
Figure 4-30: Tank AX-102 Differential Displacement (RPP-RPT-55202)

Tank	Concern	Resolution Possibilities
Tank AX-102, pg 46-48	Differential between pit and riser 009F located near the wall exceeds the 0.24" deflection tolerance. This deflection differential has been increasing since 2010. See Figure 4-30.	Conclusions of RPP-RPT-55202 Rev 02 state "Discrepancies between the true deflection and the calculated deflection can exist when the initial survey data is inaccurate. It is believed that the negative deflections measured in tanks AX-102 and B-111 were due to an early event that dirupted the benchmark elevation." pg 19 Recommend setting 1985 as the baseline to give a better understanding of the changes in deflection.
Tank TX-103, pg 347-349	The differential between Riser 13A and Riser 8 exceeds 0.24 in. These two risers are very close together and the pattern created by these differiential deflections was not explained in the report. See Figure 4-31.	The deflections of riser 13A have been rising gradually over time signifying that this riser has moved up. It does not make sense that this would be moving up while the adjacent riser is moving down if both are fixed to the top of the dome. Recommend verifying that riser 13A and riser 8 are both affixed to the top of the dome. If these points are floating in the top of the dome, new benchmark locations that are not floating should be established. It appears that riser 8 and riser 9A are moving roughly together, therefore consider the possibility that riser 13A is not an accurate benchmark point.

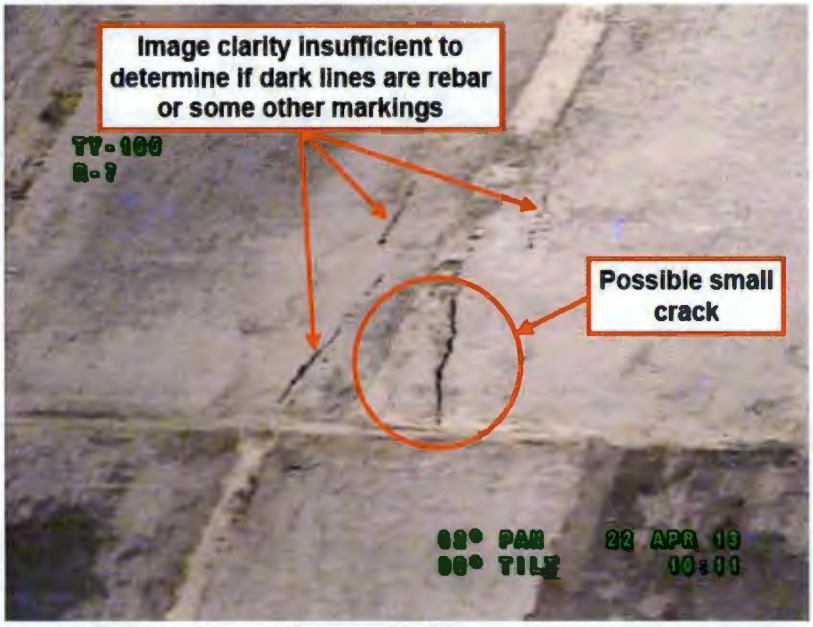
Figure 4-39: Possible Cracks in Tank TY-105 (RPP-RPT-55951)

The Expert Panel recommended that any cracks or flaws larger than 1/16 in. be identified and a baseline and means of comparison be developed for calibrating the photos from the videos (RPP-ASMT-55981, pg 2). The current technology does not appear to be adequate to identify or calibrate a 1/16-in. flaw. Lighting, camera resolution, and riser access all contribute to the limitation for locating tank cracks and other flaws. It is important to document the exact location on the tank where a flaw is identified to enable future videos to examine the same location for modifications to the flaw. This IQRPE agrees that it is unrealistic to identify 1/16-in. wide flaws using video inspection. Figure 4-39 and Figure 4-40 are examples of cracks that have been observed during video inspection. These cracks do not appear to be located in the areas shown in Figure 4-37 after the failure of the 1/10 scale model. Due to the location and appearance, the crack in Figure 4-40 may be a construction joint during the dome concrete pour.

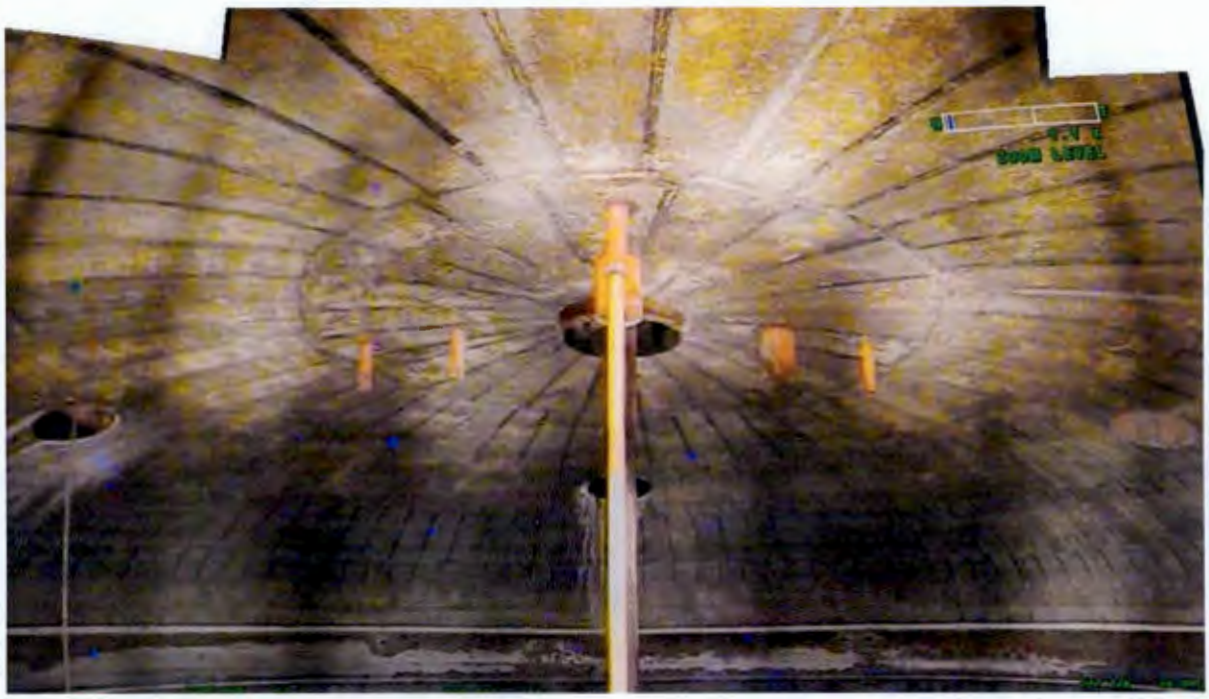
Figure 4-41: Composite of Tank BY-109 Concrete Dome (RPP-RPT-60093)

The original form lines are visible in almost all the tank domes. Some of these lines have metal strips just below the surface as shown in Figure 4-41.

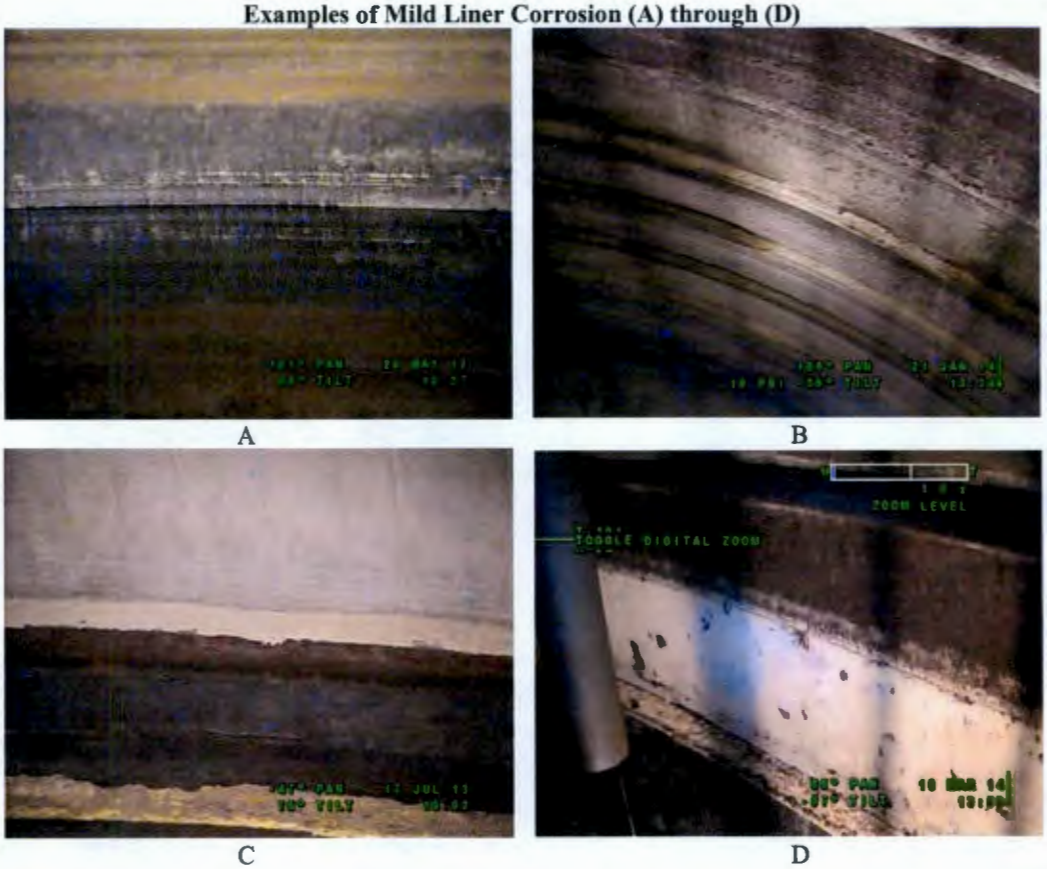
Figure 6-1: Pictorial Definitions of Degrees of Corrosion (RPP-RPT-55951) (6 sheets)

Examples of Mild Liner Corrosion (A) through (D)

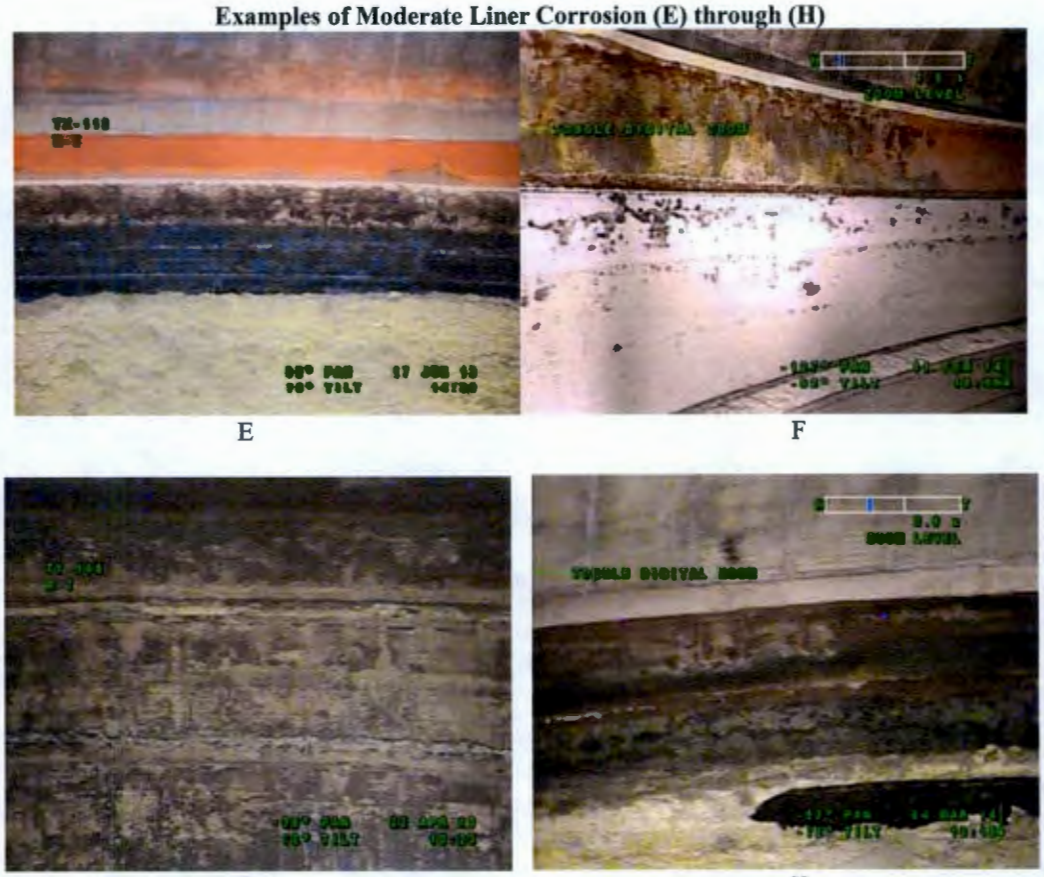
Examples of Moderate Liner Corrosion (E) through (H)

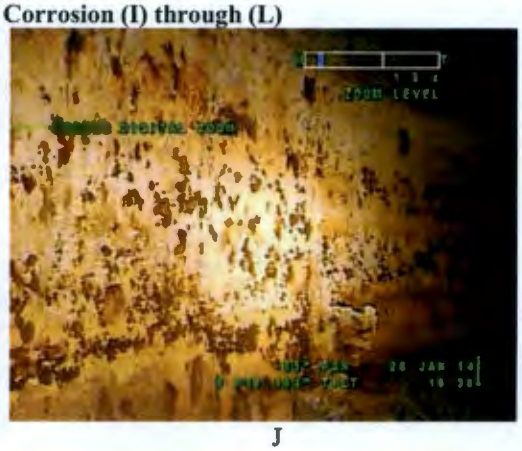
I (some growth material)

Examples of Severe Liner Corrosion (I) through (L)

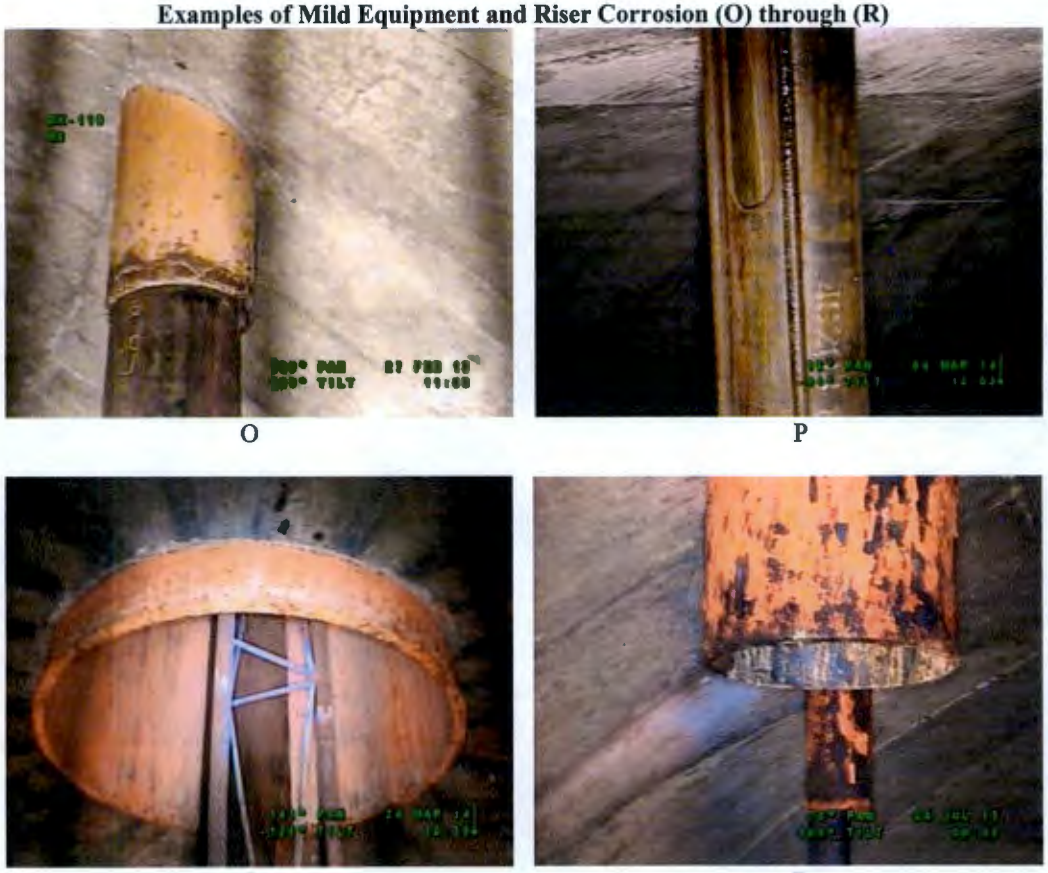
Examples of Mild Equipment and Riser Corrosion (O) through (R)

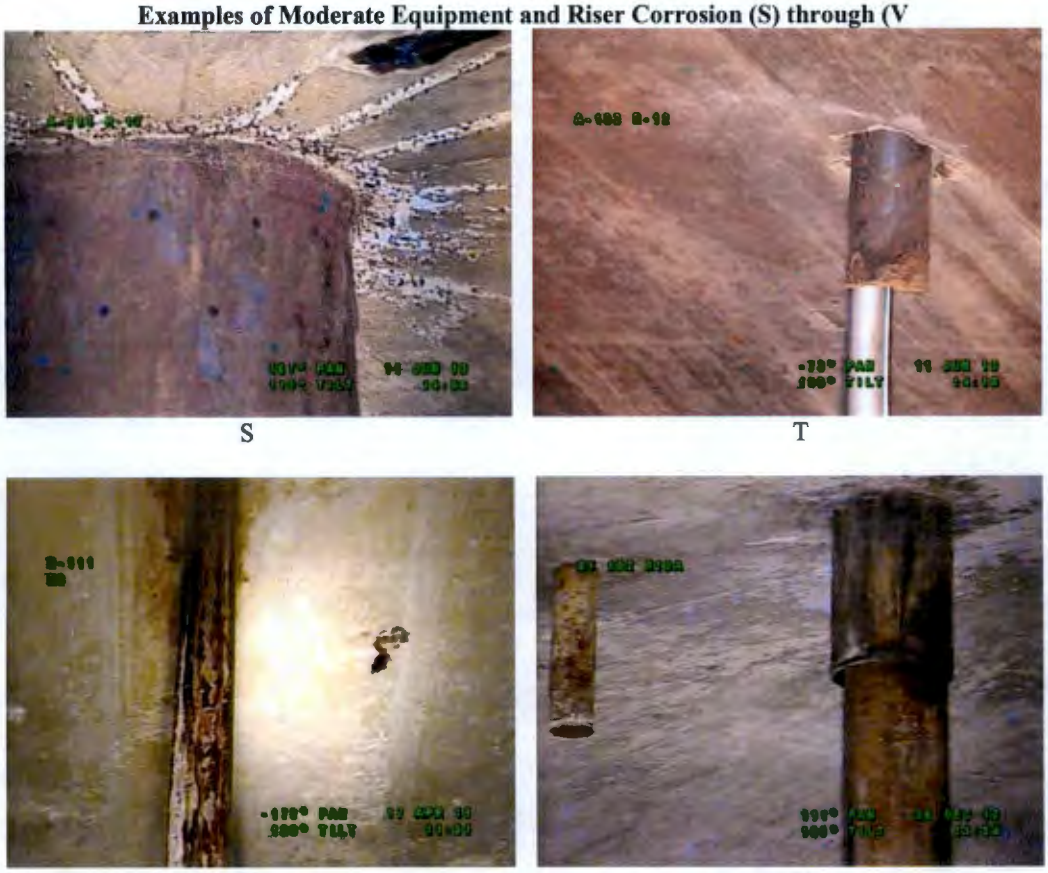
Examples of Moderate Equipment and Riser Corrosion (S) through (V

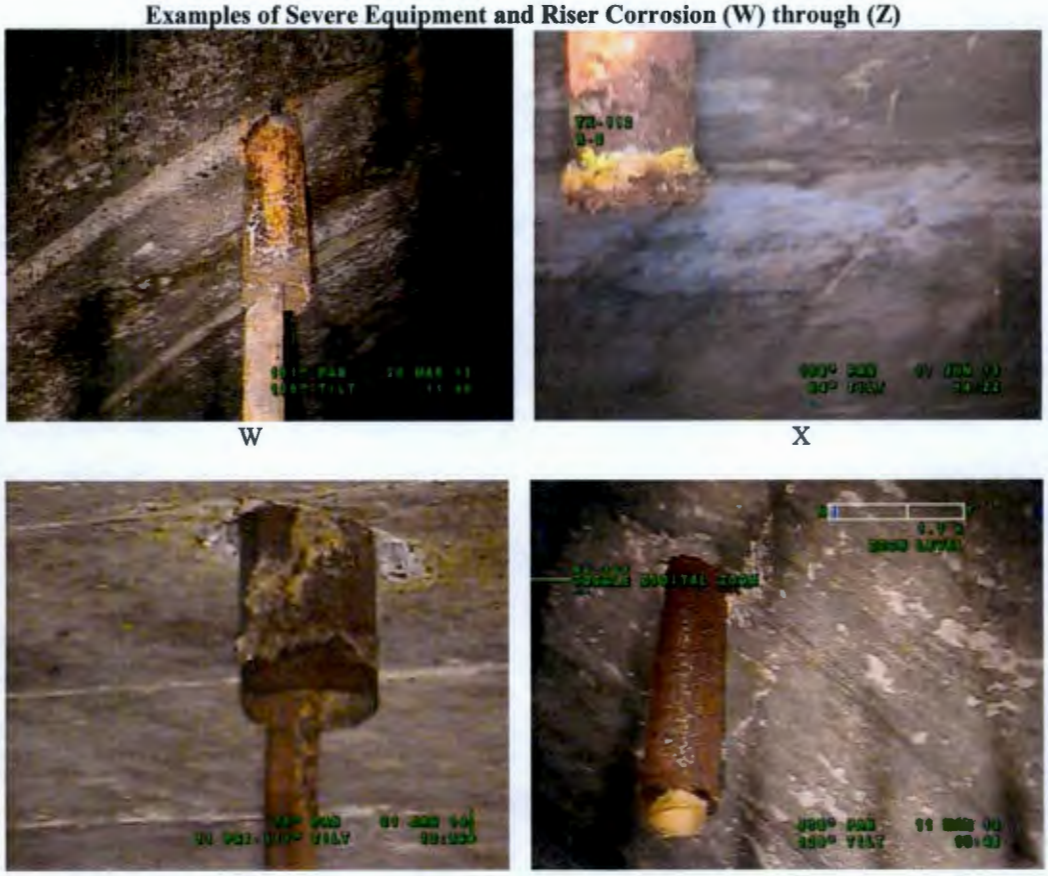
Examples of Severe Equipment and Riser Corrosion (W) through (Z)

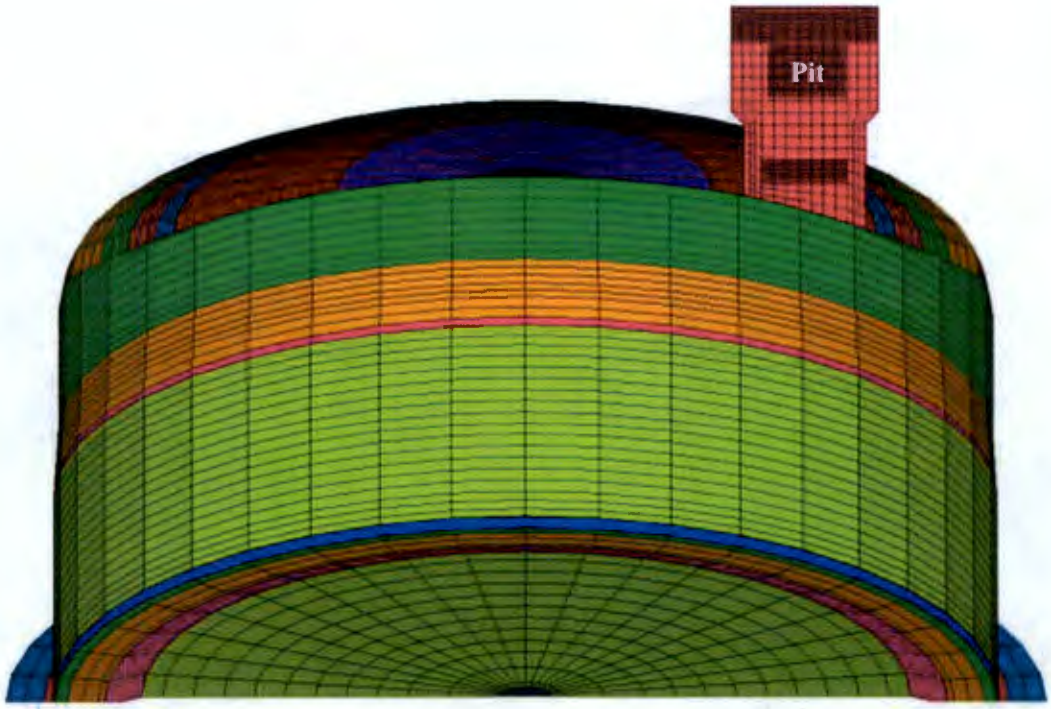
Figure E-23: Type IV Seismic Appurtenance Model (RPP-RPT-49992)

The Type IV appurtenance model showed that the haunch produced a demand/capacity ratio of 1.02 near the appurtenance. Otherwise, there was more variation between the baseline and the appurtenance model than shown in the Type II or III models, but the demand/capacity ratio did not exceed 1.0. The author then concludes that the tank is adequate due to the conservatism in the model.

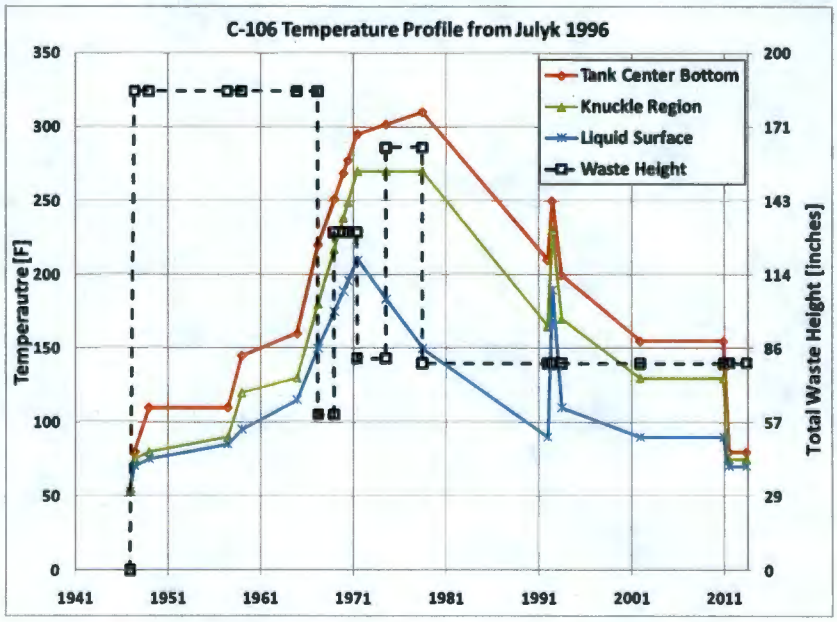
Figure 1: Type-II Temperature and Waste Height History

The Type II AOR applied the temperature history in Figure 1 and found that the calculated tank temperatures were similar to the bounding temperatures of the previous tank C-106 analysis. Both the Type III and Type IV thermal transients begin with steep temperature ramps to the highest temperature recorded for each tank type (Figures 2 and 3) to ensure that the maximum amount of concrete degradation was included in the analysis.

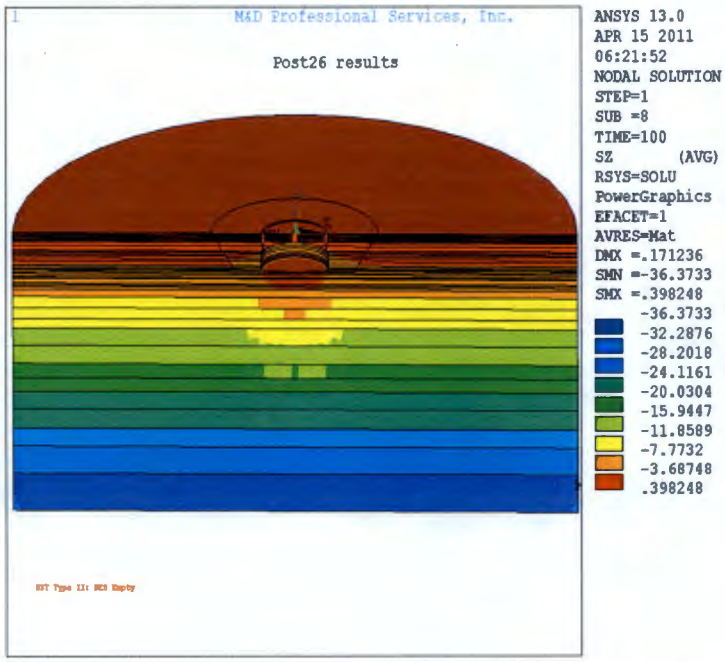
Figure 6.29: SST Type II Seismic Model BES: Soil Stresses (kip/ft^2) – Vertical Component

IQRPE Question: The seismic model produces 400 psf uplift at the soil surface under dead load only in RPP-RPT-49989 Figure 6.29. Can you explain these results and why they are acceptable?

PNNL Response: 0.4 kip/ft^2 is approximately zero for the contour range used in Figure 6.29. The finite element code first calculates the nodal forces and displacements in the soil, then the stresses at the internal integration points, and finally extrapolates the integration point stresses to approximate the nodal stresses at the surface. The nine stress contours on Figure 6.29 range from -36.4 to 0.4 kip/ft^2, with the red contour from -3.69 to 0.40 kip/ft^2. Zero is within the red contour. The 0.4 kip/ft^2 maximum value is shown locally in the soil at the left side of the tank dome. If finer contours were chosen with one ending at 0.0, we expect that most of the surface would be at zero, and the 0.40 kip/ft^2 value would be evident and localized.

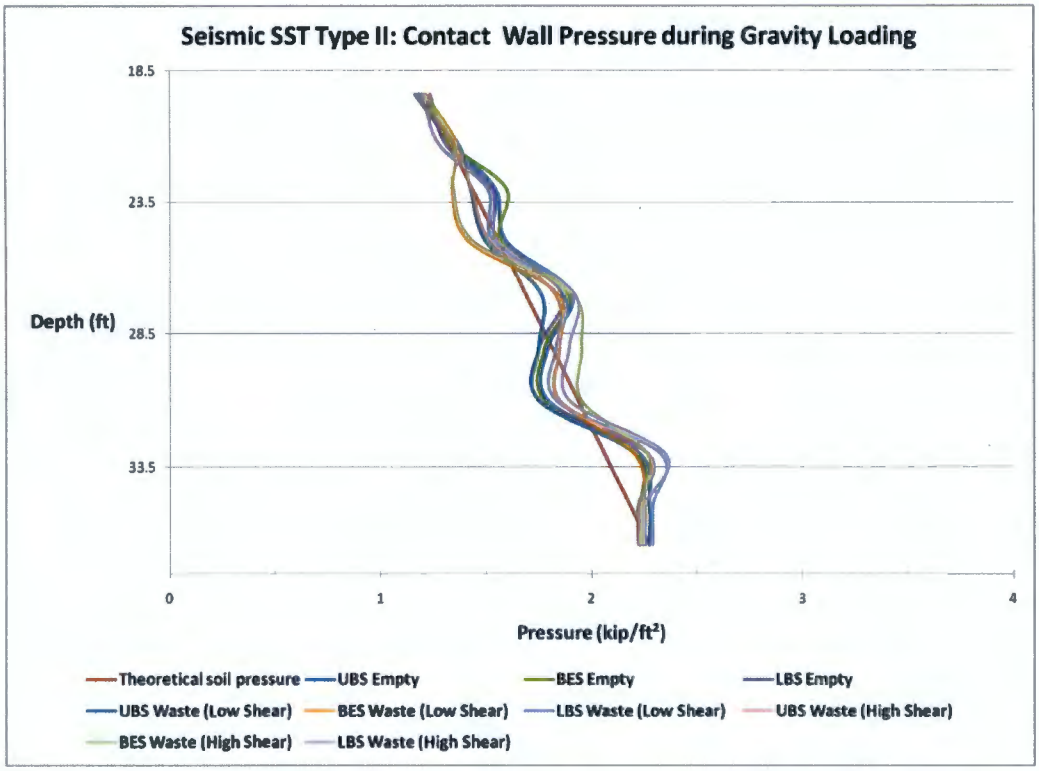
Figure 6.12: Seismic Model Soil/Concrete Contact Element Normal Pressure for At-Rest Calibration – Gravity Only

IQRPE Question: The soil pressure at the side walls produces odd at rest pressure results against the tank side walls (see RPP-RPT-49989 Figure 6.12). Appendix H discusses these results as a function of geometry of the tank. Was this phenomena also shown in the axisymmetric model or only the shell model? With a well-defined phenomenon as pressure increase along depth of soil it is odd to see a wave like distribution of soil pressure. Has this type of pressure distribution been observed/measured in real world tests?

PNNL Response: Figure 6.12 shows the approximated soil pressures from the 180° seismic model. Appendix H is the axisymmetric static model, which is actually a 3D wedge (with symmetric boundary conditions) because the STIF65 concrete elements are 3D. The waviness of Figure 6.12 is an artifact of the finite element modeling approximation. We don't expect that real-world tests would show similar behavior.

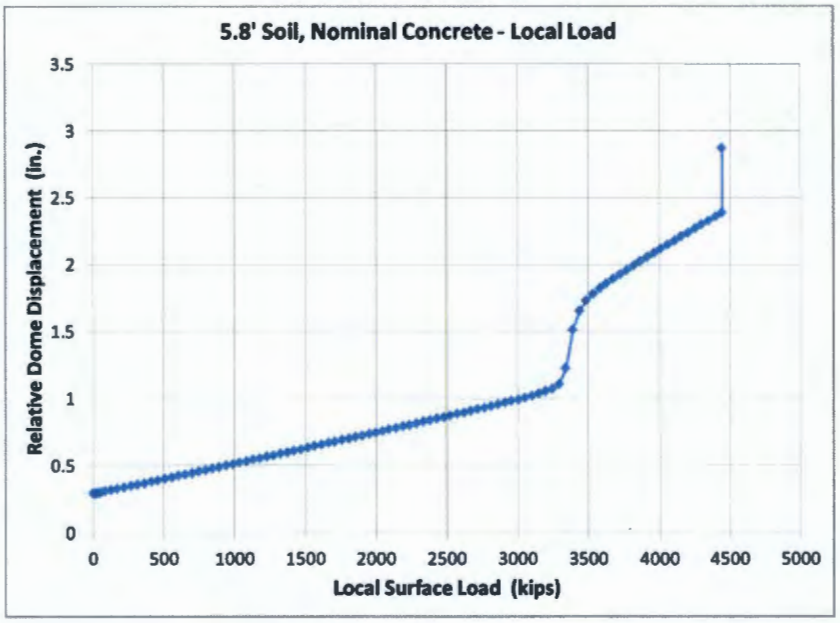
Figure 11.11: Load-Displacement Response of Nominal Concrete Under 5.8 ft of Soil with Local Load

IQRPE Question: In the load-displacement response graphs for the limit analysis, what causes the non-linear behavior in each of the graphs (RPP-RPT-49989 Figure 11.11)? Based on RPP-46442 Figure 4.5, it seems that this behavior is similar to the ASME collapse load but the collapse limit line is not shown in the plots so it is difficult to discern.

PNNL Response: The nonlinear slope change in RPP-RPT-49989 Figure 11.11 load/deflection curve results from extensive cracking in the dome and the haunch concrete. The slope change is more pronounced for the local limit load cases than the uniform limit load cases.

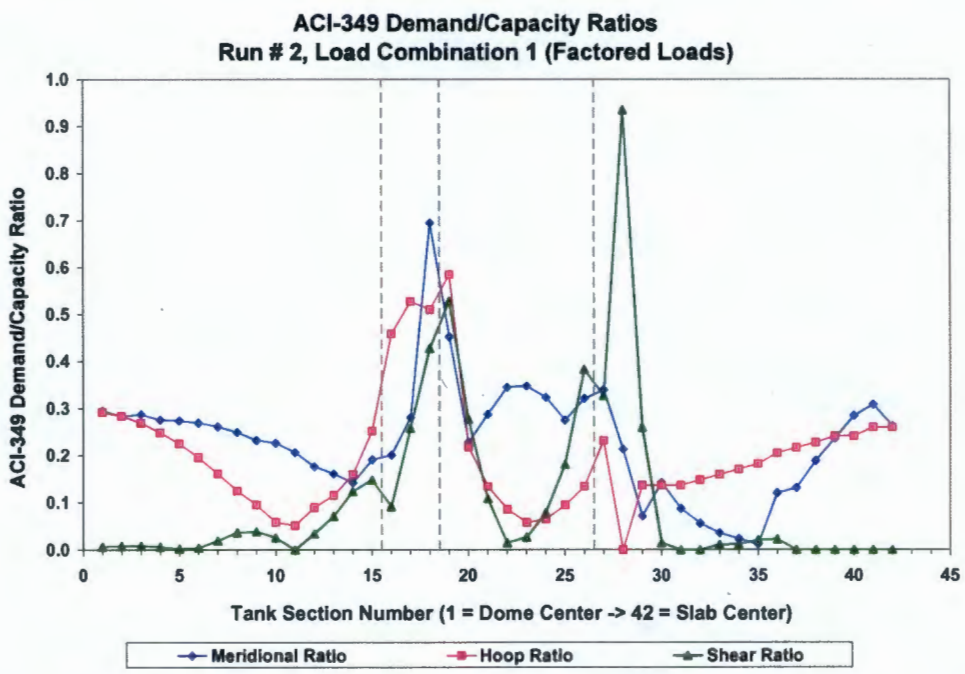
Figure 8.18: Run 2, ACI D/C Ratios for LC1, BES + BEC, No Creep

Figure 8.18 Factored static loads, BES+BEC, no creep, shows shear peak D/C=0.52 at section 19.

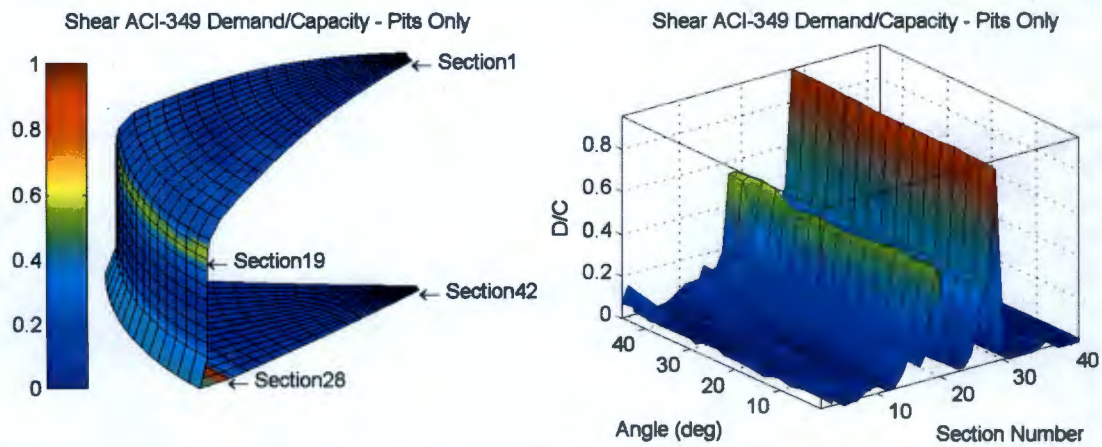
Figure 10.9: Pits-Only LC1 D/C Ratios in Shear (top), Meridional (middle), and Hoop (bottom), BES + BEC, No Creep

Figure 10.9 Appurtenance model, factored static loads, BES+BEC, no creep, shows shear peak D/C~0.55 at section 19.

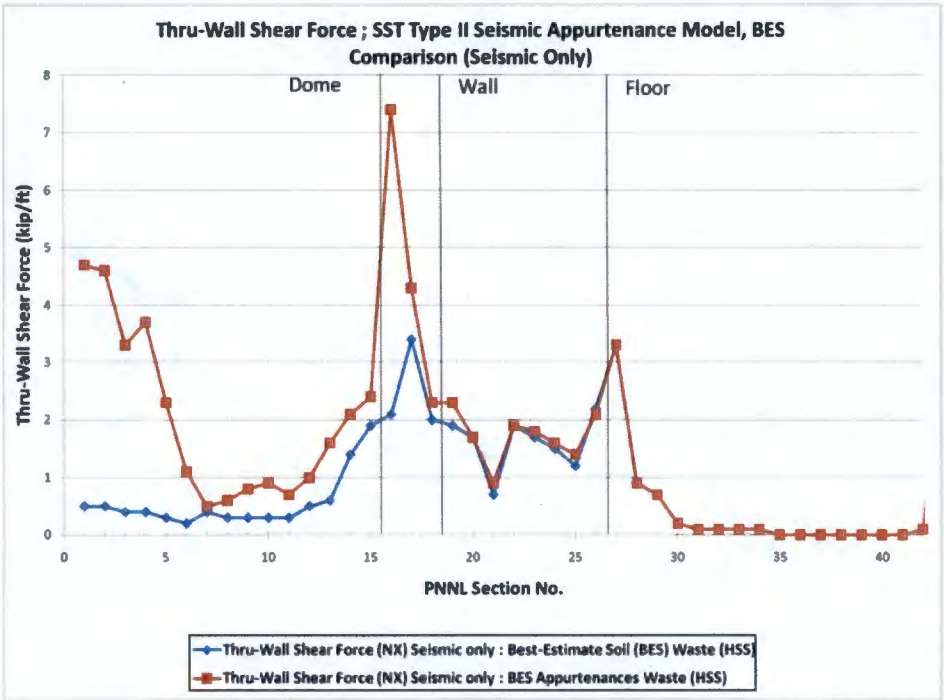
Figure 10.33: Concrete Tank Through-Wall Shear – BES, HSS Waste Comparison with and without Appurtenances (Seismic Only)

Figure 10.33 Concrete tank through-wall shear – BES, HSS waste comparison with and without appurtenances (seismic only),

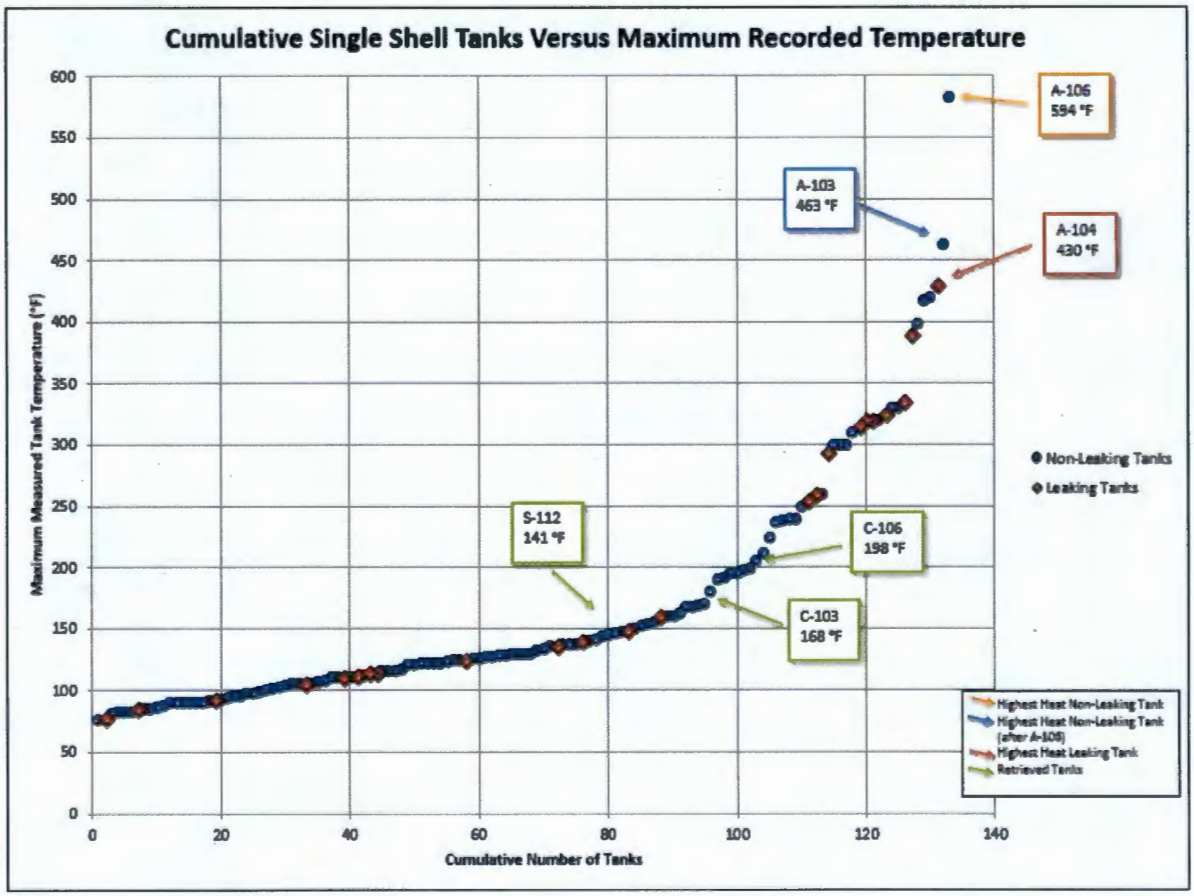
Figure G-1: Leaker SSTs and Temperature

As shown in Figure G-1, there does not appear to be a correlation between leaker tanks and temperature. Table G-1 shows length of time non-leaker tanks exceeded 200 °F, the point where it is postulated that temperature starts to cause degradation of concrete. Figure G-2 also illustrates non-leaker tanks with prolonged periods of elevated temperatures.
