ENGINEERING DATA TRANSMITTAL

(A) Item No.	(B) Document/Drawing No.	(C) Sheet No.	(D) Rev. No.	(E) Title or Description of Data Transmitted	(F) Approval Designator	(G) Reason for Transmittal	(H) Originator Disposition	(I) Receiver Disposition
1	RPP-15765	All	0	Ultrasonic Inspection Results for Double-Shell Tank 241-AZ-102 - FY 2003	EQ	1	1

Abstract: This report documents the required ultrasonic examination of double-shell tank 241-AZ-102 performed during FY 2003. This examination included specified primary wall areas, welds, lower knuckle, tank bottom, and SAFT/T-SAFT examination. Results indicated that there were nine areas of wall thinning that did not exceed accepance criteria in plates 1 and 2 and no areas of cracking or pitting identified. An issue of insulating concrete spalling was reported via PER-2003-3006.

RPP-15765
Revision 0

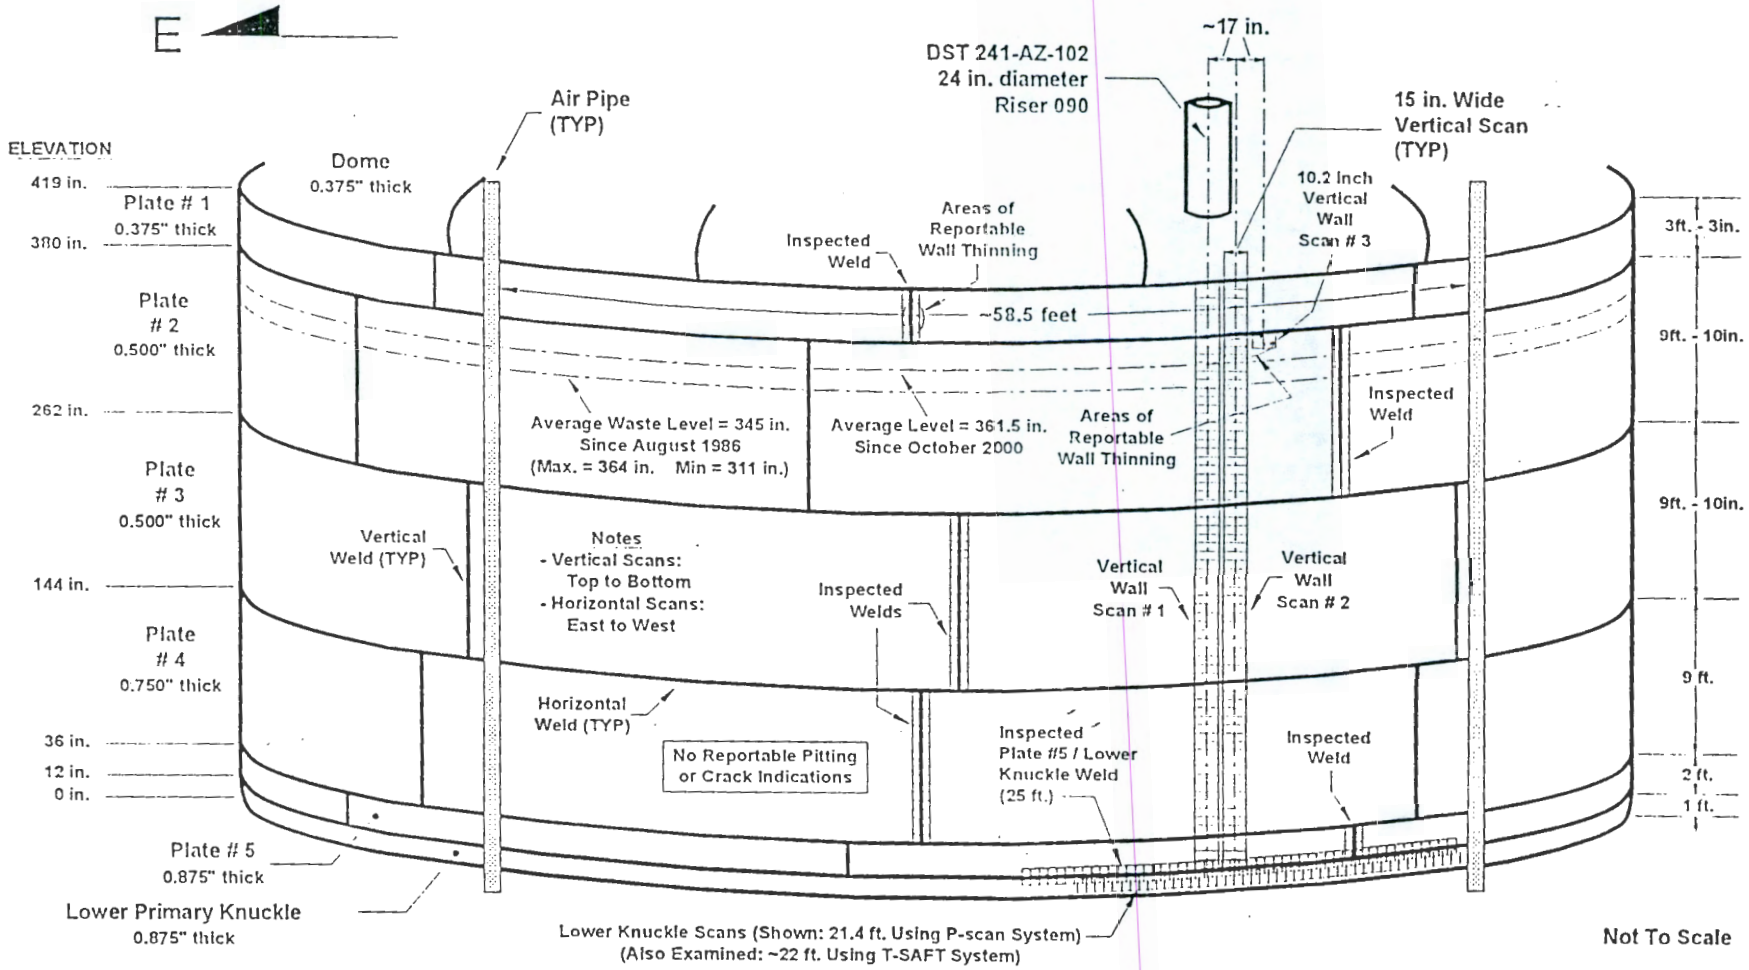
Figure 10-1. Schematic of UT Scan Paths on North Side of Tank 241-AZ-102 Wall (via Riser 090)

However, areas of reportable wall thinning were detected during the second primary tank vertical wall scan of Plate #2. The wall thinning was confined to three areas in the upper portion of the plate, approximately 6 to 17 inches below the Plate #1 / Plate #2 horizontal weld, equivalent to tank elevations of approximately 374 to 363 inches (Figure 10-1). This discovery prompted a third, short (10.2 inches long) inspection scan adjacent to the second scan on Plate #2 to determine the extent of thinning. Three more areas of wall thinning were detected approximately 1 to 9 inches below the Plate #1 / Plate #2 horizontal weld, equivalent to tank elevations of approximately 379 to 371 inches. The six areas ranged from 0.4 to 1.14 inches in width, from 0.71 to 2.58 inches in length, and from 0.49 to 2.94 square inches in area. A total of 8.1 square inches of thinned area was identified, ranging from 0.066 to 0.089 inches deep (based on nominal wall thickness values of 0.500 inches), or 13.2% to 17.8% wall thickness reduction (Tables 10-2, 10-3, 10-14 and 10-18).

However, areas of reportable wall thinning were detected during the primary tank vertical weld scan of Plate #1. The wall thinning was confined to three small areas, approximately 12 to 30 inches below the Dome / Plate #1 horizontal weld, equivalent to tank elevations of approximately 407 to 389 inches (Figure 10-1). The three areas ranged from 0.07 to 0.69 inches in width, from 0.05 to 0.38 inches in length, and from 0.0035 to 0.26 square inches in area. A total of 0.27 square inches of thinned area was identified, ranging from 0.041 to 0.063 inches deep (based on nominal wall thickness values of 0.375 inches), or 10.9% to 16.8% wall thickness reduction (Tables 10-5 and 10-22).

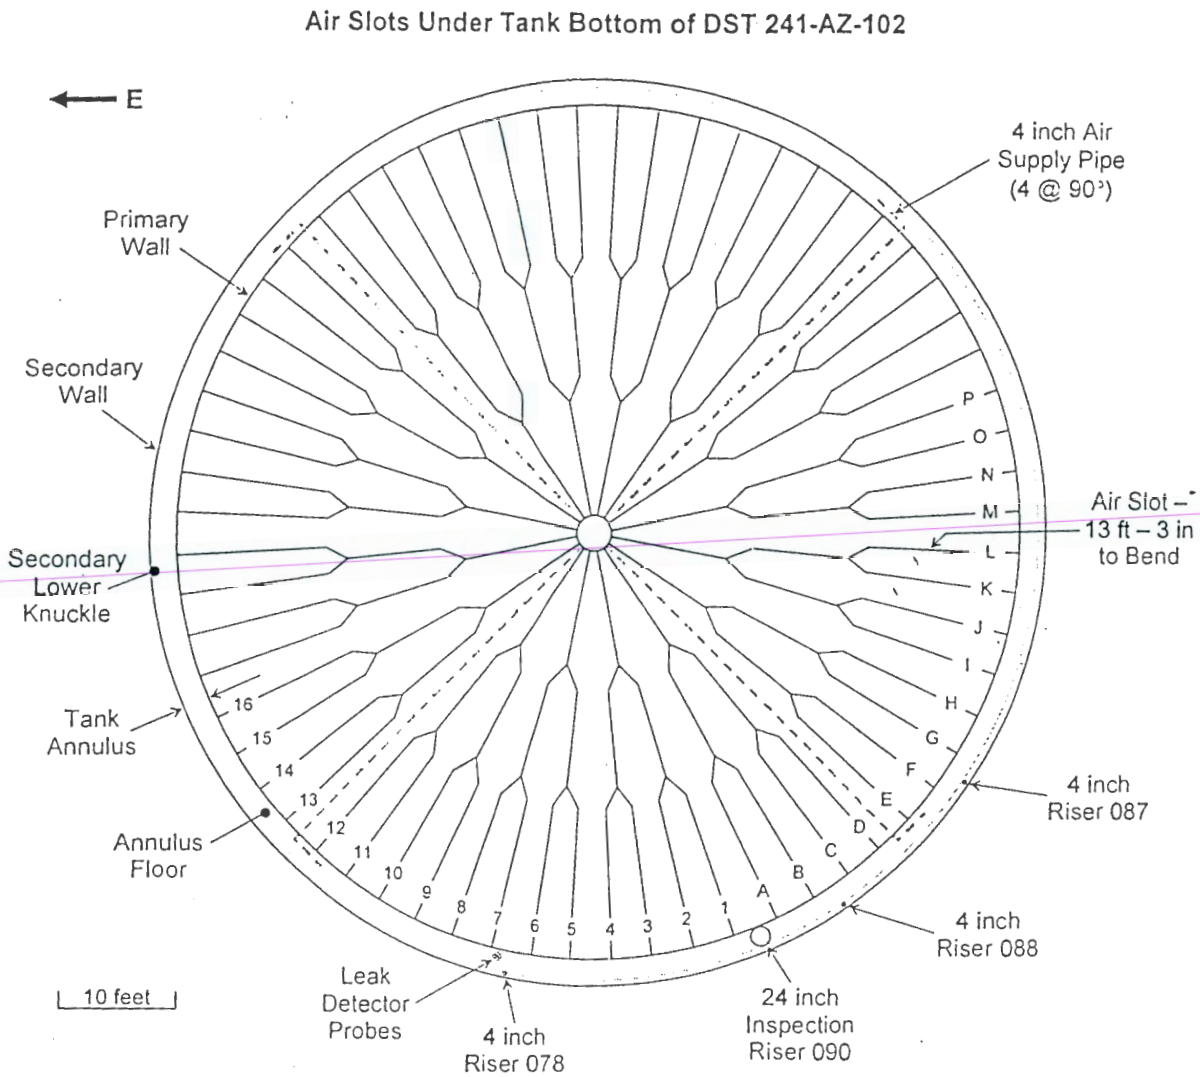
Figure 10-2. Top View Schematic of Tank 241-AZ-102 Bottom Showing the Air Slots

Additional P-scan measurements of the lower knuckle were made using the P-scan crawler equipped with the extension arm lined up with air slots in the insulating concrete. The locations of these scan paths are shown in the Figure 10-2 schematic. Also, P-scan measurements of the tank bottom were planned using the RUTI system, which is equipped with the UT probe lined up with air slots in the insulating concrete. However, problems with crumbling concrete in the air slots prevented this task from being performed at this time (discussed in Section 11.0). The locations of the air slots that were visually examined prior to abandoning this task are identified in Figure 10-2.

Primary Tank Bottom: According to the inspection scope outlined in the engineering task plan (Jensen 2002b), several strips on the primary tank bottom along the insulating concrete air slots were to be inspected to detect the presence of pits, wall thinning and cracks orientated perpendicular to the air slot channels. However, when the RUTI system was used to first view the air slots for condition and obstructions, it was discovered that the insulating concrete within the slots was severely crumbling, and made worse by the motion of the camera probe. Examples of two of the slots with crumbling concrete are shown in Figures 11-2 and 11-3. At one point, the camera that was attached to the end of the flexible cable became lodged within a slot, requiring considerable effort to withdraw it. Air slots were visually inspected on either side of Riser 090 (Figure 10-2), but all of the slots showed some form of degradation. A management decision was made to halt further attempts to scan the tank bottom due to the possibility of the RUTI probe being permanently wedged between spalled concrete inside an air slot. The

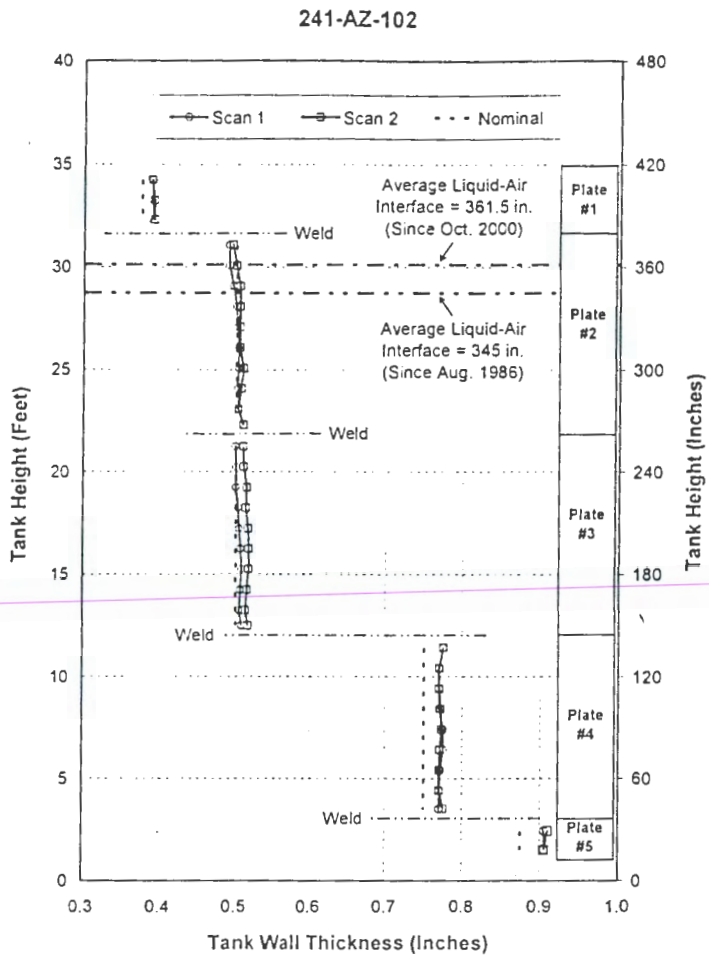
Figure 11-1. Scan Data Average Wall Thickness Compared to Nominal Plate Thickness

As stated earlier, the average waste level since August 1986 has been 345 inches, with a maximum recorded waste level of approximately 364 inches. Since October 2000, the level has been relatively constant, averaging 361.5 inches. The six areas of reportable wall thinning occurred in the vicinity above these liquid-air interface levels.

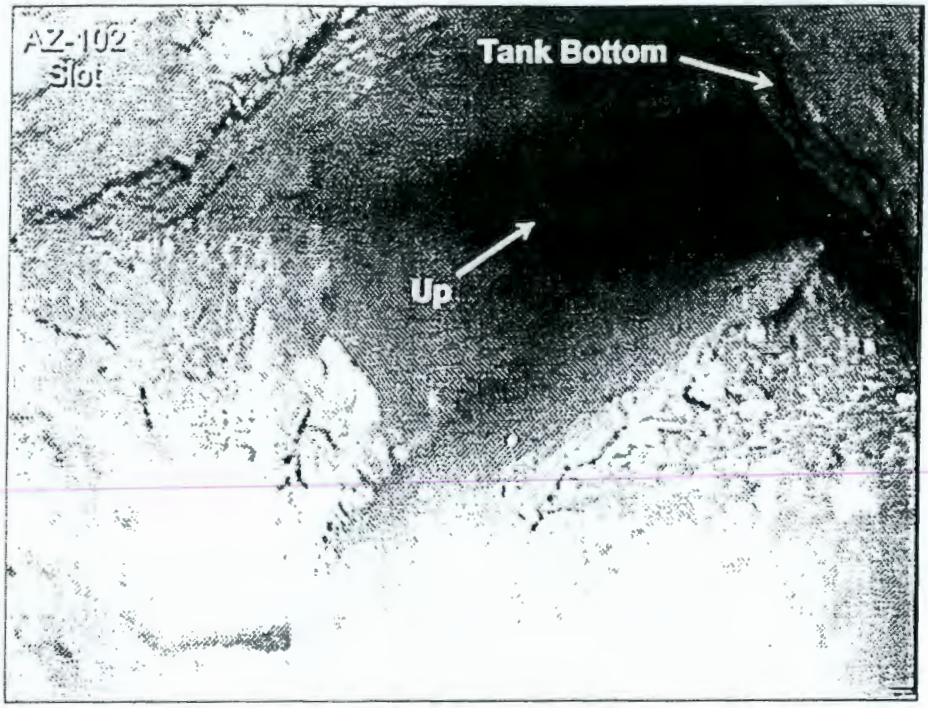
Figure 11-2. Air Slot in DST 241-AZ-102 Showing Crumbling Concrete

There was no additional reportable wall thinning in any of the other plate areas examined. This included the remaining primary wall vertical scans and the lower knuckle horizontal scan. In addition, there were no reportable pitting indications nor any crack-like indications detected in any of the plates. This included examination of the lower knuckle for cracks using the T-SAFT system. A video from a camera located at the end of the retractable probe showed cracking and spalling in the air slots. The effort to inspect the tank bottom via the air slots was abandoned because the probe became temporarily lodged inside an air slot. Air slots were visually inspected on either side of Riser 090, but all of the slots showed some form of degradation. A management decision was made to halt further attempts to scan the tank bottom due to the possibility of the RUTI probe being permanently wedged between spalled concrete inside an air slot.

Based on the results of this examination, the material condition of the tank appears to be satisfactory for continued operation, pending results of the investigation of insulating concrete spalling, documented via Problem Evaluation Report PER-2003-3006 and the resulting DOE Occurrence Report RP-CHG-TANKFARM-2003-0039.

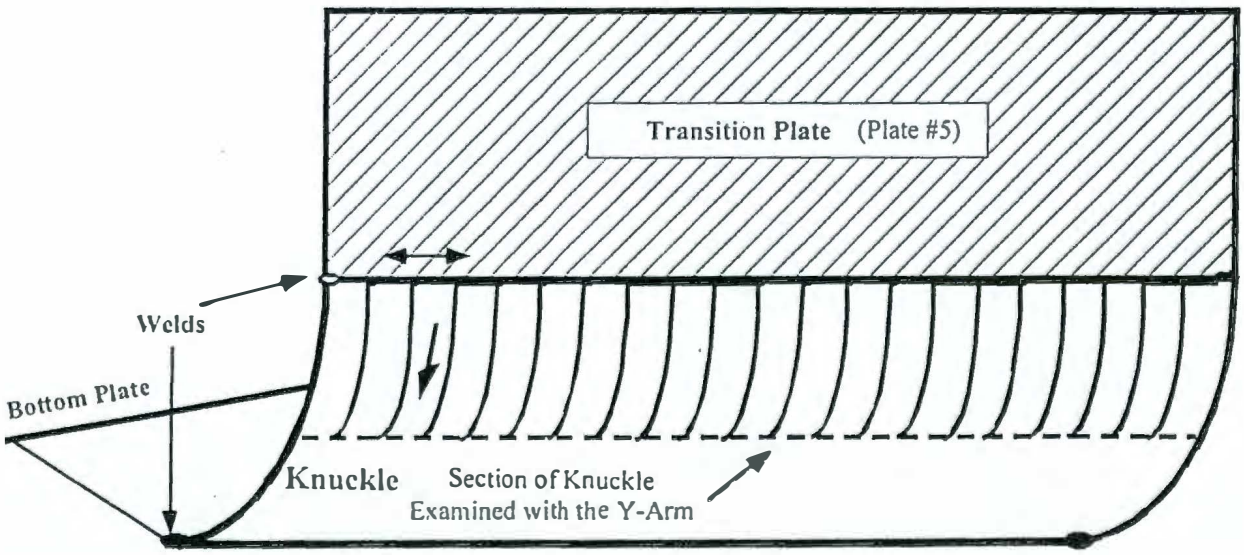
Figure 3.4. Sketch of a Section of the Knuckle Examined with the Extended-Arm Scanner

The upper portion of the knuckle area was scanned utilizing the Extended-Arm scanner attached to the AWS-5D crawler. The Extended-Arm scanned the transducers down around the knuckle approximately 12-in. from a starting position 2-in. down from the upper knuckle weld joining Plate #5 to the knuckle. The knuckle was examined for wall thinning, pitting, and cracks oriented circumferentially around the primary tank. The results indicated that the minimum thickness in the approximately 22 circumferential feet of knuckle area examined with nominal thickness of 0.875-in. was 0.840-in. There were no areas that exceeded the reportable level of 10% of the nominal thickness. No pitting or circumferentially oriented crack-like indications were detected in the upper portion of the knuckle area.

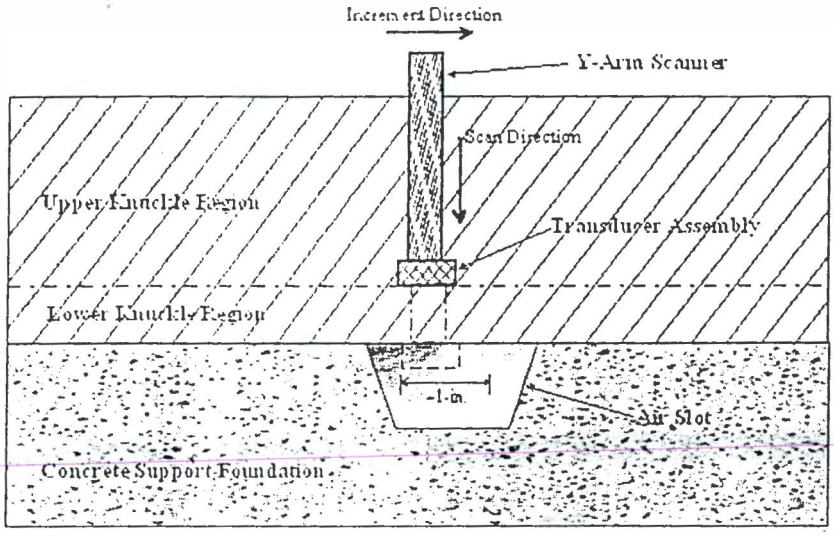
Figure 3.5. Lower Knuckle Examination in Air Slot Regions (End View)

Additional Extended-Arm scanning was done on areas that were accessible in the air slots that extend under the tank in the concrete support foundation. Figure 3.5 provides an end view (looking down the air slot) and Figure 3.6 provides a side view (looking along the circumference of the tank) of the examination of the lower knuckle in the region of the air slots.

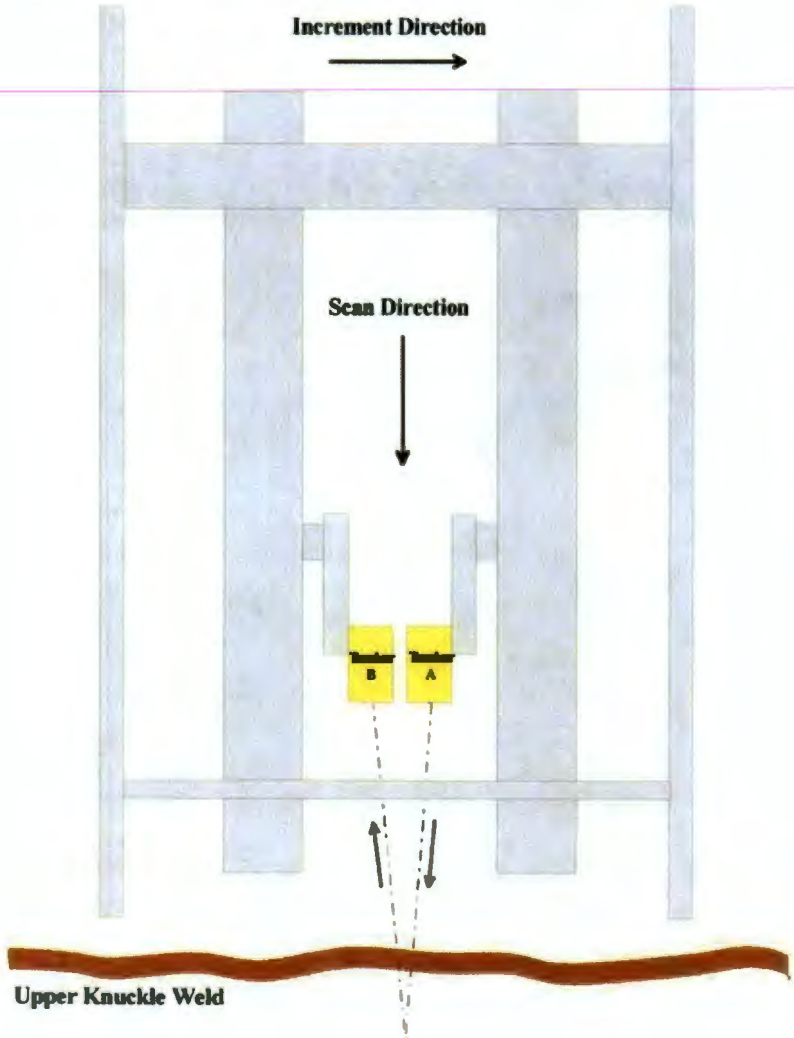
Figure 3.8 General Knuckle Scanning Arrangement

The functional diagram in Figure 3.8 shows two 70° angle-beam transducers in a pitch-catch arrangement for examining the knuckle region of the primary tank. The angle beam transducers are designed to detect and record any circumferential cracking that may be present. These transducers are

The results of the examination of Tank 241-AZ-102 indicated no circumferential cracking was present anywhere in the knuckle region between the upper knuckle weld and the predicted lower knuckle weld over the approximately 270 circumferential inches scanned.

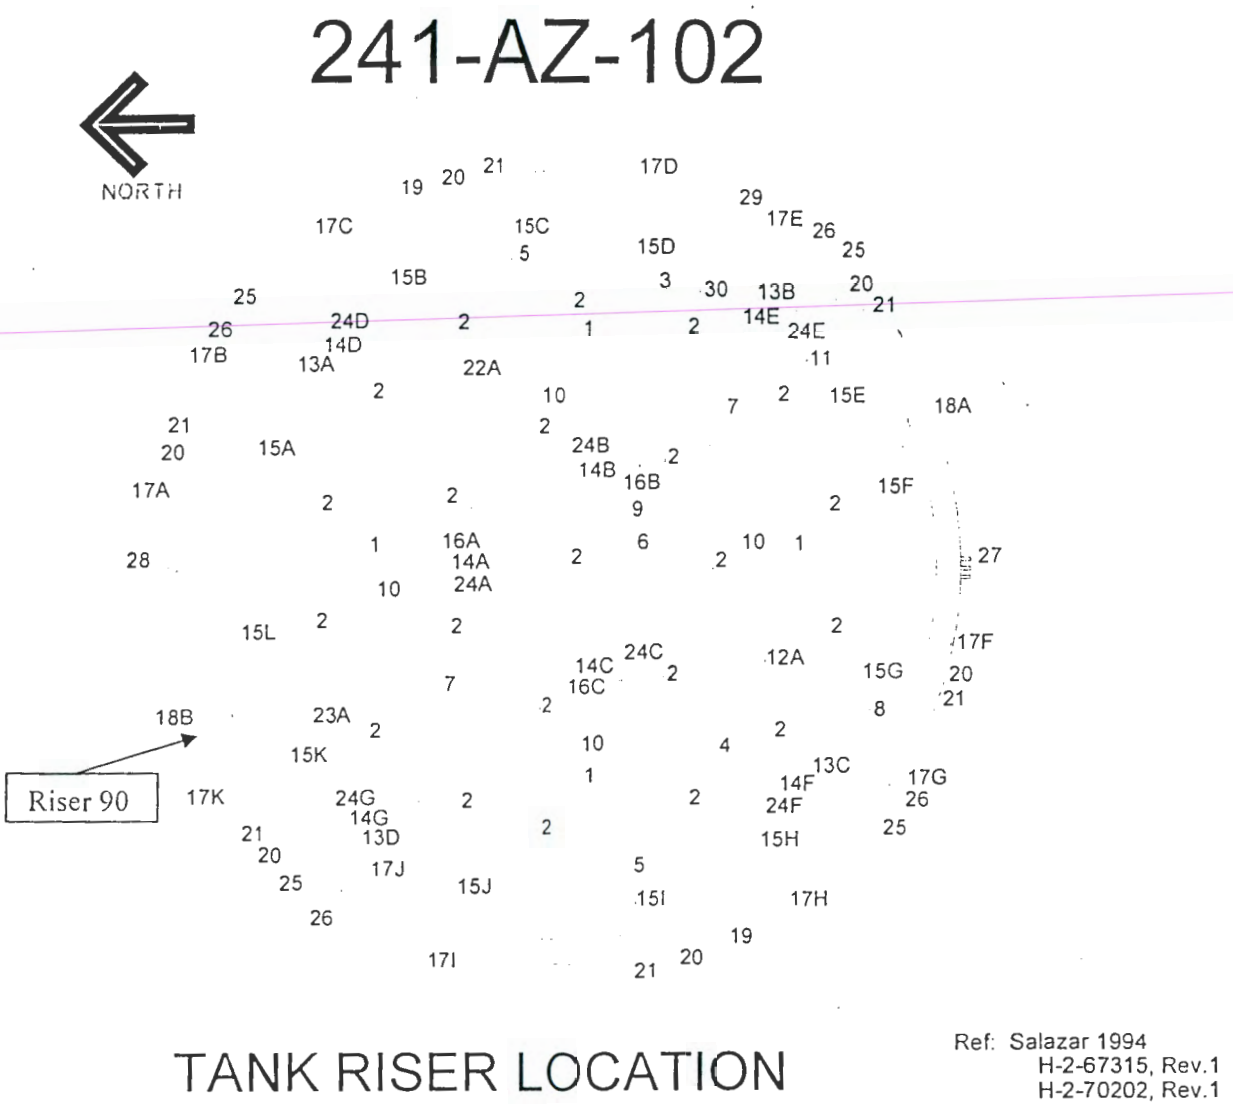
Figure 4.1. UT of 241-AZ-102 from Riser 90

Tank 241-AZ-102 is located in the Hanford 200 East area in AZ Tank Farm. The crawler and associated scanner that hold the transducers were lowered into the 24-in. riser located on the north side of 241-AZ-102 and designated as Riser 90. Riser 90 was originally called out as Riser 18B. Figure 4.1 provides a graphic of the location of this riser.

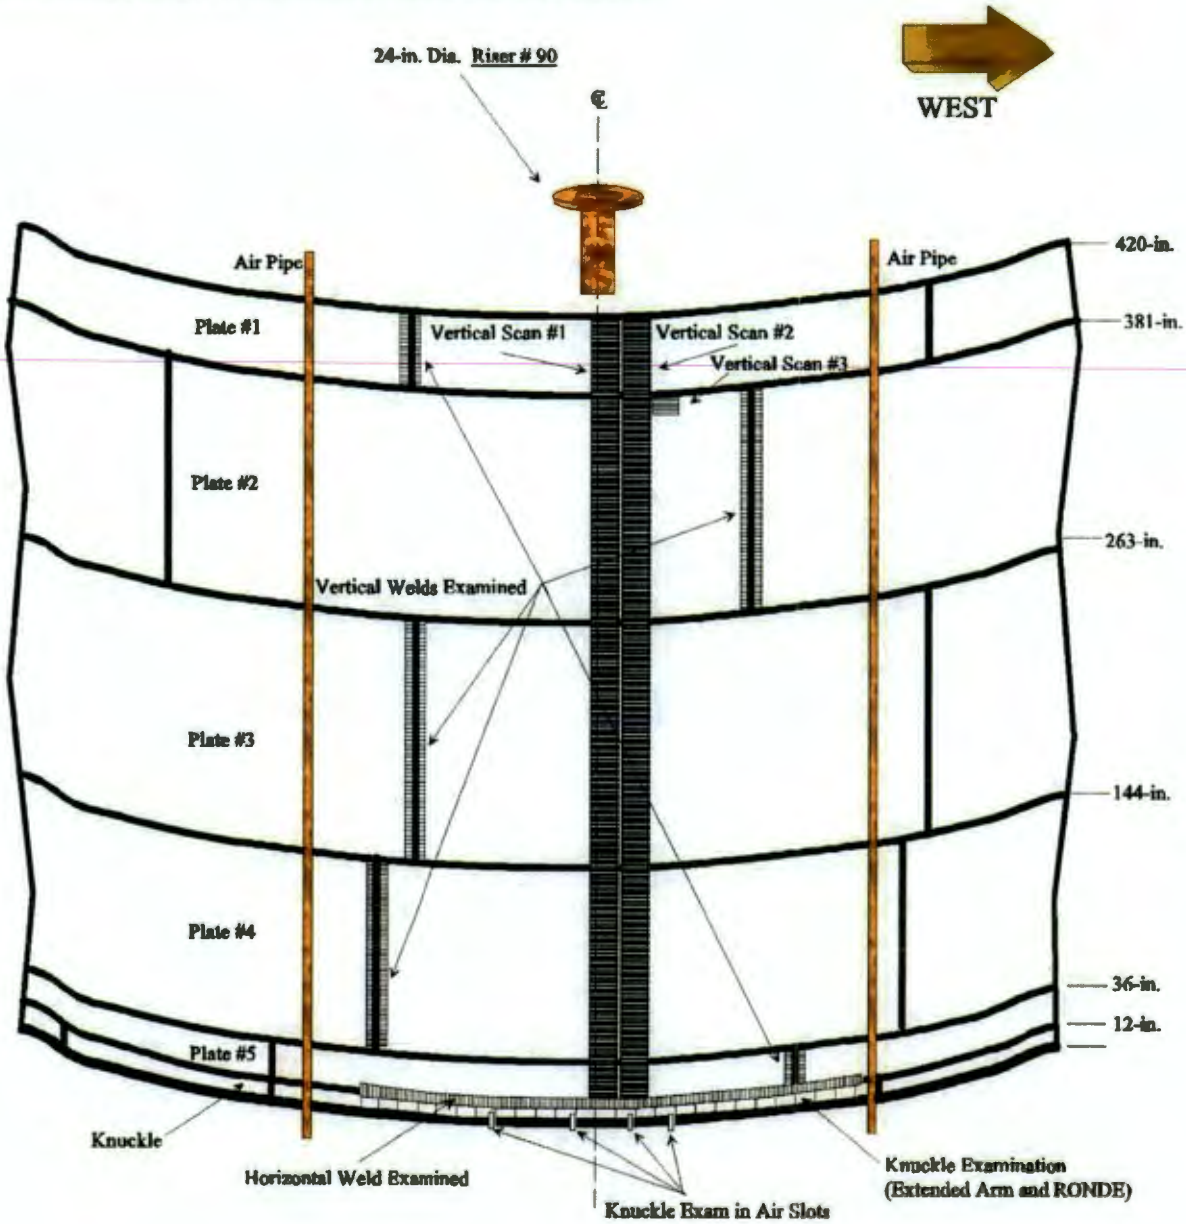
Figure 4.2. Sketch of Scan Paths on Tank 241-AZ-102

Figure 4.2 describes the areas on the primary wall of Tank 241-AZ-102 that were ultrasonically examined. Two 15-in.-wide vertical scan paths were performed on Plates #1, #2, #3, #4, and #5 below the entrance to Riser 90. A short third vertical scan was performed just west of Vertical Scan #2. Vertical weld HAZ examinations were done on Plates #1, #2, #3, #4, and #5, and the horizontal weld HAZ examination was done on the transition Plate #5 to knuckle weld. Approximately 270 circumferential inches of the knuckle region was also scanned.

Two 15-in.-wide scan paths were performed on Plates #1, #2, #3, #4, and #5 and one short 15-in. wide scan on the top of Plate #2. The plates were examined for wall thinning, pitting, and cracks oriented vertically on the primary tank wall. The results indicated that the nominal thickness in Plate #1 is 0.375-in. and the minimum thickness in this area was 0.338-in. The minimum thicknesses in the areas scanned with nominal thickness of 0.500-in. were as follows; Plate #2 was 0.411-in. and Plate #3 was 0.487-in. The nominal thickness in Plate #4 is 0.750-in. and the minimum thickness in this area was 0.752-in. The nominal thickness in Plate #5 is 0.875-in. and the minimum thickness in this area was 0.874-in. There were three areas of wall thinning that exceeded the reportable level of 10% of the nominal thickness. The areas were located near the top of Plate #2. No pitting or vertical crack-like indications were detected in Plates #1, #2, #3, #4, or #5.

The HAZ of vertical welds in Plates #1, #2, #3, #4, and #5 were examined for wall thinning, pitting and cracks oriented either perpendicular or parallel to the weld. The results indicated that the minimum thicknesses in the weld areas scanned were as follows: The nominal thickness of Plate #1 is 0.375-in. and the minimum thickness in this weld area was 0.312-in. The nominal thickness of Plate #2 is 0.500-in. and the minimum thickness in this weld area was 0.473-in. The nominal thickness in Plate #3 is 0.500-in. and the minimum thickness in this weld area was 0.474-in. The nominal thickness in Plate #4 is 0.750-in. and the minimum thickness in this weld area was 0.739-in. The nominal thickness in Plate #5 is 0.875-in. and the minimum thickness in this weld area was 0.850-in. There were three areas of wall thinning that exceeded the reportable level of 10% of the nominal thickness. The areas were located in the HAZ of the vertical weld in Plate #1. No pitting or crack-like indications were detected in the weld areas in Plates #1, #2, #3, #4, or #5.

The HAZ of the horizontal weld between Plate #5 and the tank knuckle was examined for wall thinning, pitting and cracks oriented either perpendicular or parallel to the weld. The results indicated that the minimum thickness in the weld area with nominal thickness of 0.875-in. on Plate #5 was

0.842-in. The minimum thickness in the weld area with nominal thickness of 0.875-in. on the knuckle was 0.837-in. There were no areas of wall thinning that exceeded the reportable level of 10% of the nominal thickness. No pitting or crack-like indications were detected in the weld areas on Plate #5 side or on the knuckle side of the horizontal weld.
