TRANSMITTAL OF APPROVED WASTE SITE RECLASSIFICATION FORM AND SUPPORTING DOCUMENTATION FOR THE 600-149:1, SMALL ARMS RANGE, REVISION 0

Date Submitted: 06/08/2010 Originator: M. L Proctor Phone: 372-9227	**WASTE SITE RECLASSIFICATION FORM** Operable Unit(s): 100-IU-6 Waste Site Code: 600-149:1 Type of Reclassification Action: Closed Out ☐ Interim Closed Out ☒ No Action ☐ RCRA Postclosure ☐ Rejected ☐ Consolidated ☐	Control Number: 2011-028

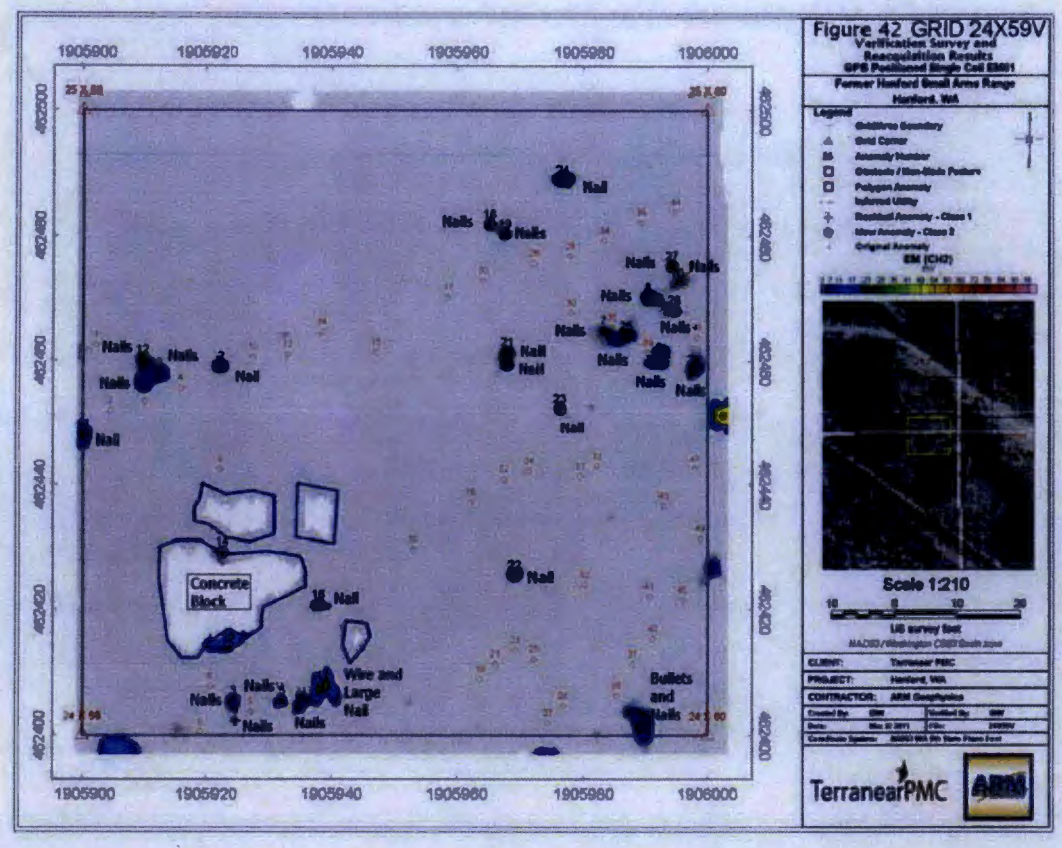
Figure 42 GRID 24X59V
Verification Survey and Reacquisition Results
Former Hanford Small Arms Range
Hanford, WA
Legend
Scale 1:210
Concrete Block
Nail
Nails
Wire and Large Nail
Bullets and Nails
TerranearPMC

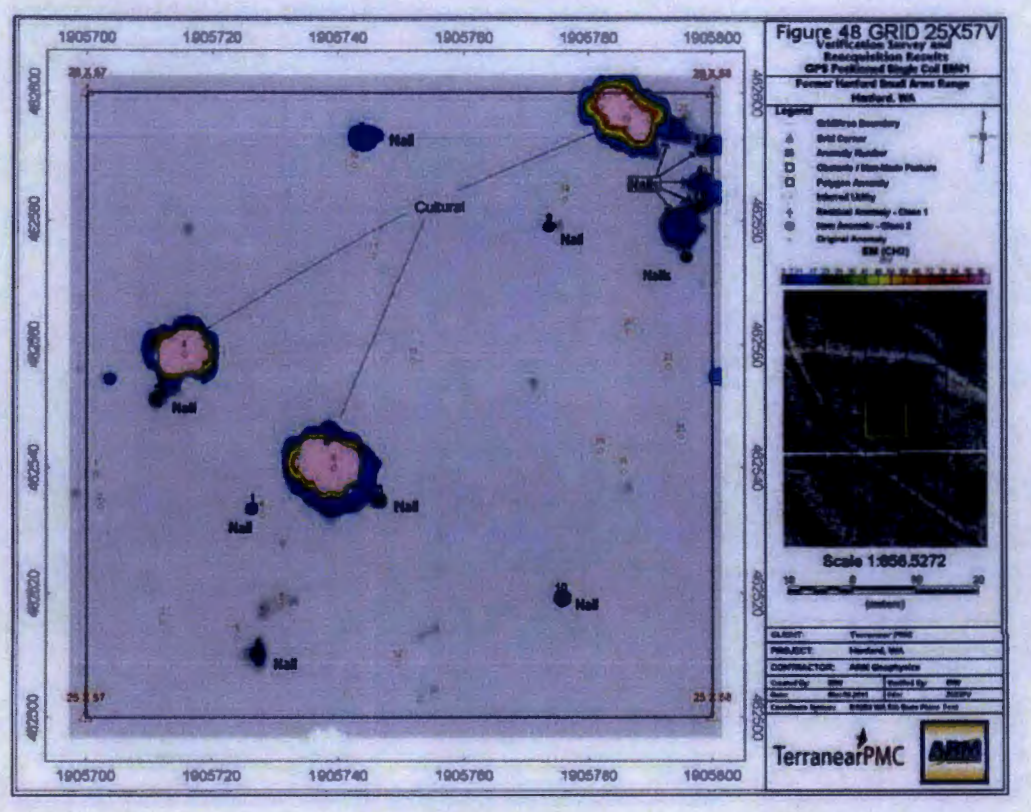
Figure 48 GRID 25X57V
Former Hanford Small Arms Range
Hanford, WA
Legend
Scale 1:656.5272
TerranearPMC
Nail
Cultural
1905700
1905720
1905740
1905760
1905780
1905800

3. Elevated counts (5+ items) of ordnance related material (larger than shell casings) were found in grids 33x63, 25x56, 25x57, 20x65, 19x62, 20x61, 22x62, 23x60, 21x60, 22x60, 25x58, 28x58, 22x61; and

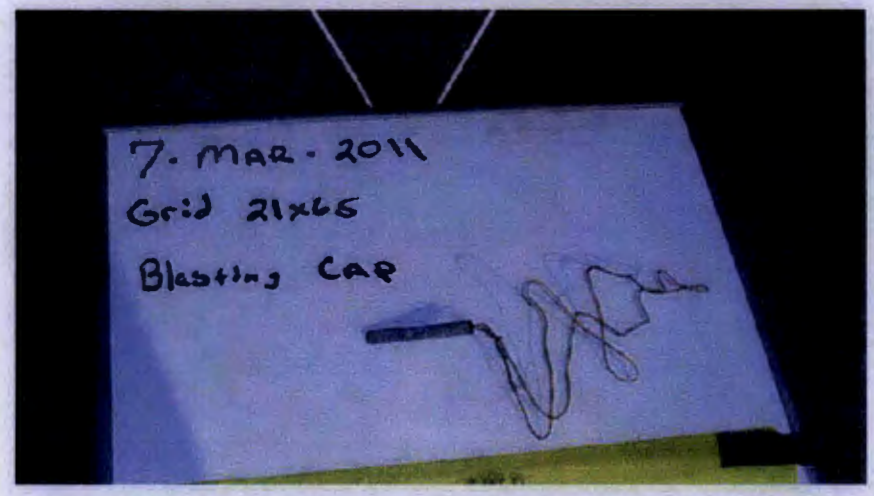
Photo 16 - Blasting Cap

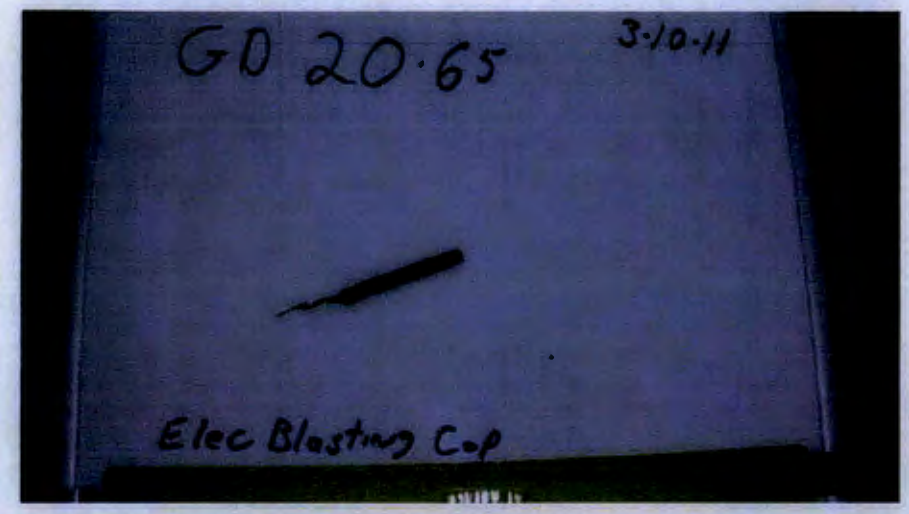
Photo 17 - Blasting Cap

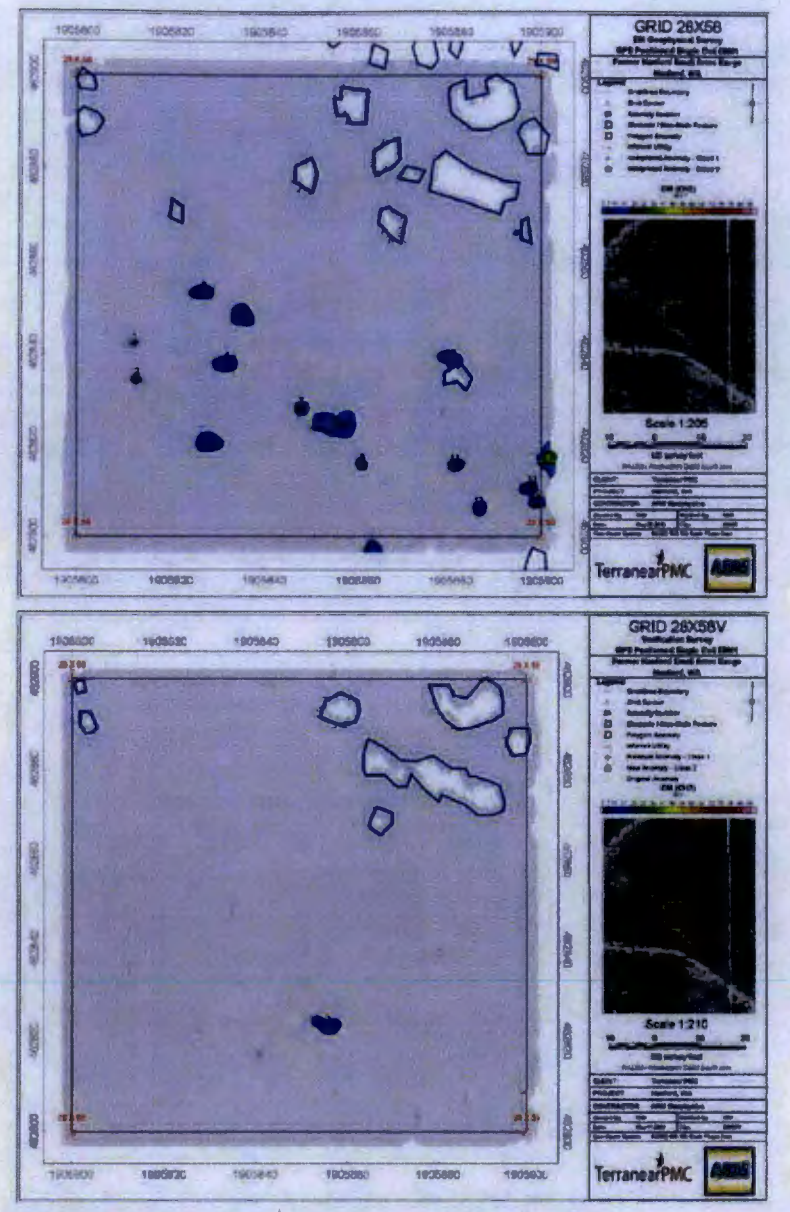
2. Where regions of response remain, the response is generally lighter or more fragmentary, implying that remaining anomalies, particularly those in locations where there was not a previous pick, may be due to broken-up sections of original anomalies disturbed during the intrusive process. The exceptions to this are areas noted as being either piles of concrete or exclusion zones which were not present during the original surveys;

Comparison of (Top) Original and (Bottom) Verification Data
