FACILITY STATUS CHANGE FORM
(for DOE/RL-2010-34 Facilities)

Date Submitted:	Area:	Control #:
Jun 6, 2013	100-B	D4-100B-001
Originator:	**Facility ID:**	
David Warren	151-B Switchgear Building	
Phone:	**Action Memorandum:**	
539-6040	General Hanford Site Decommissioning Activities

Attachment 2: Map and Photographs of the 151-B Facility

151-B Visual Inspection Photographs

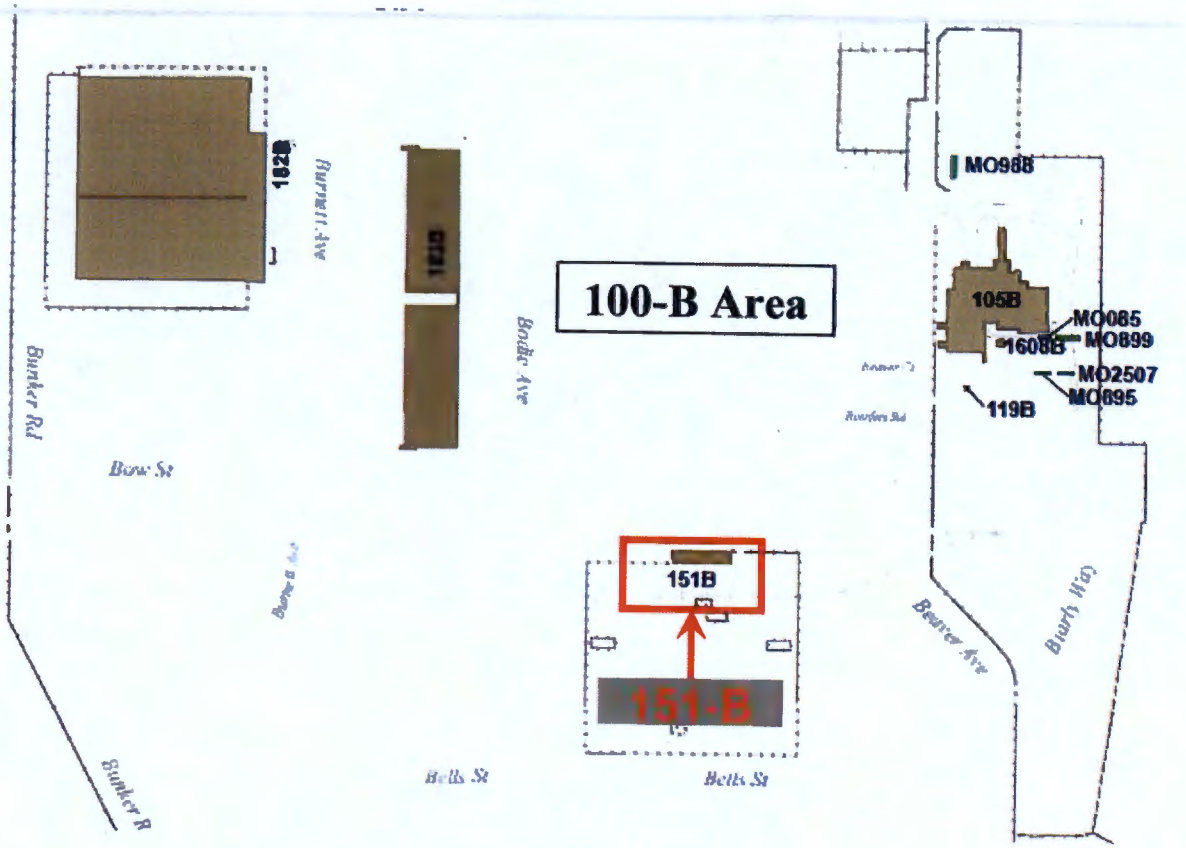
Photo of the 151-B Facility Before Demolition

151-B Switch House Completion

Photo of 151-B Facility following demolition/excavation

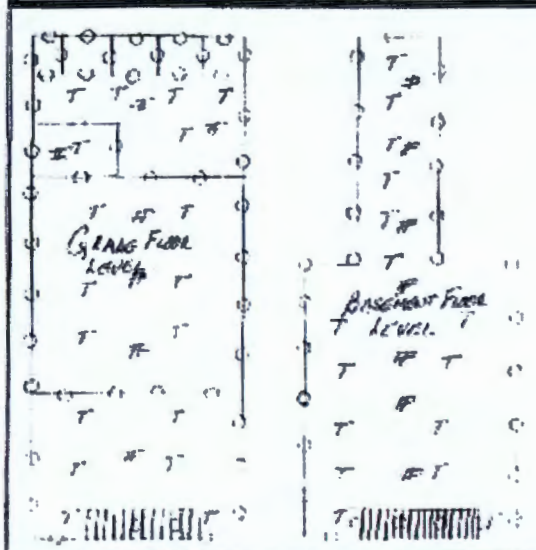
A. Floor of Basement & Grade Level has Direct Access to Terranean Surface >30
B. Walls (18" thk), Cable Trays, Conduit Parts, Stairs, Misc. Appurtenances against the Entire Perimeter >30
C. No Surveys Performed Above 8' due to Accessibility.
D. Note: Is currently Not Certified on Grade Level Access Surveyed on Some Floor Slabs
E. No Contaminated Found
