FACILITY STATUS CHANGE FORM

Date Submitted:	Area:	Control #:
12-5-2012	100-N	D4-100N-0026
Originator:	**Facility ID:**	
David Warren	116-N Exhaust Air Stack	
Phone:	**Action Memorandum:**	
(509) 539-6040	100-N Ancillary Facilities

D4 Project Facility Completion Form

116-N Exhaust Air Stack Completion

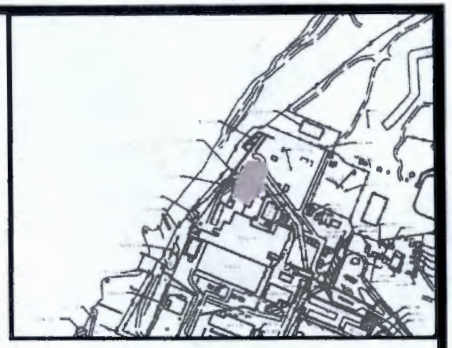
100N D4
116/117-N
GPERS Radiological Survey
Beta Track Map

Global Positioning Environmental Radiological Surveyor (GPERS) down-posting surveys were performed at the site in October of 2012. The surveys indicated that no contamination was present within the 116-N excavation. The area was transferred to FR to perform verification sampling of the adjacent, collocated, WIDS sites. The GPERS surveys are included in Attachment 3. The surveys are summarized in Table 2 below.

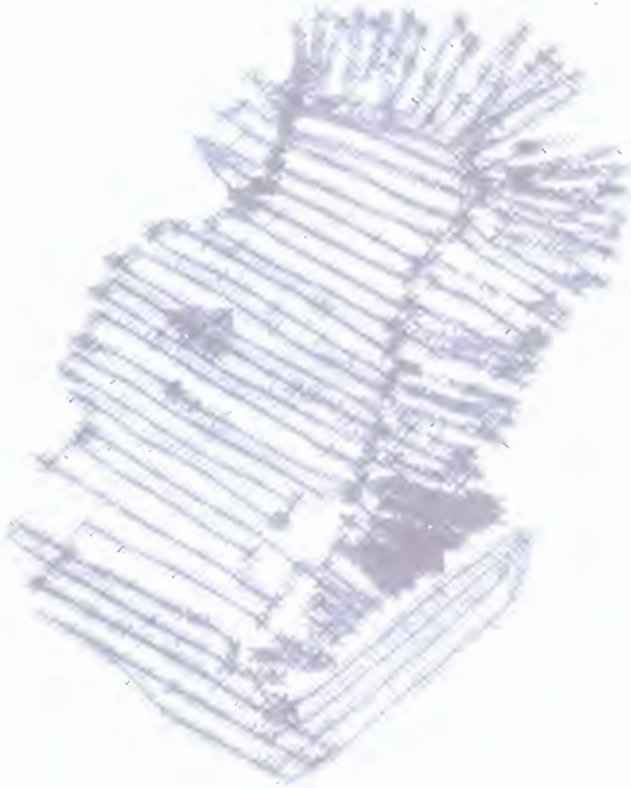
100N D4
116/117-N
GPERS Radiological Survey
Gamma Track Map

Coverage File: N277, N291A
Number of Data Pnts: 5391
Type of Survey: gamma
Max GCPM: 2676
Avg Bkg CPM: 1226
Survey Date: 10/3,17,25/2012
Area Surveyed: 2,686 m^2
Project File: 100ND4_116_117
Pdf File: 100ND4_116_117_N
