FACILITY STATUS CHANGE FORM

Date Submitted:	Area:	Control #:
Feb 13, 2013	100-N	D4-100N-0035
Originator:	**Facility ID:**	
David Warren	117-N and 117-NVH	
Phone:	**Action Memorandum:**	
539-6040	100-N Ancillary Facilities

117-N Exhaust Air Filter House & 117-NVH Valve Control House Completion

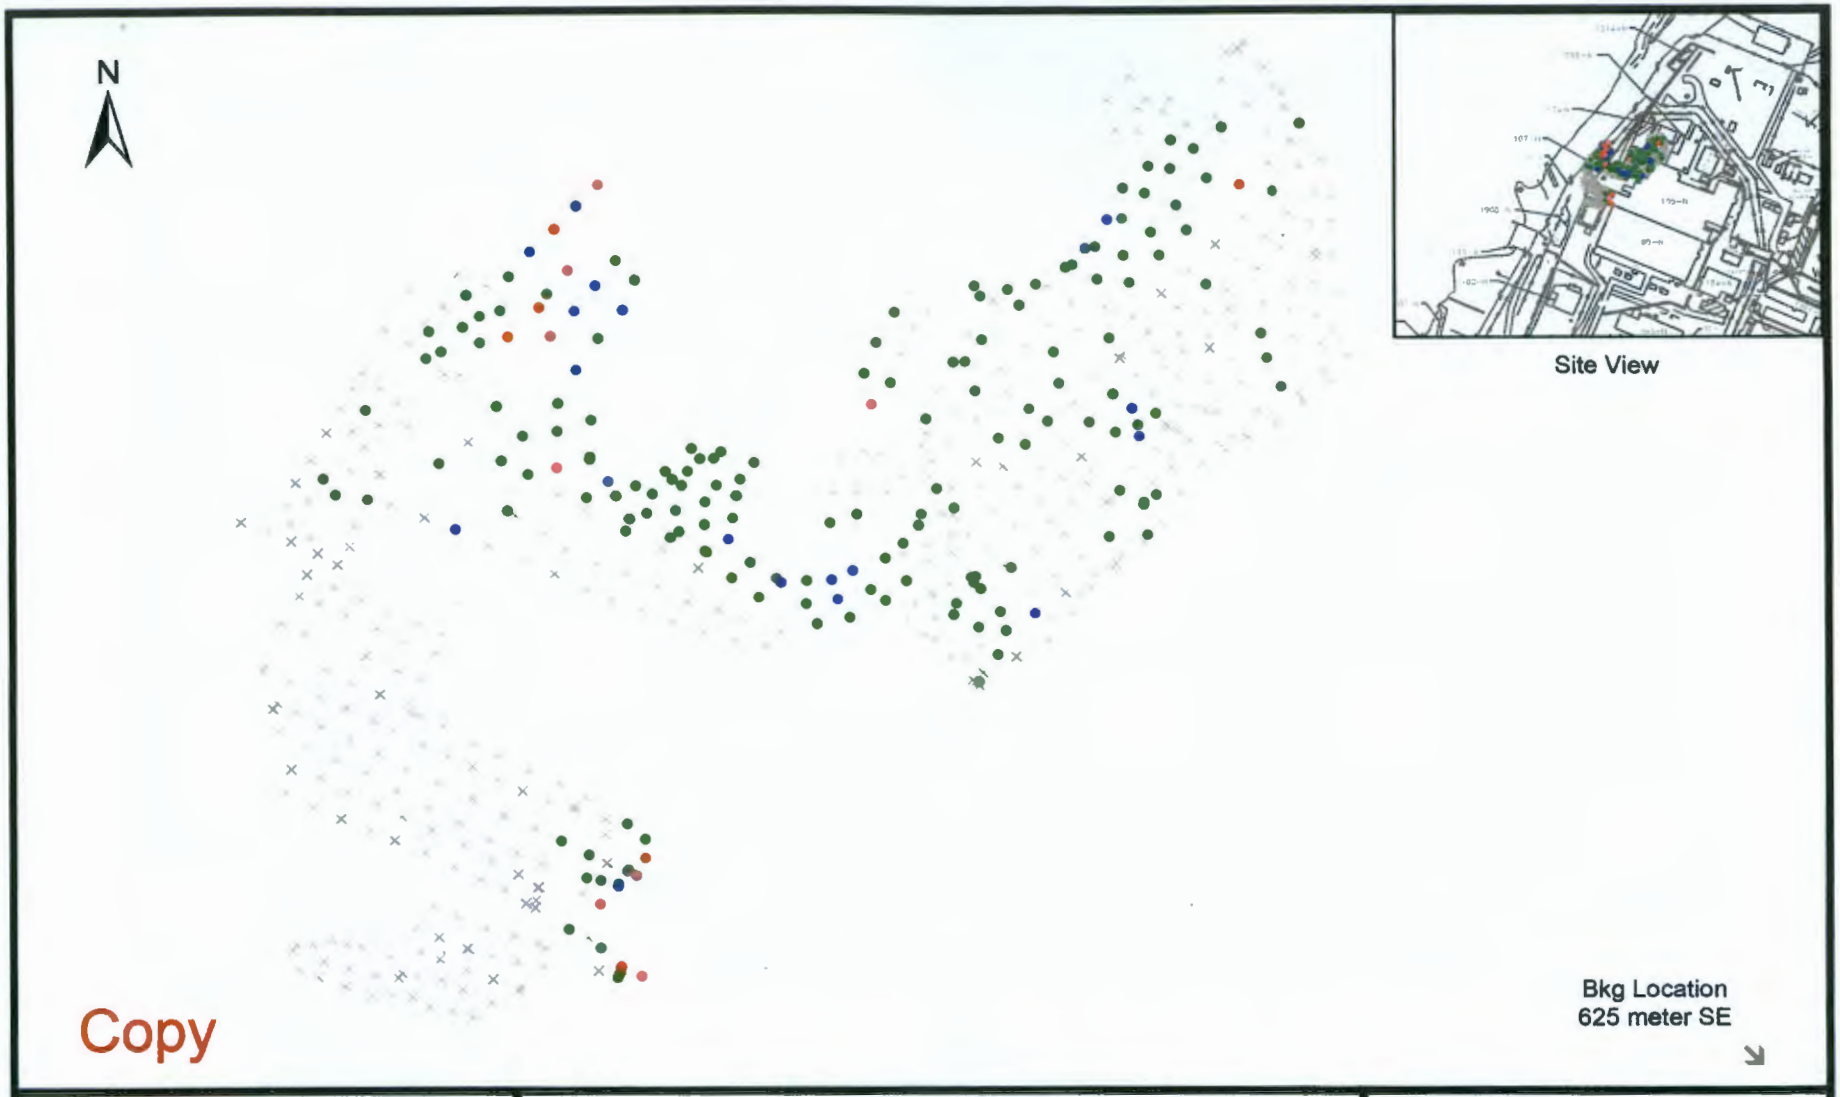
100N D4
1303-N Work Zones
GPERS Radiological Survey
Beta Track Map

Coverage File: N,NN349, A,B,C
Number of Data Pnts: 652
Type of Survey: beta
Max GCPM: 139,217
Avg Bkg CPM: 401
Survey Date: 12/14/2012
Area Surveyed: 2250 m^2
Project File: ESRFRM120150B
Pdf File: ESRFRM120150BC

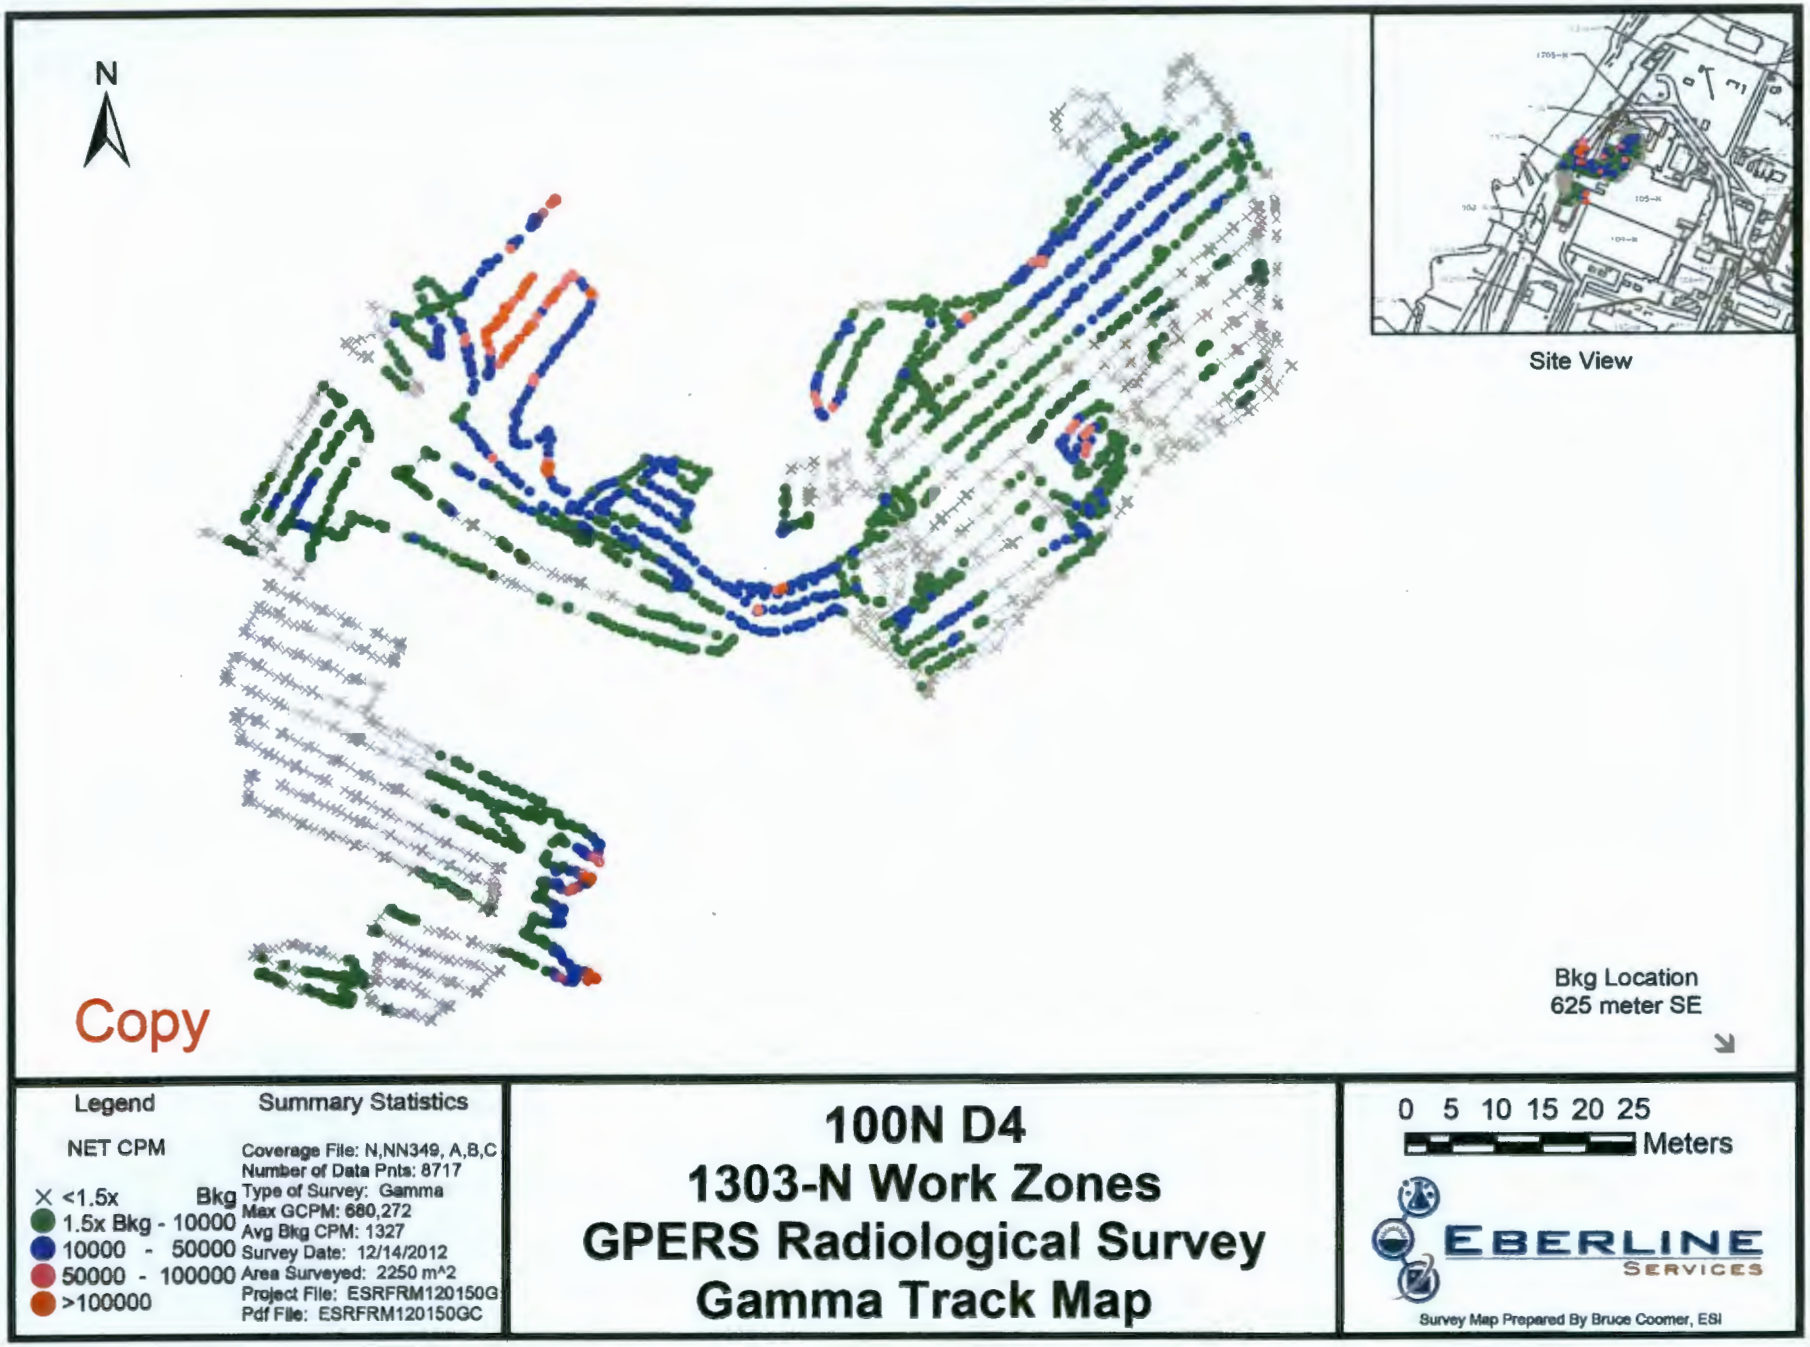
N
Site View
Bkg Location
625 meter SE
Copy
Legend
NET CPM
<1.5x Bkg
1.5x Bkg - 10000
10000 - 50000
50000 - 100000
>100000
Summary Statistics
Coverage File: N,NN349, A,B,C
Number of Data Pnts: 8717
Type of Survey: Gamma
Max GCPM: 680,272
Avg Bkg CPM: 1327
Survey Date: 12/14/2012
Area Surveyed: 2250 m^2
Project File: ESRFRM120150G
Pdf File: ESRFRM120150GC
100N D4
1303-N Work Zones
GPERS Radiological Survey
Gamma Track Map
0 5 10 15 20 25
Meters
EBERLINE
SERVICES
Survey Map Prepared By Bruce Coomer, ESI

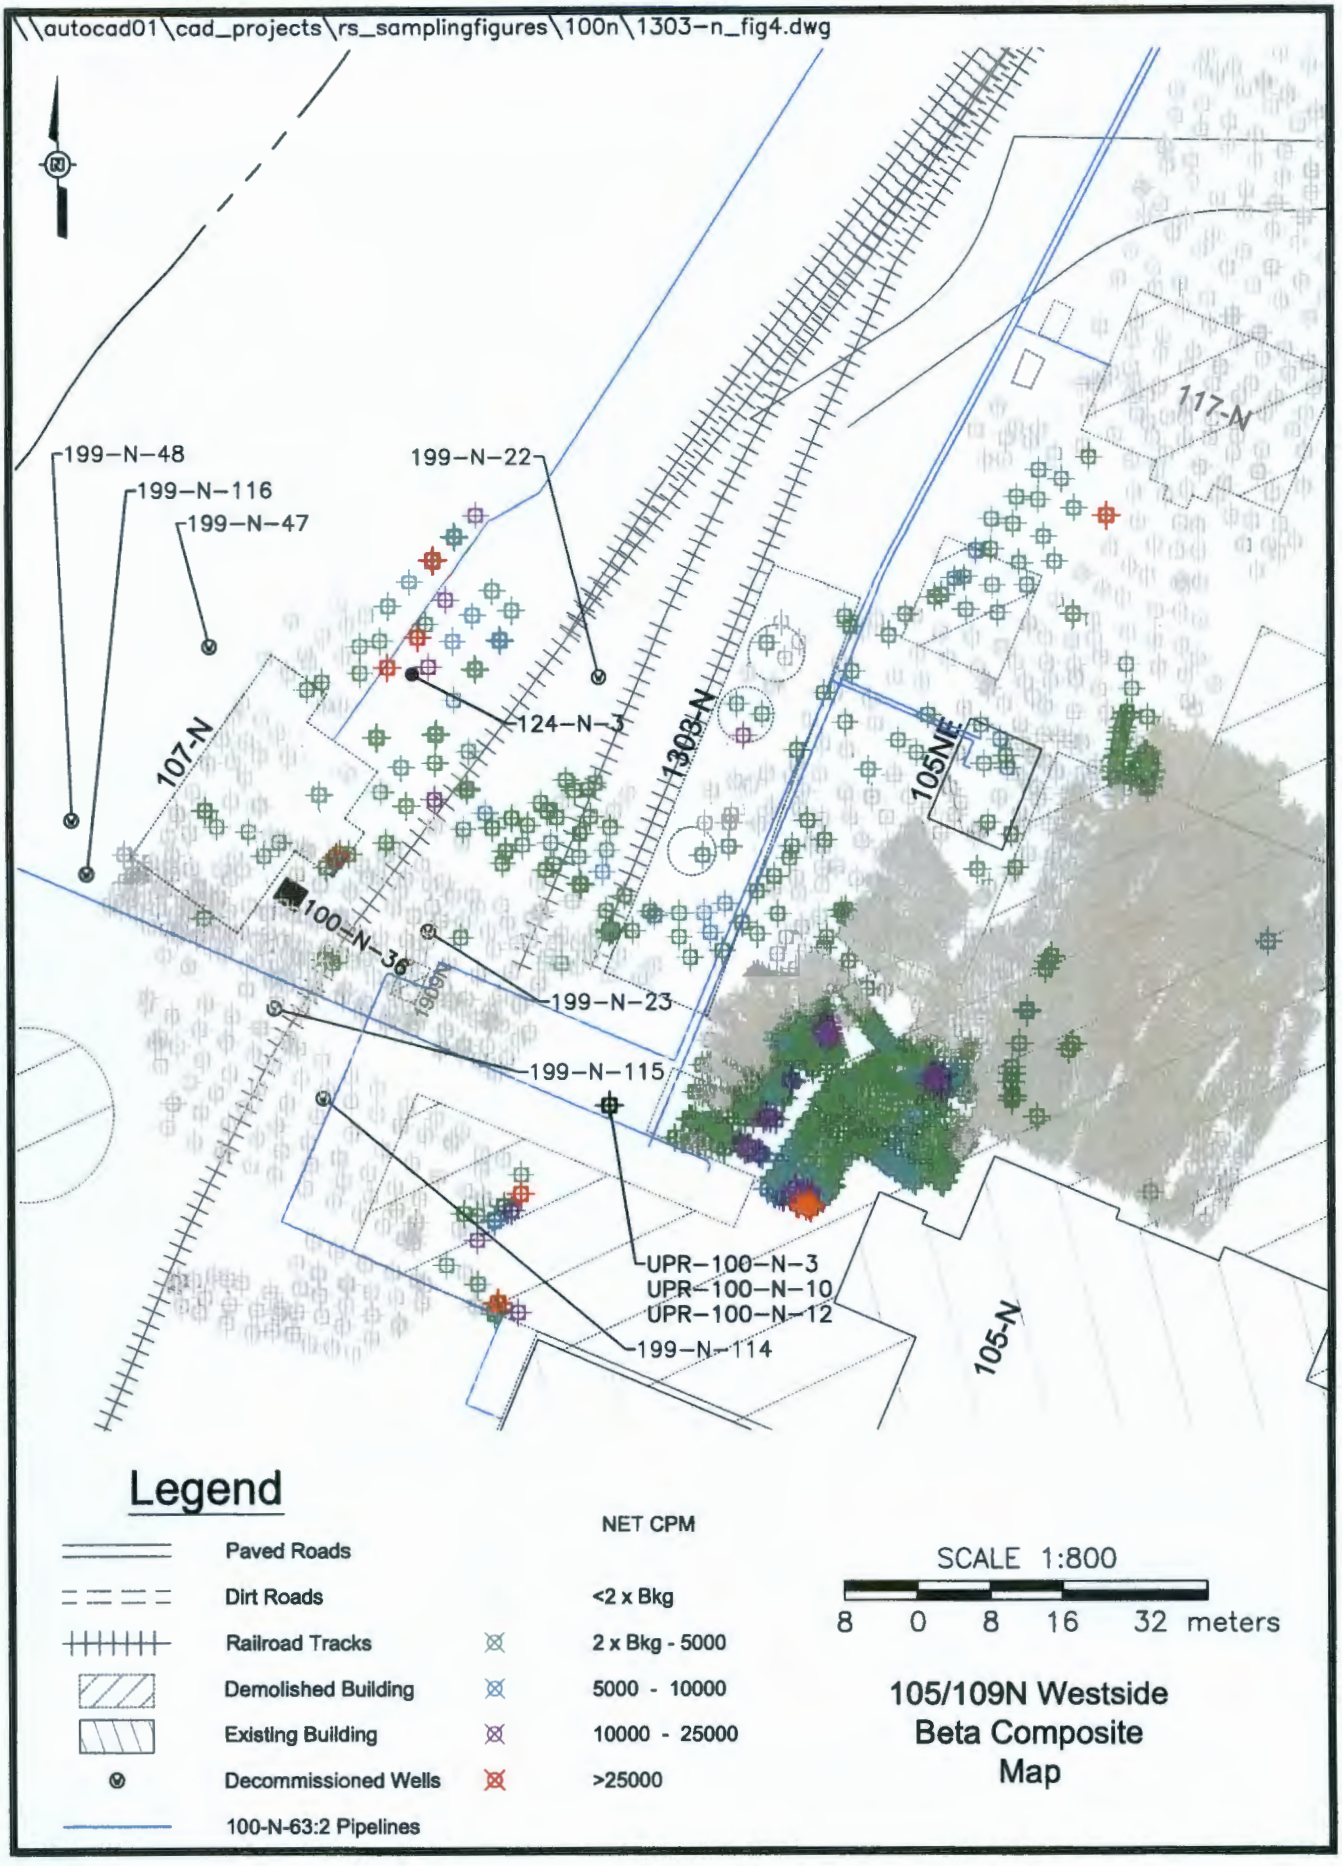
\\autocad01\cad_projects\rs_samplingfigures\100n\1303-n_fig4.dwg
199-N-48
199-N-116
199-N-47
199-N-22
124-N-3
107-N
1303-N
105NE
117-N
100-N-36
199-N-23
199-N-115
UPR-100-N-3
UPR-100-N-10
UPR-100-N-12
199-N-114
105-N
Legend
Paved Roads
Dirt Roads
Railroad Tracks
Demolished Building
Existing Building
Decommissioned Wells
100-N-63:2 Pipelines
NET CPM
<2 x Bkg
2 x Bkg - 5000
5000 - 10000
10000 - 25000
>25000
SCALE 1:800
8 0 8 16 32 meters
105/109N Westside
Beta Composite
Map

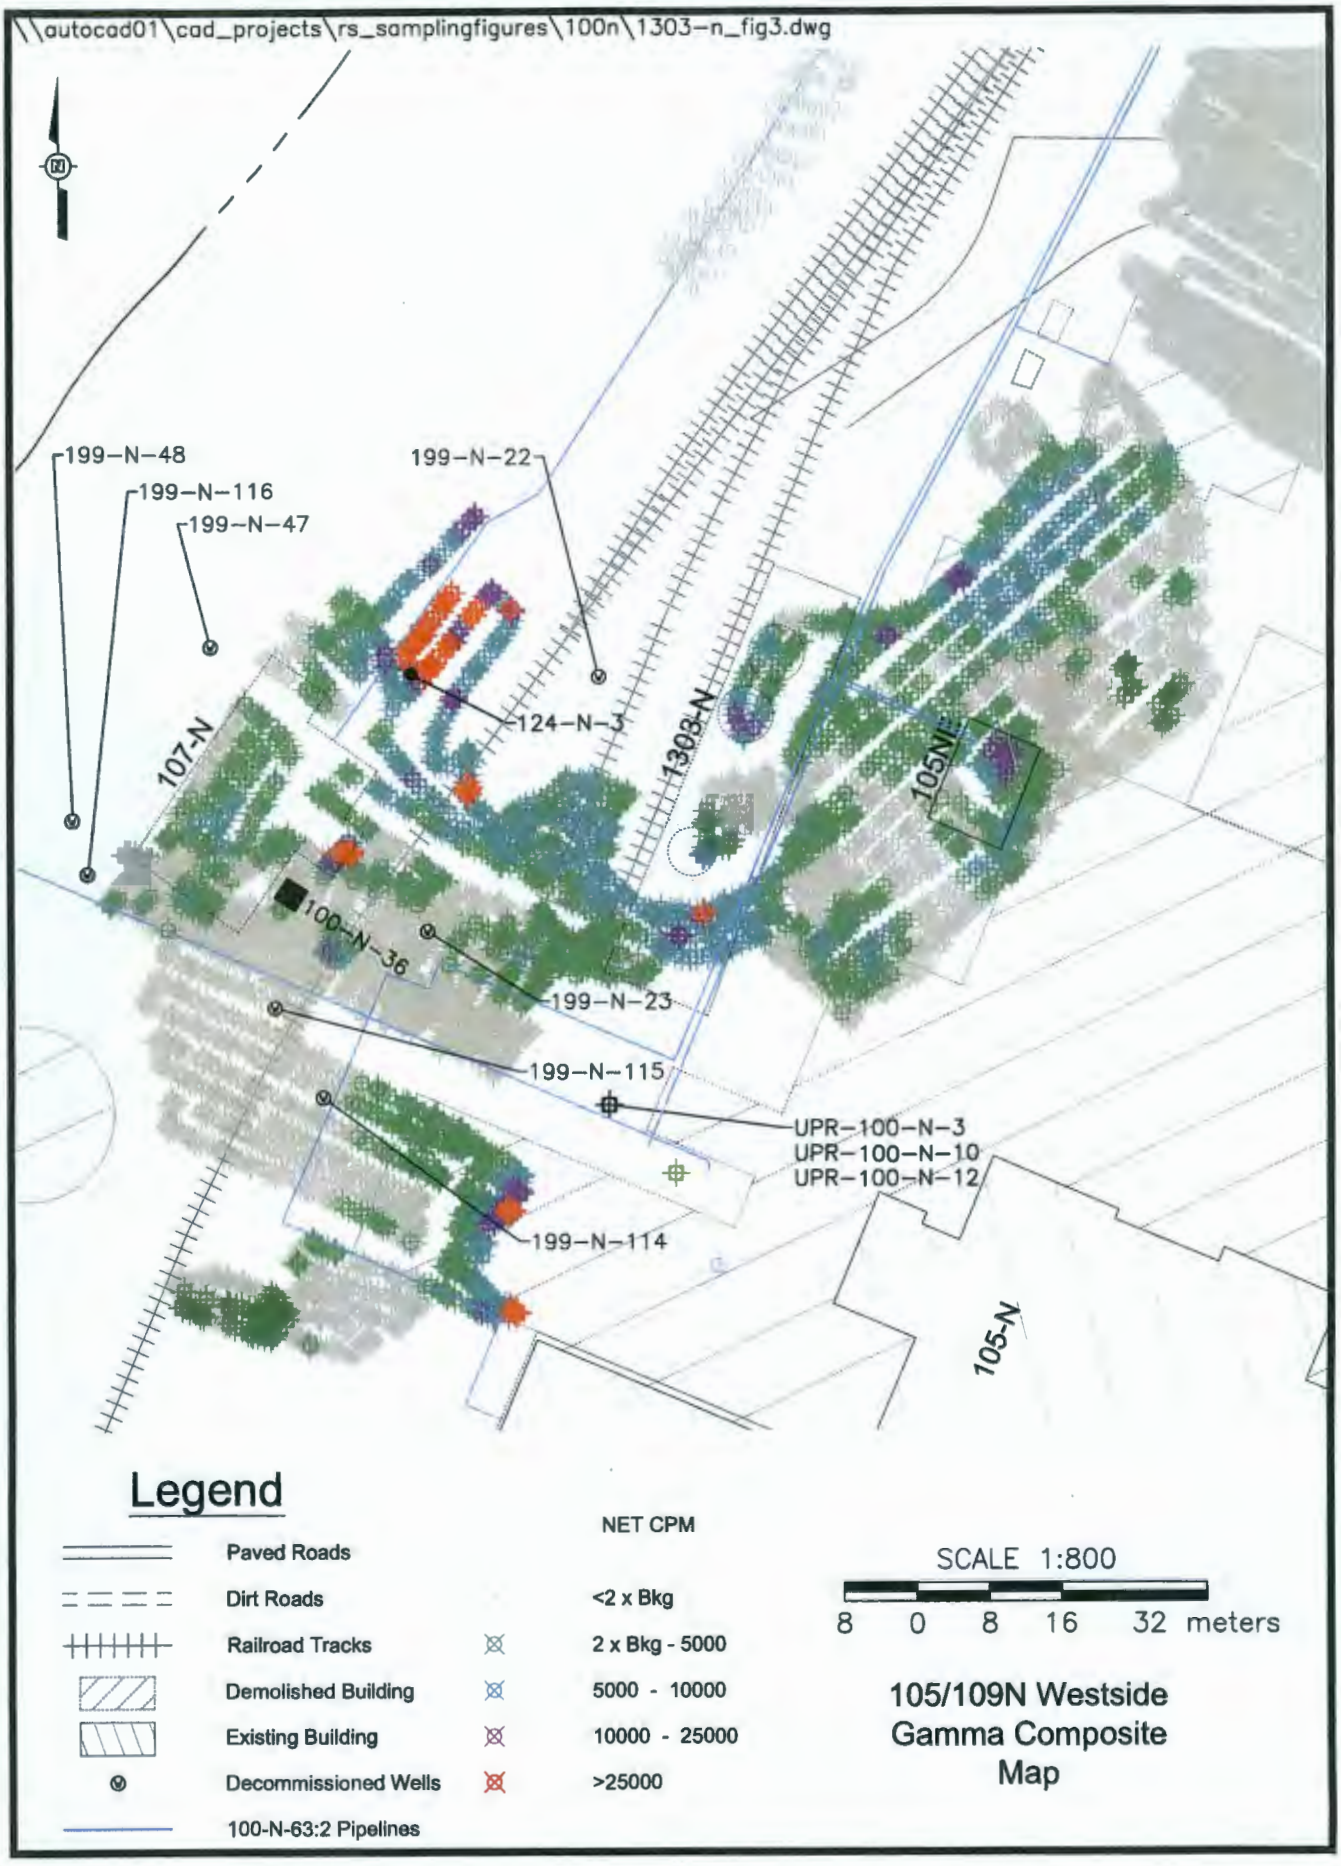
\\autocad01\cad_projects\rs_samplingfigures\100n\1303-n_fig3.dwg
199-N-48
199-N-116
199-N-47
199-N-22
124-N-3
107-N
1303-N
105N
100-N-36
199-N-23
199-N-115
UPR-100-N-3
UPR-100-N-10
UPR-100-N-12
199-N-114
105-N
Legend
Paved Roads
Dirt Roads
Railroad Tracks
Demolished Building
Existing Building
Decommissioned Wells
100-N-63:2 Pipelines
NET CPM
<2 x Bkg
2 x Bkg - 5000
5000 - 10000
10000 - 25000
>25000
SCALE 1:800
8 0 8 16 32 meters
105/109N Westside
Gamma Composite
Map
