FACILITY STATUS CHANGE FORM

Date Submitted:	Area:	Control #:
August 7, 2013	300 Area	D4-300-090
Originator:	**Facility ID:**	
Chris Strand	3906, 3906B	
Phone:	**Action Memorandum:**	
554-2720	Action Memorandum #3

3906 Lift Station

3906B Lift Station

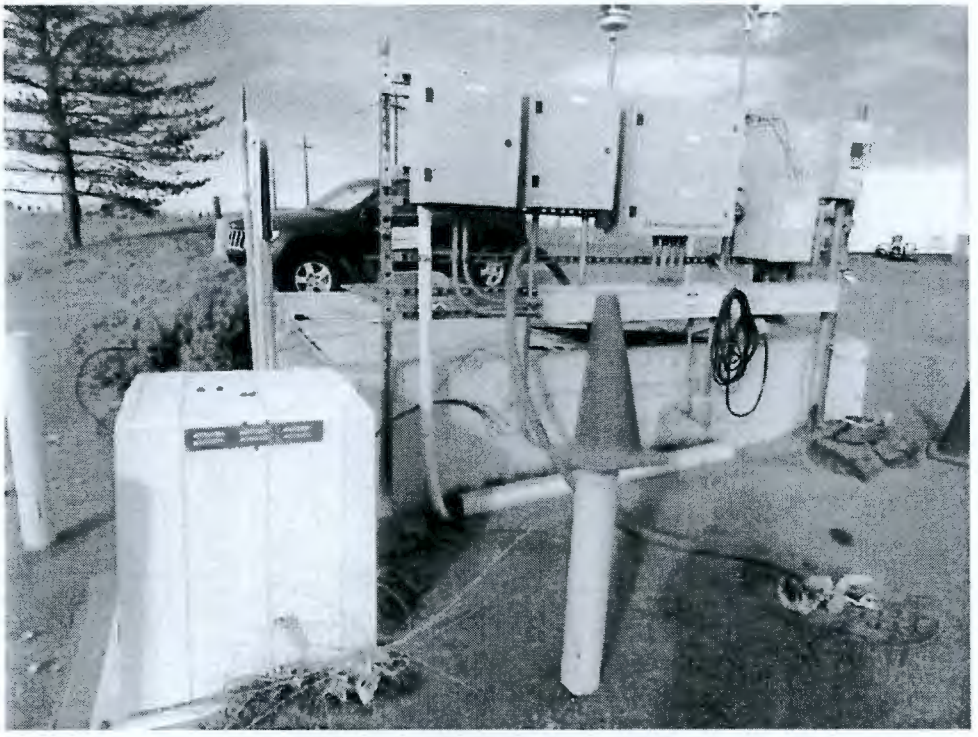
Photograph 1: 3906 Lift Station, looking west on February 22, 2013.
