SGW-64372
Revision 0

100-D/H Continuing Hexavalent Chromium Source Evaluation

Date Published
April 2020

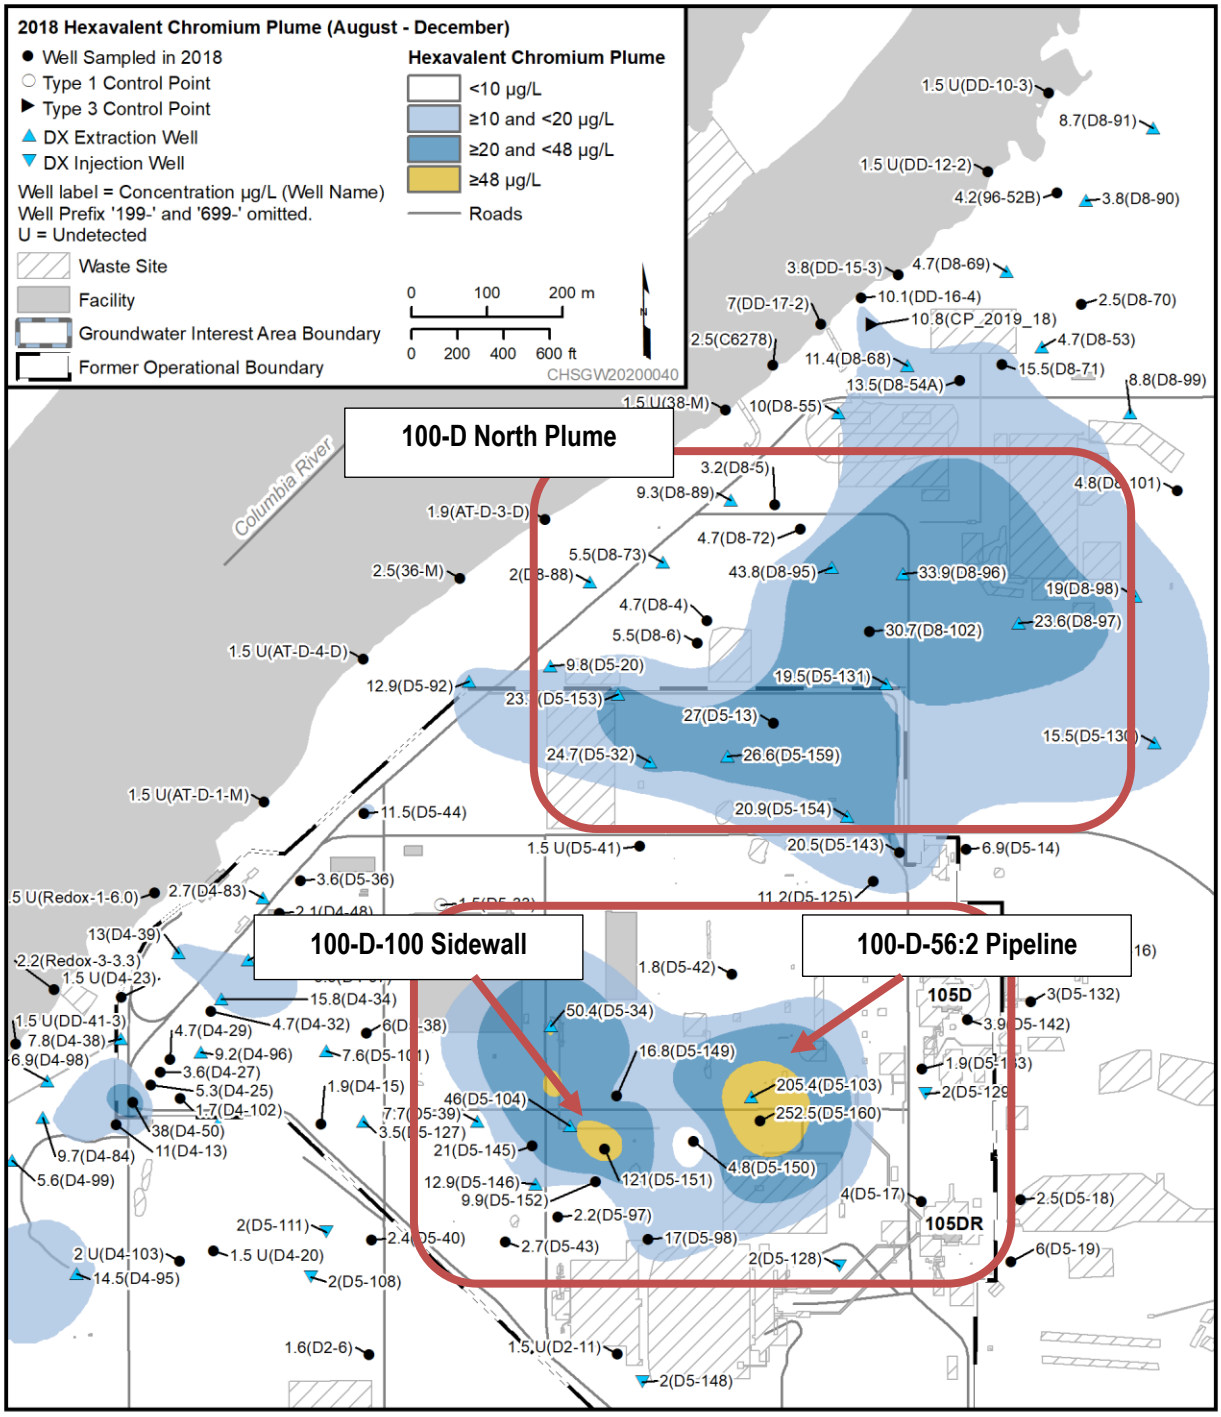
Figure 1. 100-D Area Cr(VI) Plumes and Areas with Potential Sources, 2018

The 100-D operational area includes two major Cr(VI) plume areas: one in the south and one in the north. Figure 1 shows the potential source area locations and the 2018 Cr(VI) plumes.

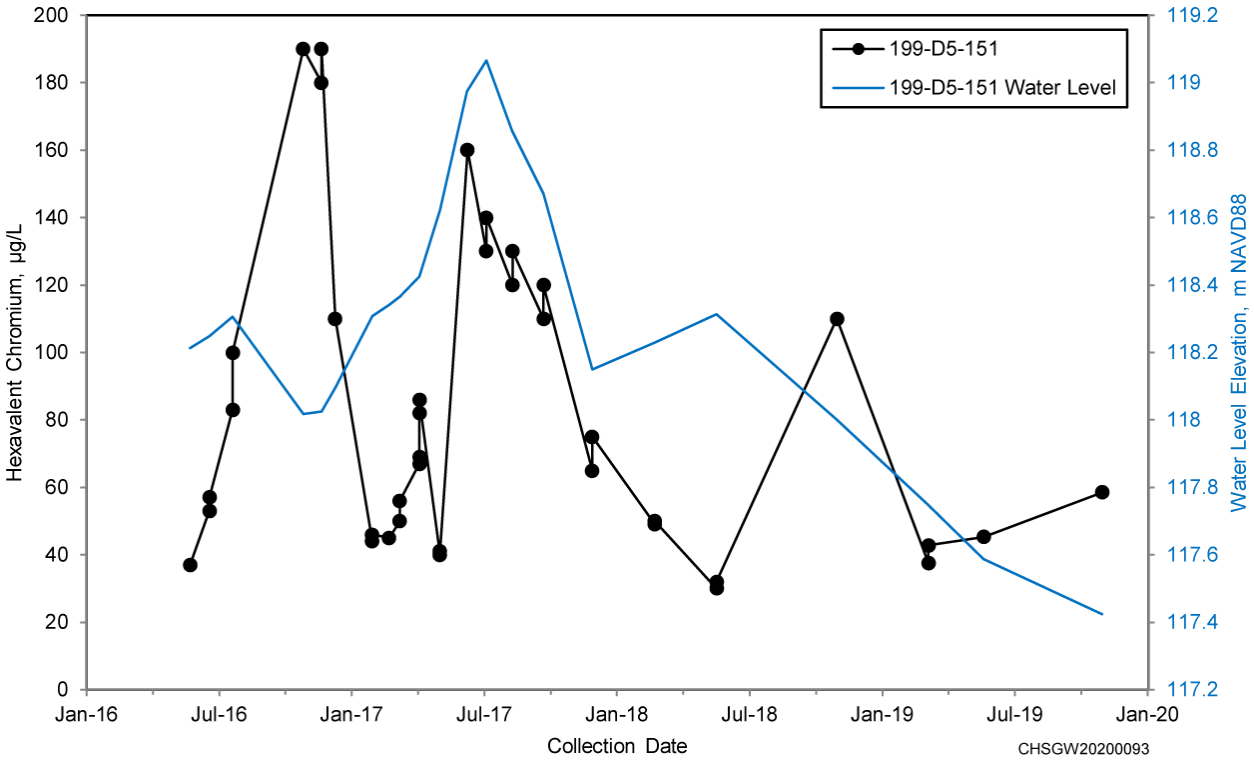
Figure 2. Cr(VI) Concentrations Response to Groundwater Fluctuation at Well 199-D5-151

- Elevated Cr(VI) in groundwater at well 199-D5-151 responds to groundwater fluctuations. Increased concentrations have been noted when the water table is high. Concentrations have remained >40 µg/L in well 199-D5-151 (Figure 2) since June 2016. Figure 3 shows the Cr(VI) plume, the location of well 199-D5-151 and other wells in the area, and the extent of the excavation footprint.

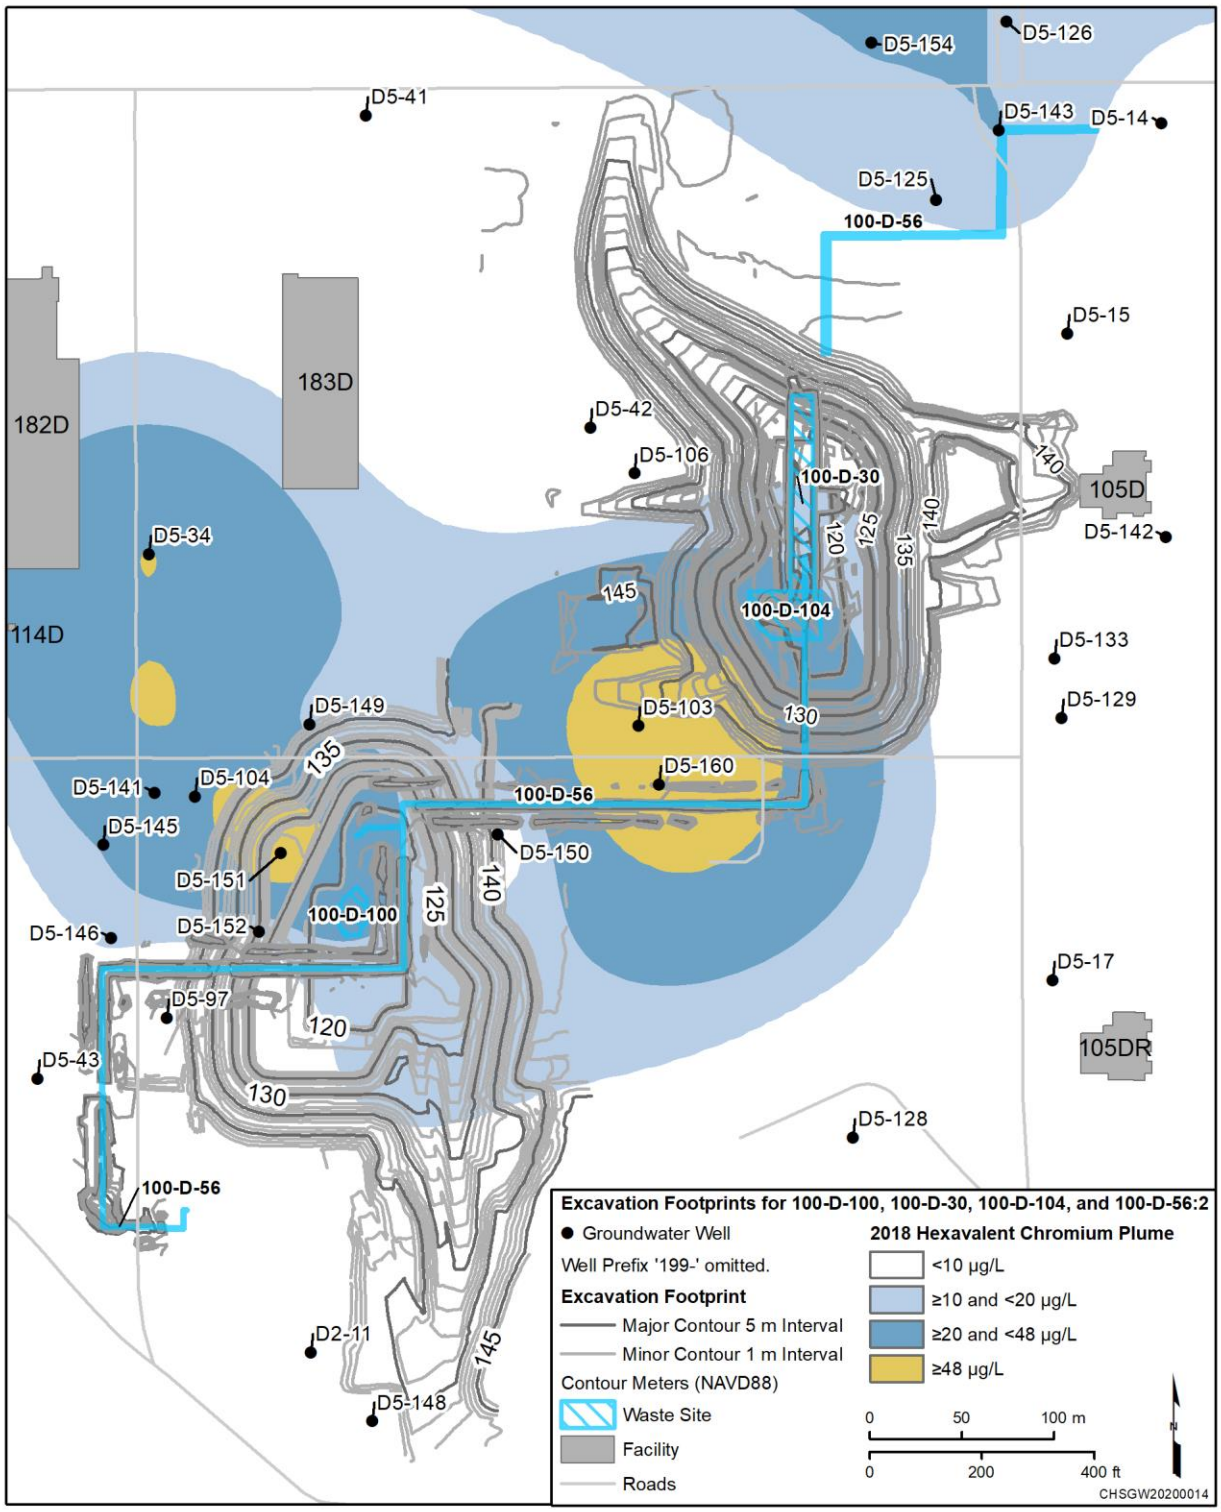
Figure 3. Cr(VI) Plume and Previous Excavation Extent Details

A continuing Cr(VI) source is known to be present along the former 100-D-56 sodium dichromate supply pipeline that was remediated in 2006, of which 100-D-56:2 is the southern segment. As shown in Figures 3 and 4, later remediation of the 100-D-100 waste site extended over a portion of the 100-D-56:2 remediation footprint. The secondary source is likely located east of the 100-D-100 excavation footprint, based on the following lines of evidence. It should be noted, however, that the exact location of source material is not well defined, and there may be more than one area contributing to the elevated Cr(VI) at well 199-D5-103.

- Persistent Cr(VI) concentrations are noted in groundwater near the former pipeline at wells 199-D5-103 and 199-D5-160 (Figures 3 and 5). Previous contaminant concentrations in well 199-D5-103 also show the influences from changes of the P&T system configuration and river-stage fluctuations.
- The pipeline is a likely candidate for the Cr(VI) at well 199-D5-103; however, it should be noted that the 100-D-104 excavation may have also left residual material.

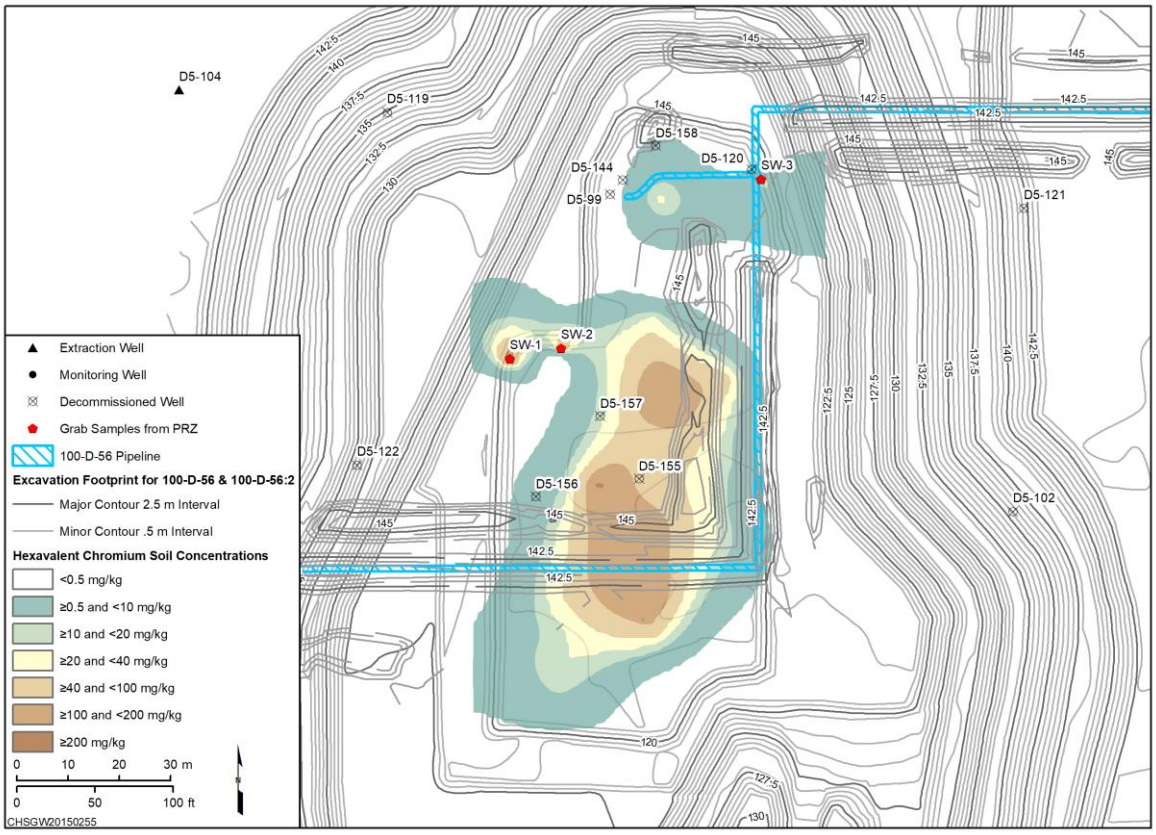
Figure 4. Cr(VI) Soil Sample Results at 100-D-100 Waste Site Excavation

- Soil samples at locations SW-1 and SW-2 collected during the excavation of 100-D-100 had elevated Cr(VI), as shown in Figure 4 (SGW-58416, *Persistent Source Investigation at 100-D Area*). The sidewall area was not excavated due to the depth and size of the excavation and the proximity of nearby structures. The extent of the contamination is not known but is assumed to be limited based on the small area of elevated groundwater contamination in the area.

- Soil samples at location SW-3 were collected during the excavation of 100-D-100 near the former 100-D-56:2 pipeline (Figure 4). Analytical results at SW-3 had detected levels of Cr(VI), with concentrations in the SW-3 samples collected above the capillary fringe having a maximum value of 6.47 mg/kg Cr(VI) (SGW-58416). Visually stained soil was noted in that area, indicating the concentration may have been higher than indicated by the SW-3 results. The sidewall area was not excavated. The area of contamination at SW-3, while not well defined, is likely to be contributing to the western portion of the Cr(VI) plume (and concentrations at well 199-D5-104) based on the groundwater flow direction in that area.

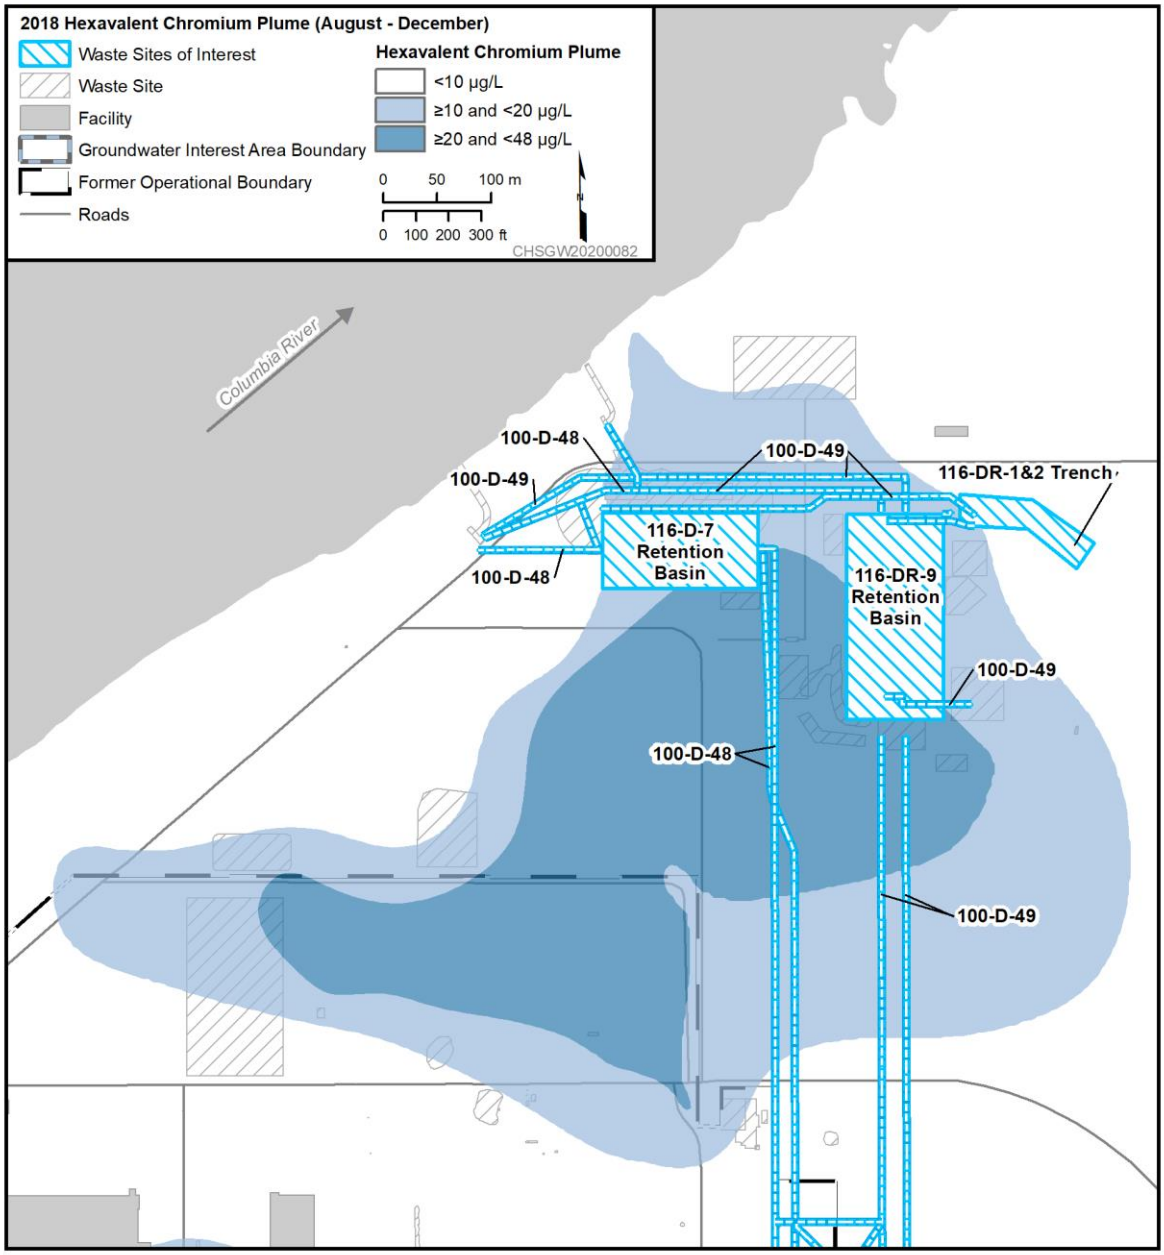
Figure 6. Cr(VI) Plume in the 100-D North Area

Waste sites in the northern portion of 100-D have been remediated. However, even though source area removals have been completed, Cr(VI) levels remain >20 µg/L in multiple wells (Figure 6). The persistent contamination in groundwater indicates the potential for a secondary source. The location of a secondary source has not been determined; however, several possible source areas are discussed in the following sections. Other potential causes for the slow reduction in Cr(VI) concentrations include the presence of mass in a lower transmissivity zone and/or hydraulic effects of stagnation due to the alignment of extraction wells in the area.

The area at 100-D North is not considered a candidate for soil flushing or excavation at this time due to the undefined area that may need remediation. After the Cr(VI) plume has been further remediated and the plume footprint is smaller, a rebound test is recommended to identify a potential treatment area.

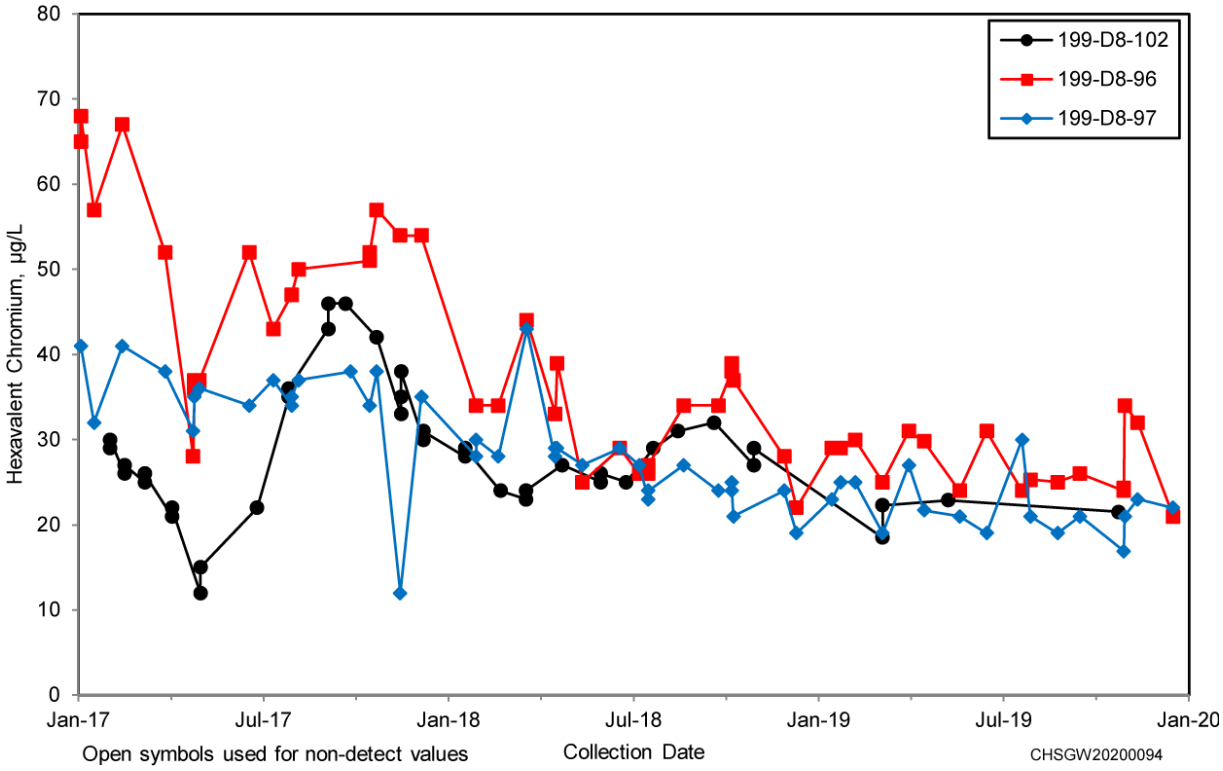
Figure 7. Cr(VI) Concentrations in 100-D North Area Wells

- Cr(VI) groundwater concentrations in wells in the 100-D North Plume have been slowly decreasing but remain >10 µg/L. As shown in Figure 7, the concentration decrease in wells 199-D8-96, 199-D8-97, and 199-D8-102 is becoming asymptotic, indicating that source material may be leaching from the vadose zone into the groundwater.

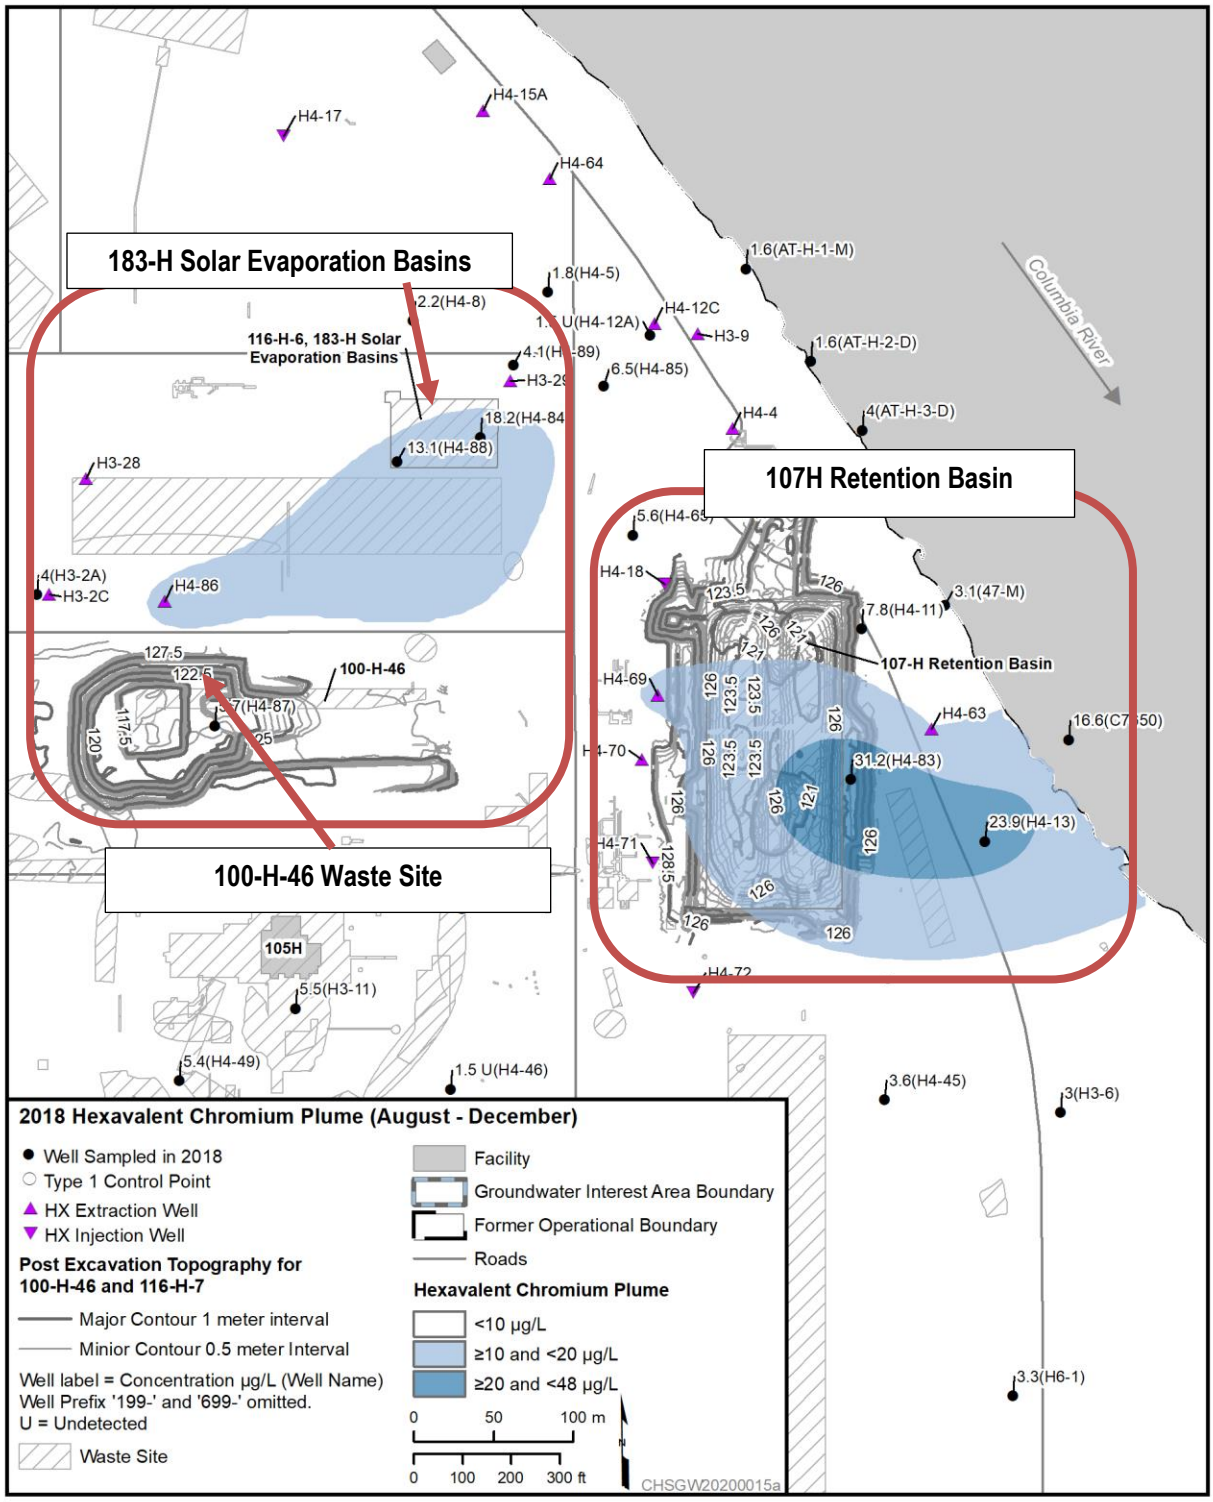
Figure 8. 100-H Area Cr(VI) Plumes with Excavation Footprints, 2018

Two Cr(VI) plumes remain in the 100-H operational area: a plume near the 183-H Solar Evaporation Basins and a plume near the 107H Retention Basin (Figure 8). The plume near the 183-H Solar Evaporation Basins extends upgradient to extraction well 199-H4-86, which is located on the edge of the excavation area for the 100-H-46 contaminated soil waste site. The 100-H-46 waste site is discussed separately as a potential secondary source area. The areas where a secondary source is known or suspected are discussed in the following sections. Figure 8 presents the site locations and the 2018 Cr(VI) plumes.

- A Cr(VI) plume remains persistent in the area of the former retention basin, regardless of ongoing groundwater extraction in the area (Figure 8).
- Monitoring well 199-H3-21, which was drilled on the edge of the 107H Retention Basin (116-H-7 waste site), had Cr(VI) concentrations at 25 µg/L in July 11, 2019. Upgradient wells 199-H4-69, 199-H4-70, and 199-H4-71 have Cr(VI) concentrations <10 µg/L in most samples. Downgradient concentrations are slowly declining.

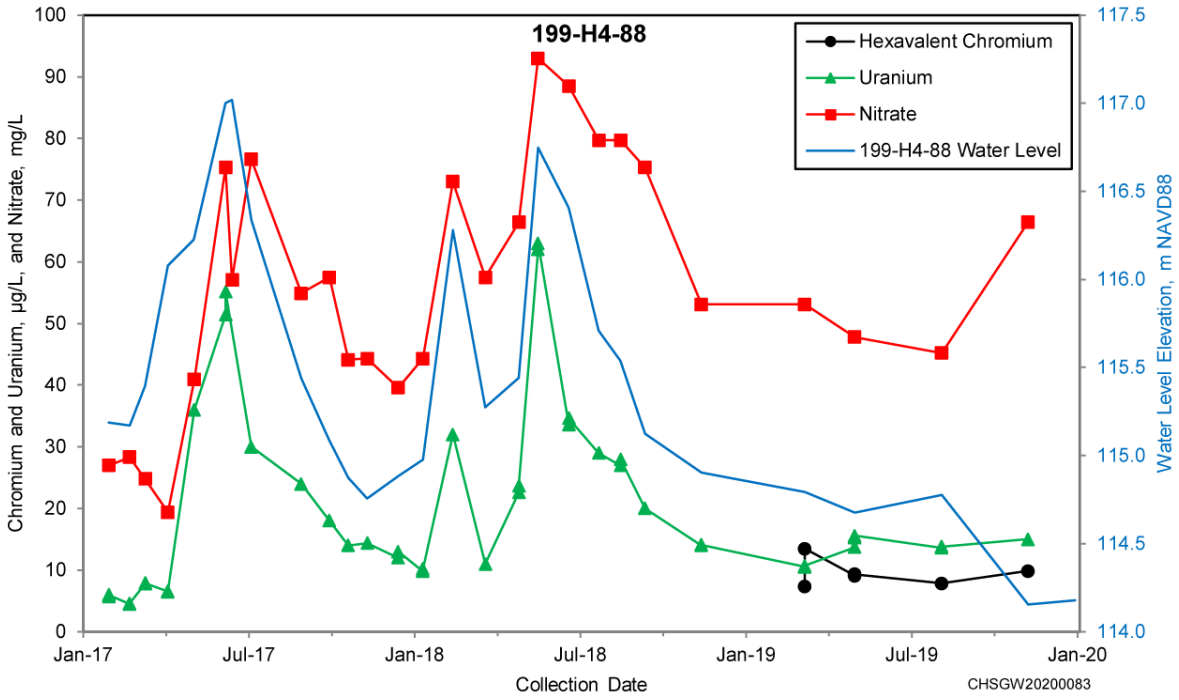
Figure 9. Contaminant Response to Groundwater Fluctuation at Well 199-H4-88

- Eleven soil samples were analyzed from the basin area following excavation, which extended up to 3.5 m (11.5 ft) beneath the base of the former facility. The samples were collected from within the Basin #1 footprint as deep vadose zone samples. The Cr(VI) results ranged from nondetected to 1.07 mg/kg. Nitrate results (also found in this waste site area) ranged from 26.9 to 1,930 mg/kg (Table 4-3 in BHI-00932, *1996 Phase II Soil Sampling at the 183-H Solar Evaporation Basin Site*).
- Concentrations of Cr(VI), nitrate, and uranium in groundwater at well 199-H4-88 responded to groundwater fluctuations. Increased concentrations are noted when the water table is high (Figure 9). Well 199-H4-84 has a similar pattern of responses to water level.

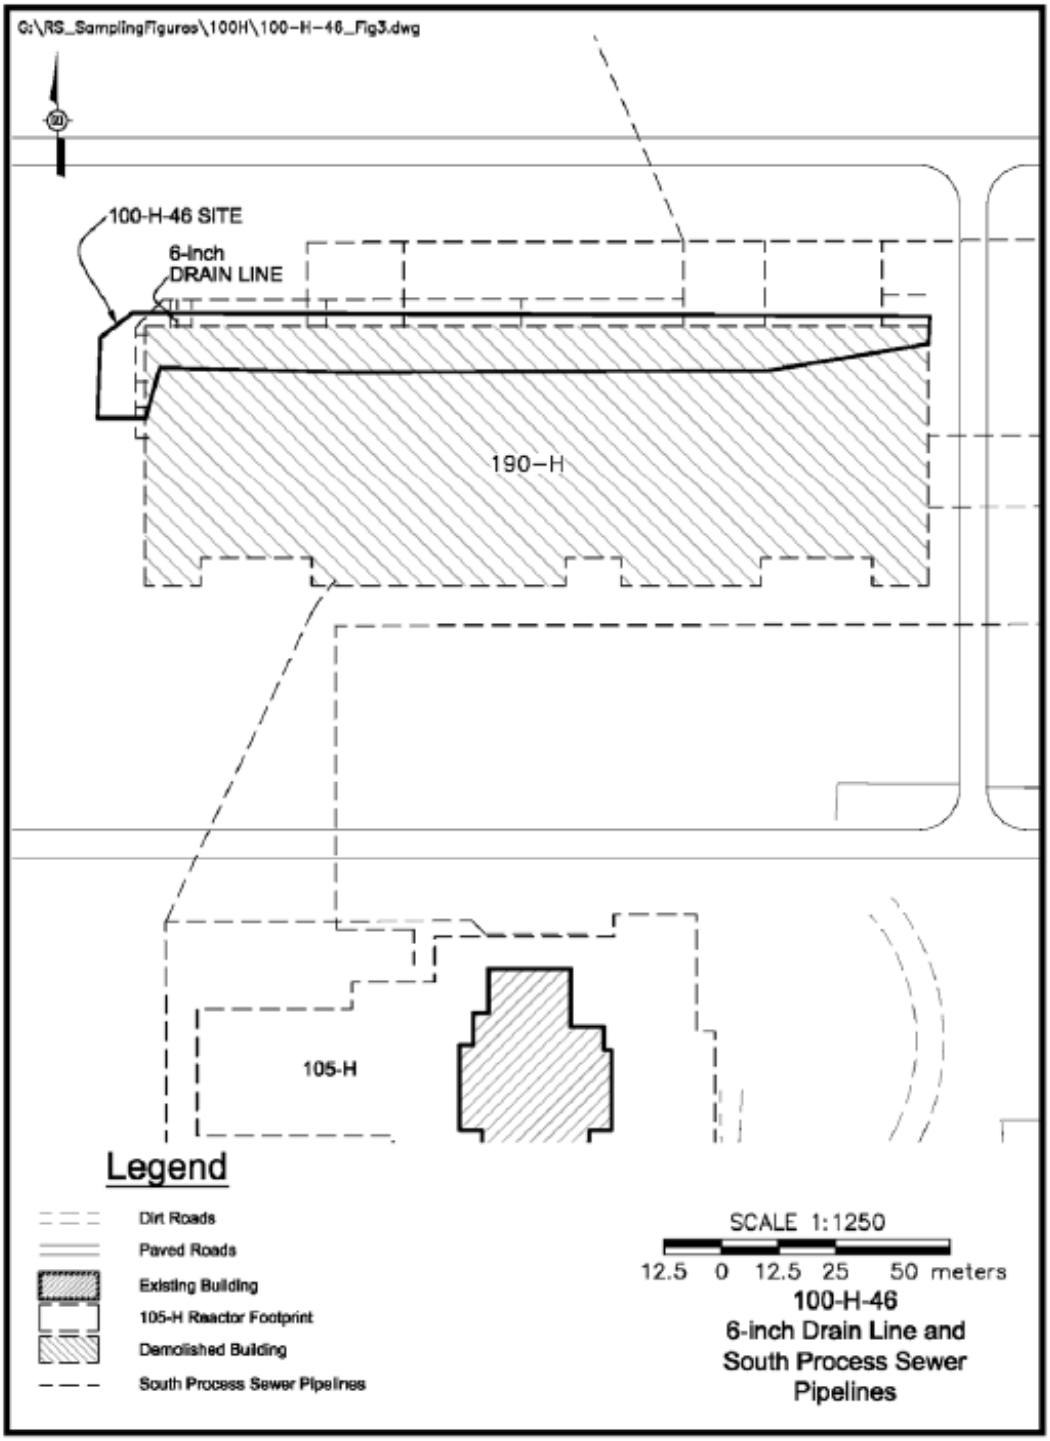
Figure 10. Location of the 100-H-46 Waste Site and 190H Pump House

The 100-H-46 waste site includes a portion of the former 190H Pump House footprint associated with concentrated sodium dichromate handling (Figures 10 and 11). Dry and concentrated bulk sodium dichromate was received via railcar on the northwestern side of the pump house and was mixed and stored within the facility. The concentrated solution was injected into treated water supplied by the 183H Facility, which was then held in the four large water tanks within the 190H Pump House for supply to H Reactor. The mixing and feed tanks, injection pumps, and associated distribution piping for concentrated sodium chromate were all located within the 190H Pump House on the northern side of the facility. Above-grade portions of the 190H Pump House were demolished in 1977, leaving the slab in place.

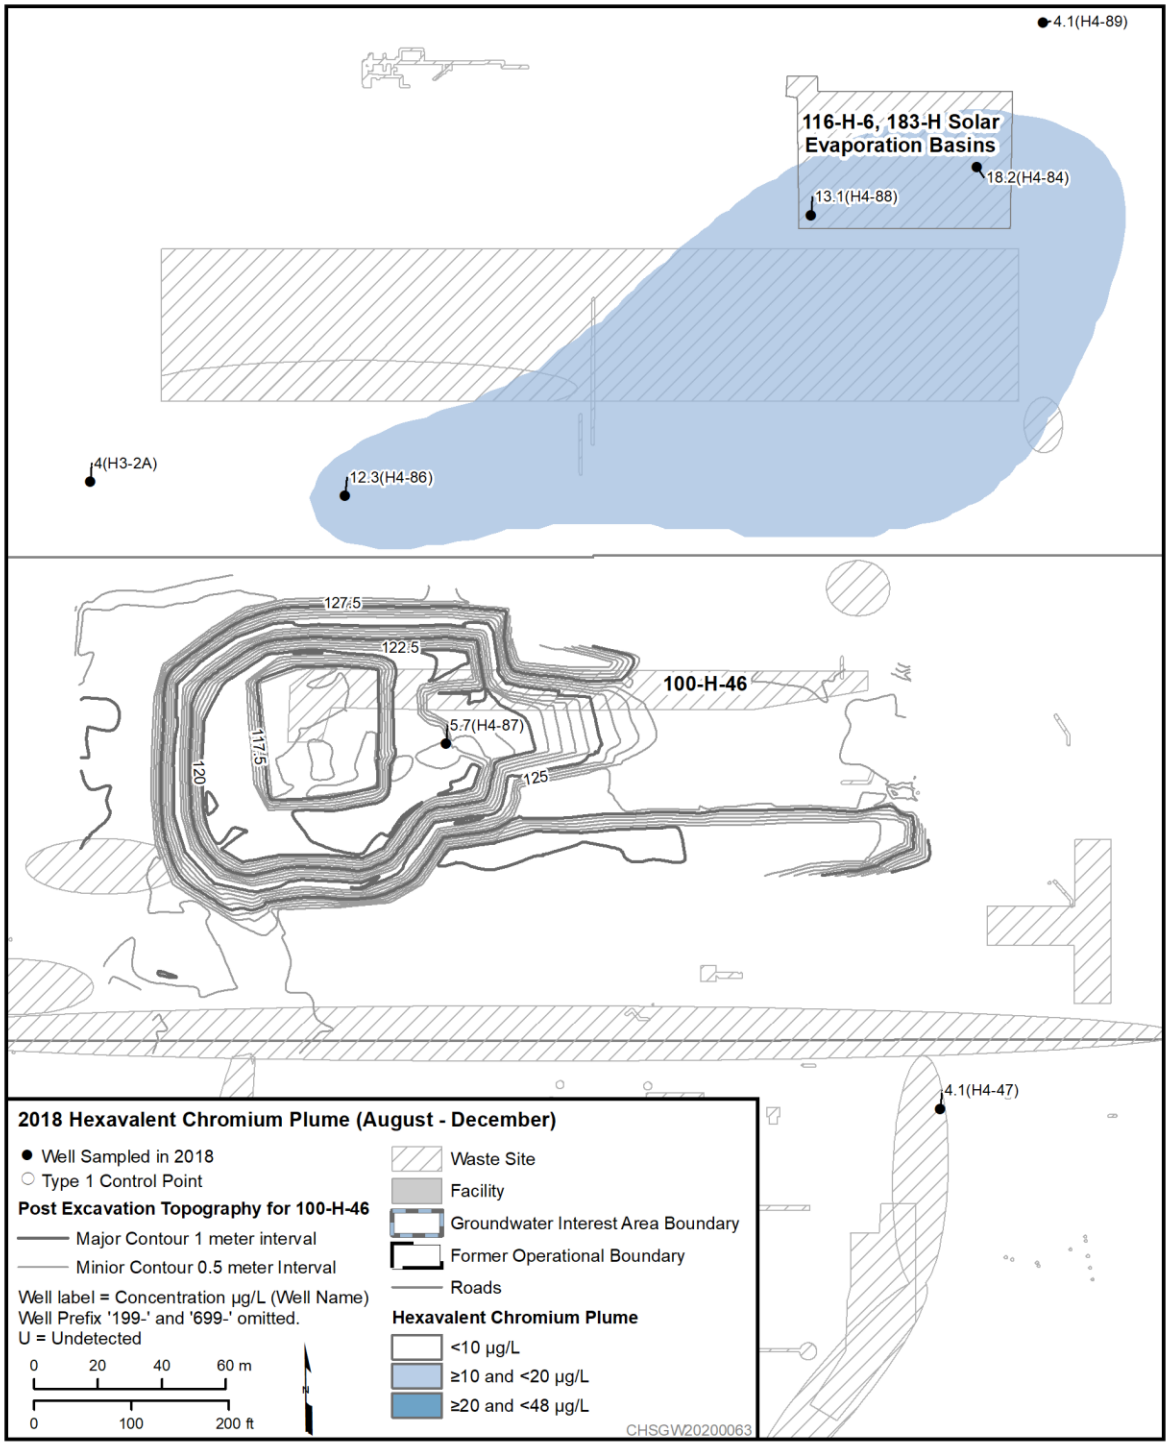
Figure 13. 100-H-46 Waste Site Excavation Footprint and Cr(VI) Plume

- Green-stained concrete was observed in areas of the remediation, and systematic in-process sampling during remediation detected Cr(VI) in deeper soil at concentrations up to 4.53 mg/kg. During remediation activities, the site was excavated to a depth of 12.5 m (41 ft) bgs, which was just above the water table during high river stage when the excavation took place (May 2013). Monitoring at nearby well 199-H3-2B indicates that the water level decreased about 1 m (3.3 ft) following the completion of excavation at the site.

- Cr(VI) contamination remains elevated in well 199-H4-86, located on the edge of the former excavation. This side of the excavation was observed to have soil staining during remediation activities. Because the well is operating as an extraction well, it is unclear if the contamination is originating in that area or is migrating from a separate upgradient source.

- Cr(VI) concentrations in well 199-H4-87 (installed in the footprint of the excavation) have also periodically shown elevated Cr(VI) concentrations, up to 30 µg/L during high river stage in May 2017. This was the highest water period since the well was installed, which raised the water level to an elevation of 116.07 m (380 ft) (NAVD88, *North American Vertical Datum of 1988*). The water level was also high in August 2018; however, the water rose to only 115.74 m (379 ft). The response in well 199-H4-87 along with the limited area of contaminated groundwater further indicates a small zone of contamination remaining in the lower vadose zone.

The 100-H-46 waste site has several data needs to be addressed prior to evaluating whether soil flushing is the best treatment option (Table 2). The primary data need is the location of the source material. A rebound test is recommended to confirm the presence of a secondary source and to identify a treatment area.
