RPP-ENV-37956, Rev. 2

# Hanford 241-A/AX Farm Leak Inventory Assessment Report

# **HANFORD 241-A AND 241-AX TANK FARMS LEAK INVENTORY ASSESSMENT REPORT**

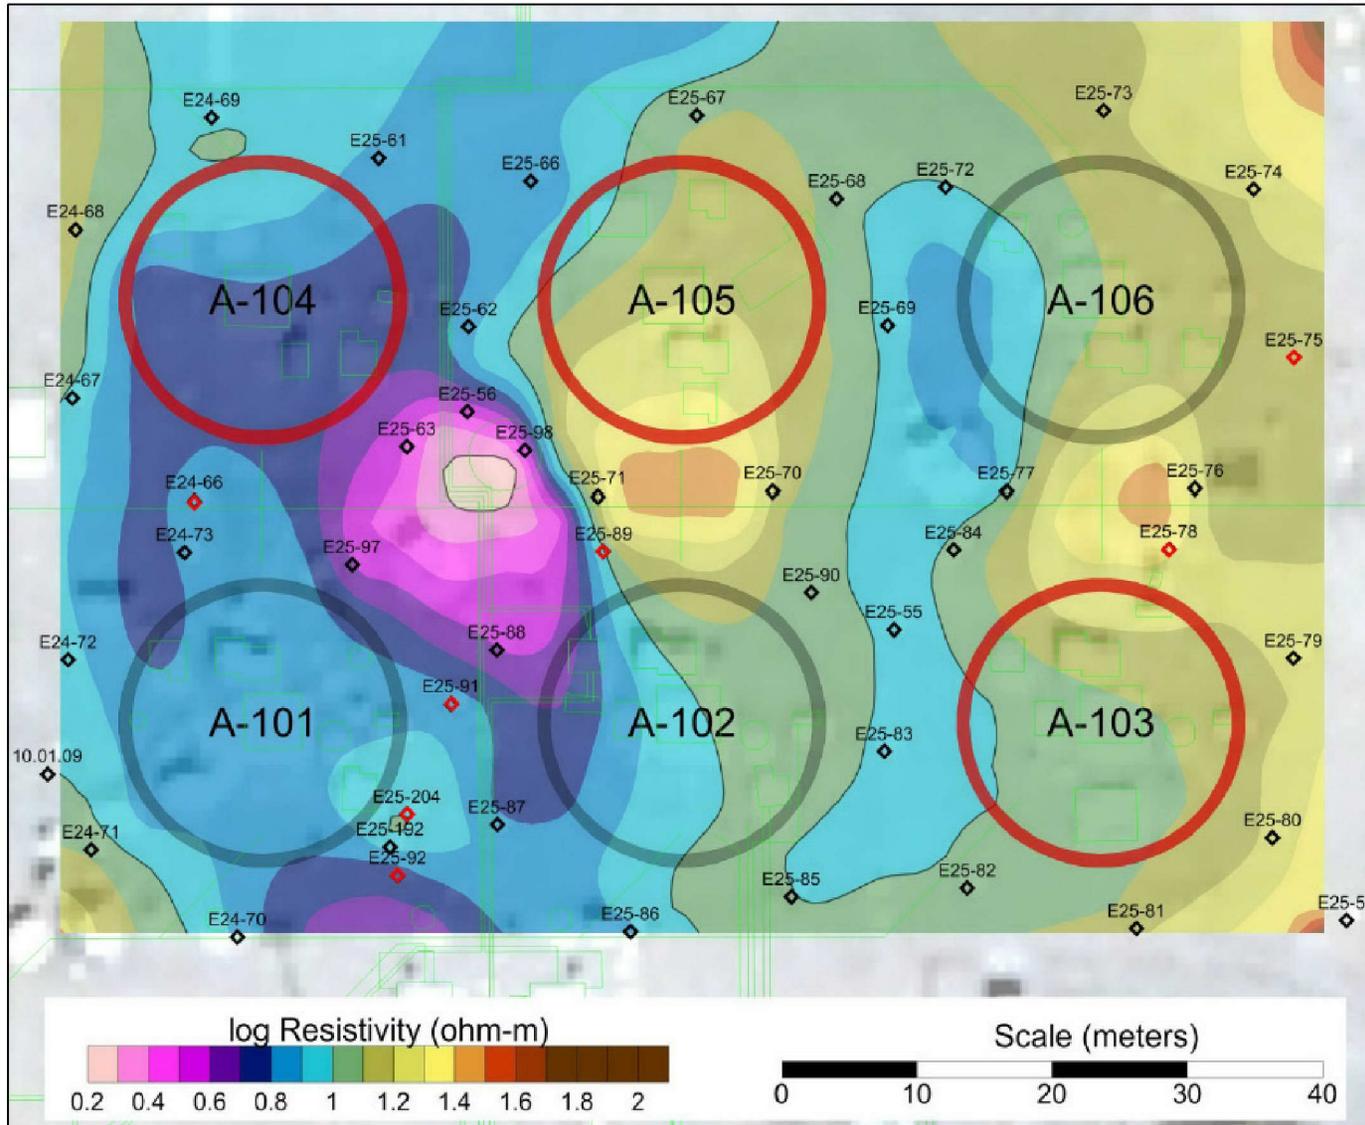
Figure 3-9. 241-A Tank Farm Well-to-Well Surface Geophysics Exploration Results

In general, the well-to-well model for A Farm shows the lowest resistivity areas southeast of tank A-104, southwest of tank 241-A-105 (A-105) and south-southeast of tank A-101. Low resistivity is also observed throughout the east side of A Farm and west of tank A-106. There is some indication of a low resistivity area near tank A-103, but not to the extent seen in other areas. Low resistivity areas were shown throughout AX Farm and were lowest to the north of tank AX-101, east of tanks AX-101 and AX-102 and on the east side of tank 241-AX-104 (AX-104). The well-to-well analysis provides only a two-dimensional image for low resistivity and does not indicate the depth of the resistivity anomalies. The results are consistent with observed drywell logging results, as well as the level losses associated with this evaluation. Vertical electrode resistivity arrays and direct push sample results in these areas are needed to determine the depth and corroborate the existence of anomalies observed. Consequently, for the purposes of this report the resistivity data were not considered to determine whether a tank leaked, nor the leak location, leak volume, or inventory.

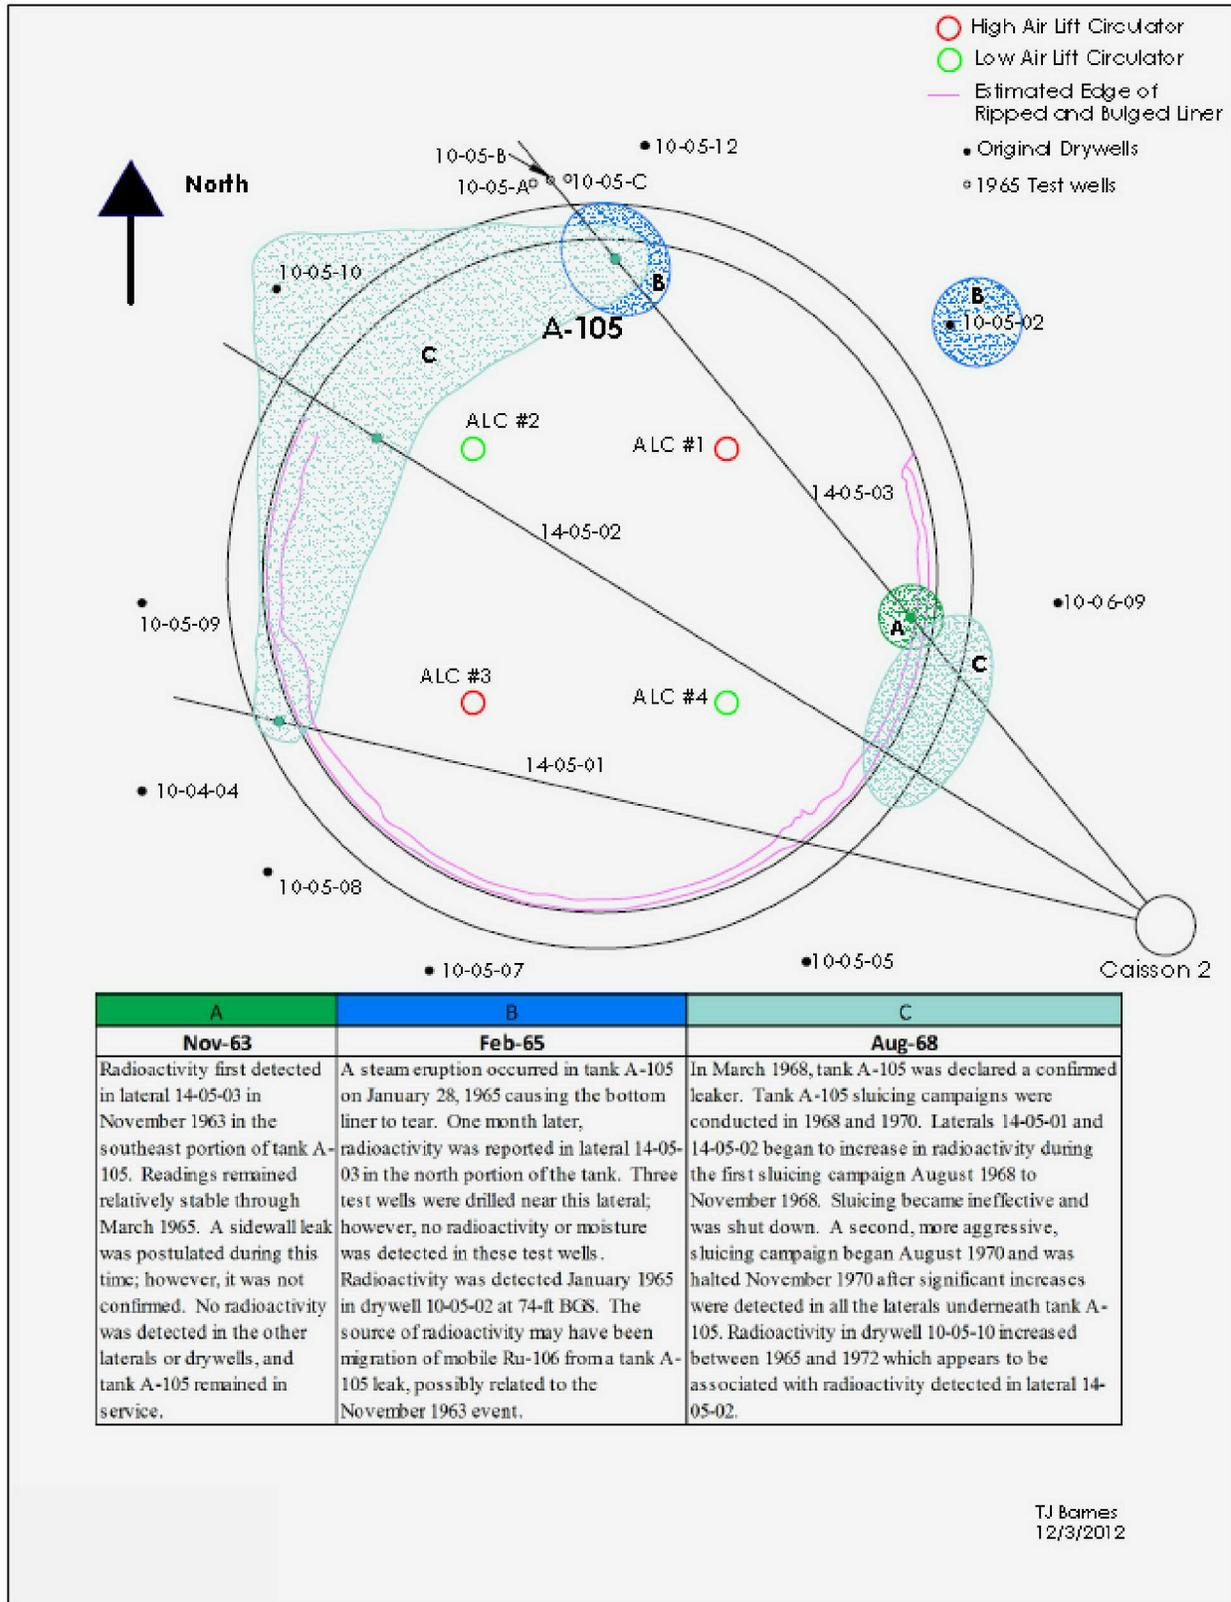
Figure 4-2. Tank 241-A-105 Possible Leak Locations and Indicators

**4.3.3.2 Depth of Release.** Leak locations in Figure 4-2 are based on peak readings and are a representation of possible initial and subsequent boundaries of radioactivity. Based on gamma activity measured in the laterals, and the ripped liner on the tank perimeter at the base of the tank, the tank likely leaked from around the tank perimeter at the tank base.

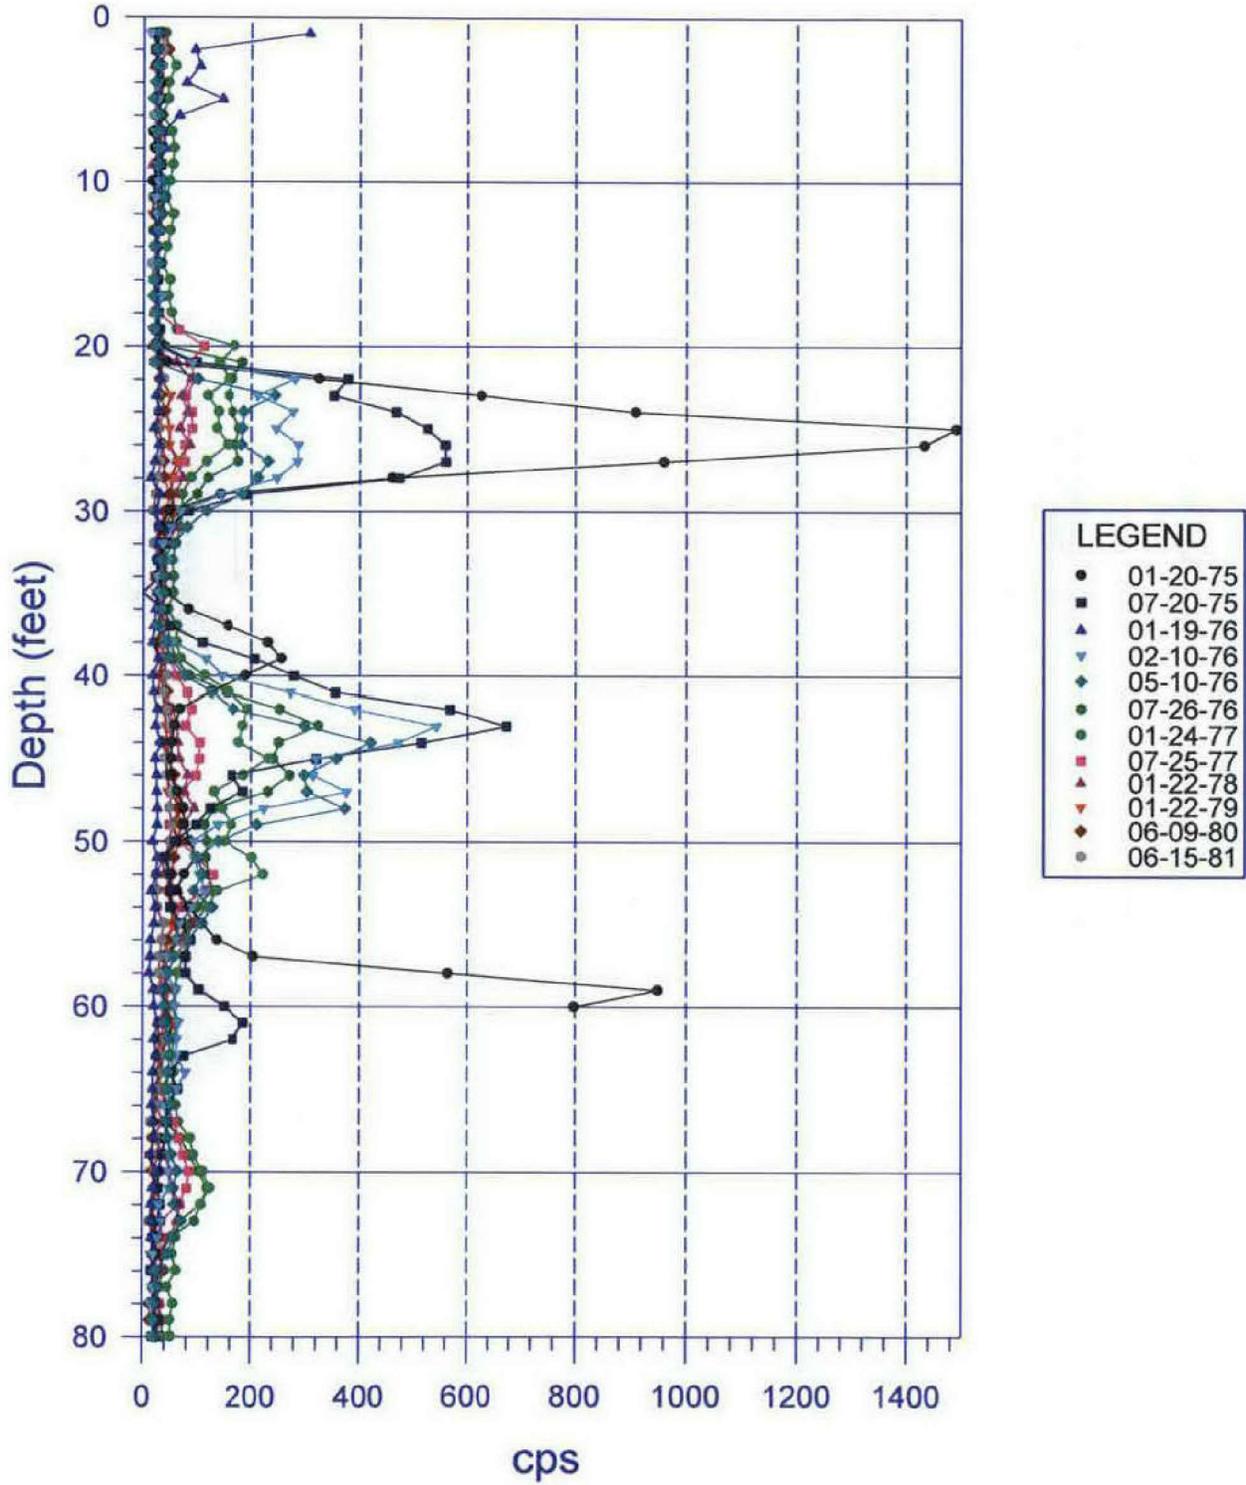
Figure 4-5. Historical Gross Gamma Log Data from Drywell 11-04-11

241-AX-104	The likely source of radioactivity detected historically in drywells 11-04-01 and 11-04-11 is the leaking Dresser coupling associated with the tank off-gas piping and releases from the ventilation system.	---	0 gal Tank appears sound Tank integrity assessment (TFC-ENG- CHEM-D-42) recommended

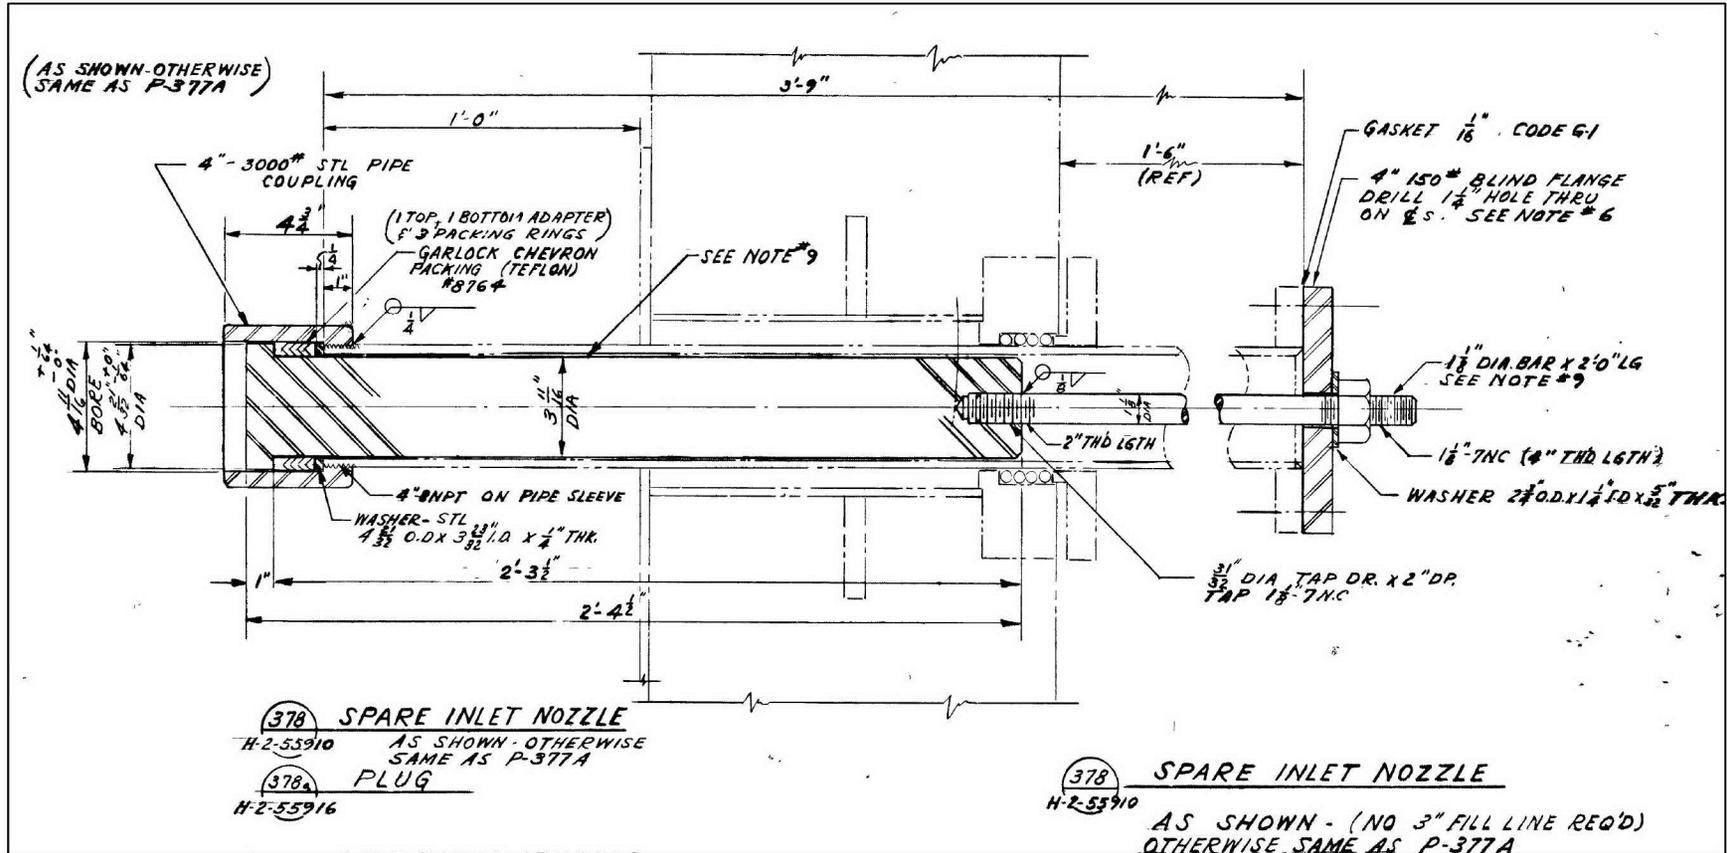
Figure 5-1. 241-A Farm Tank Spare Inlet Nozzles

Waste may have been lost to the ground in the A and AX Farms if SSTs were filled above the height of the spare inlet nozzles (32 ft 6 in. above the tank bottom, at which level the tank contains ~1,070,000 gal and is designated as “full”).

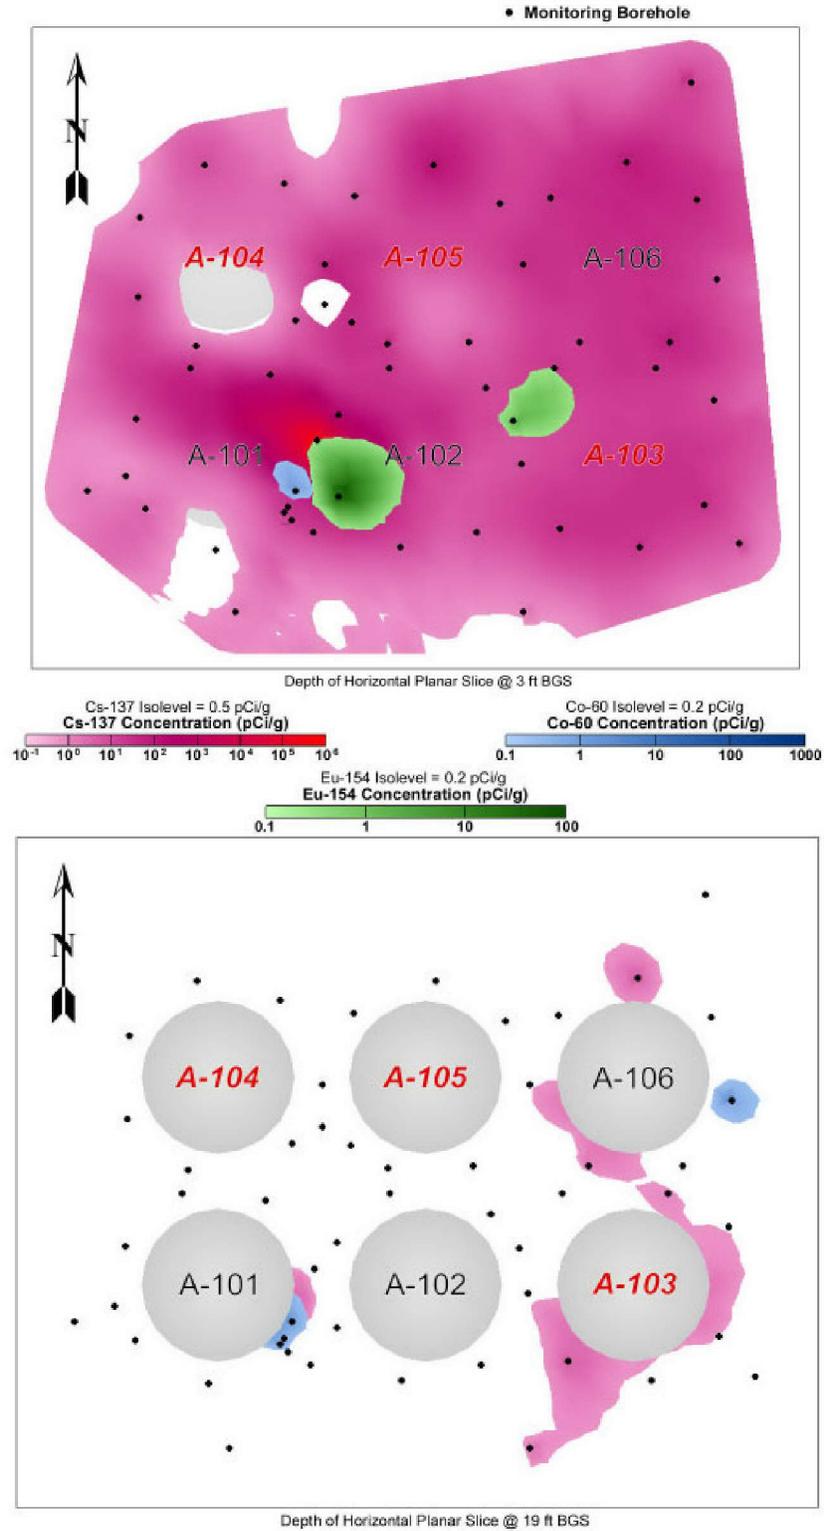
Figure 5-4. 241-A Tank Farm Spectral Gamma Logging Visuals

High activity 137Cs and 154Eu plumes near tanks 241-A-101 and 241-A-105 attributed to XXXX

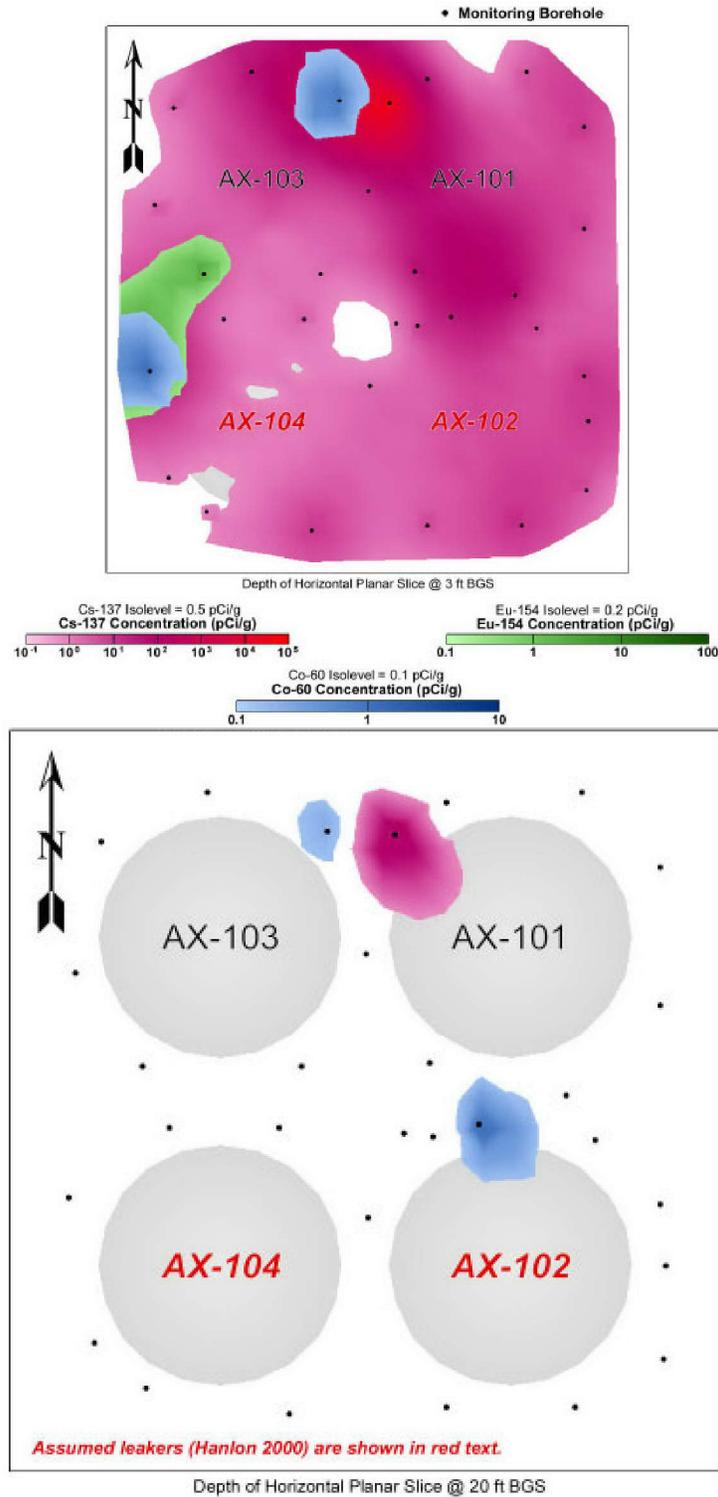
**Figure 5-5. 241-AX Tank Farm Spectral Gamma Logging Visuals**

<sup>154</sup>Eu and <sup>60</sup>Co plume near tank 241-AX-104 attributed to XXXX

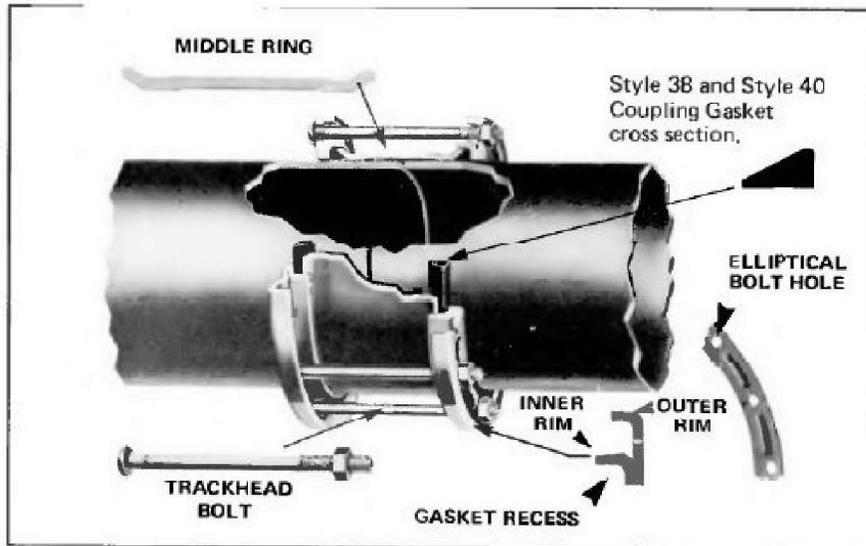
**Figure 1. Typical Dresser Coupling arrangement**

Dresser couplings provide a compression seal on the outer surface of vapor header pipe segments in the 241-AX and 241-A tank farms. The couplings provide for expansion and contraction of the vapor header pipe segments (See Figure 1). The team concluded that waste losses from dresser couplings were a probable cause of measured gamma in drywells and a leak from the tank was unlikely. No liquid level decreases were observed in Tank AX-104. Other contamination in nearby drywells and radioactivity surface data will be discussed in the next meeting.

Contamination from a dresser coupling was verified as the source of 1975 contamination discovered in a nearby drywell. However, no drywell contamination was discovered after 1975 or near the time of liquid level decreases. Liquid level decreases equating to 3400 gallons do not correlate with potential evaporation losses. Liquid level measurement results have been questioned because of a buildup of corrosion/scum on the instrument probe. However, there is insufficient evidence to verify the instrument was bad. It was further observed that AX-102 is one of the few tanks where multiple gamma emitters were measured. Gamma emitters should have been observed if there was a 3400 gallon leak from the tank.

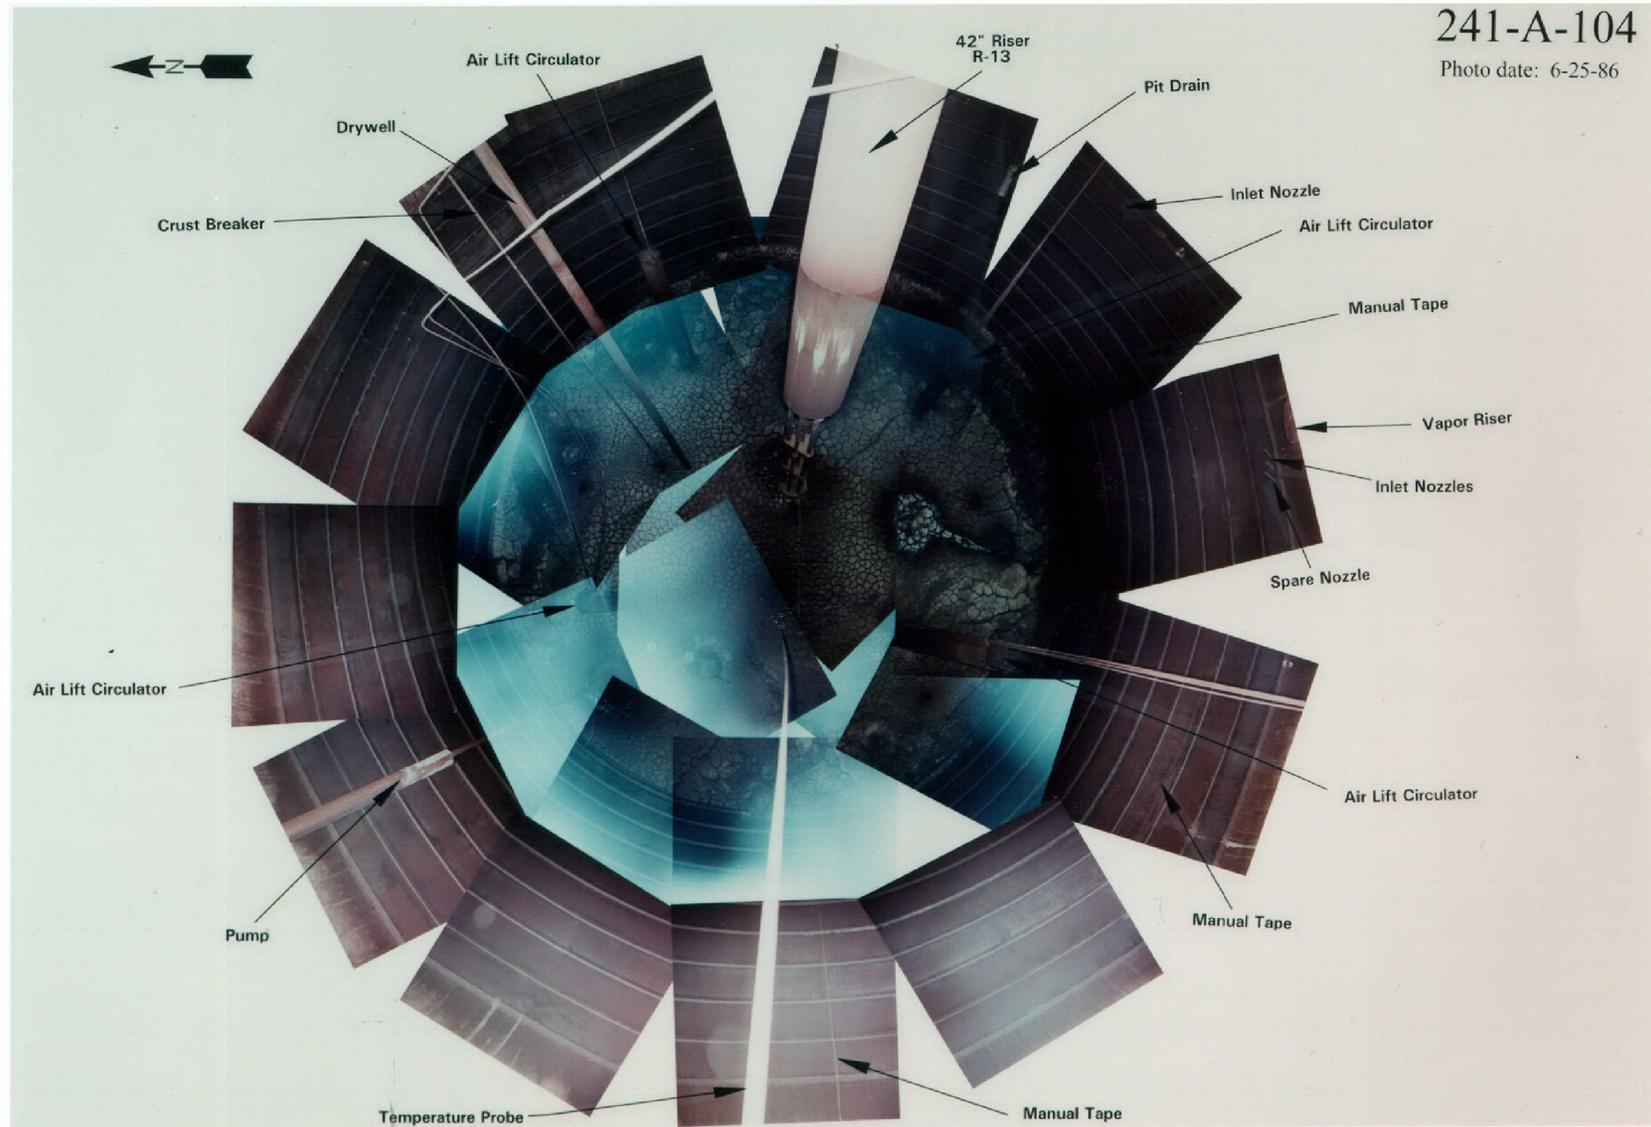
Figure B2-3. Tank 241-A-104 Waste Surface Photo Mosaic

Approximately 47,000 gal of supernate were pumped from tank A-104 from April 9 through April 19, 1975 (ARHCO Occurrence Report 75-39). Tank A-104 was declared interim stabilized in September 1978 (HNF-SD-RE-TI-178). Photographs taken in 1986 show a dry, cracked waste surface with no visible liquid present (Figure B2-3).

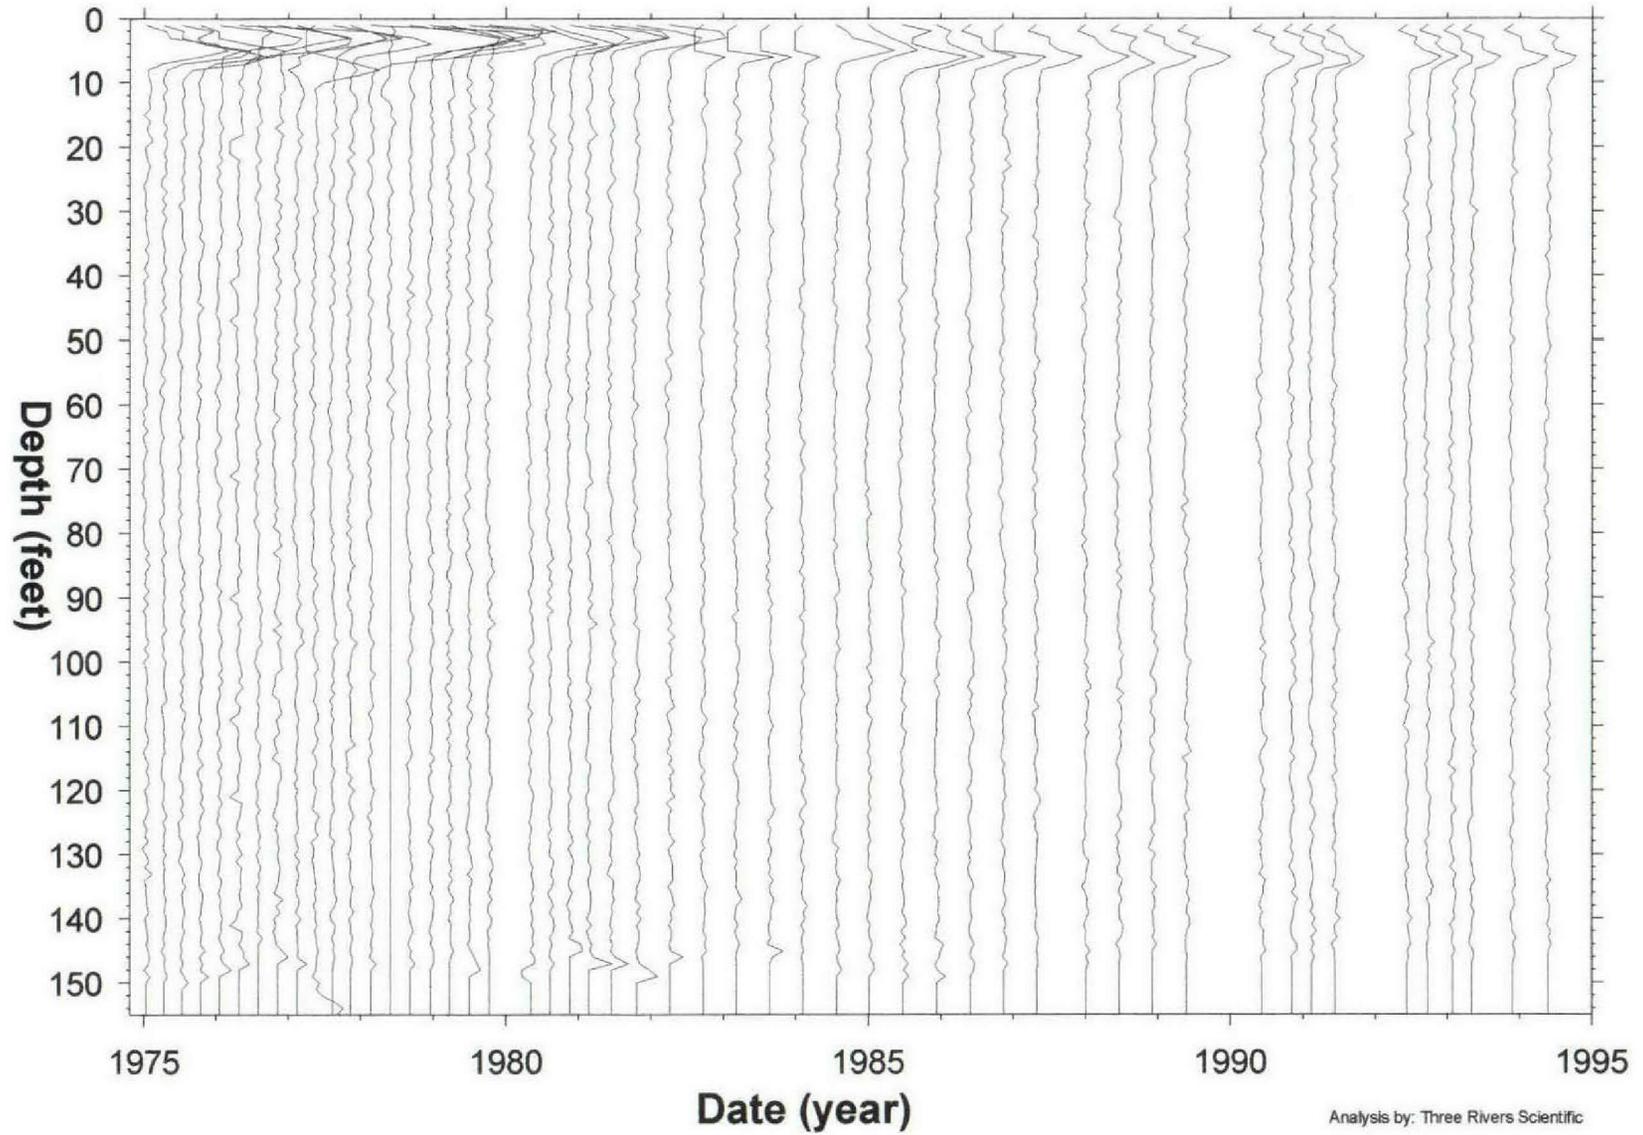
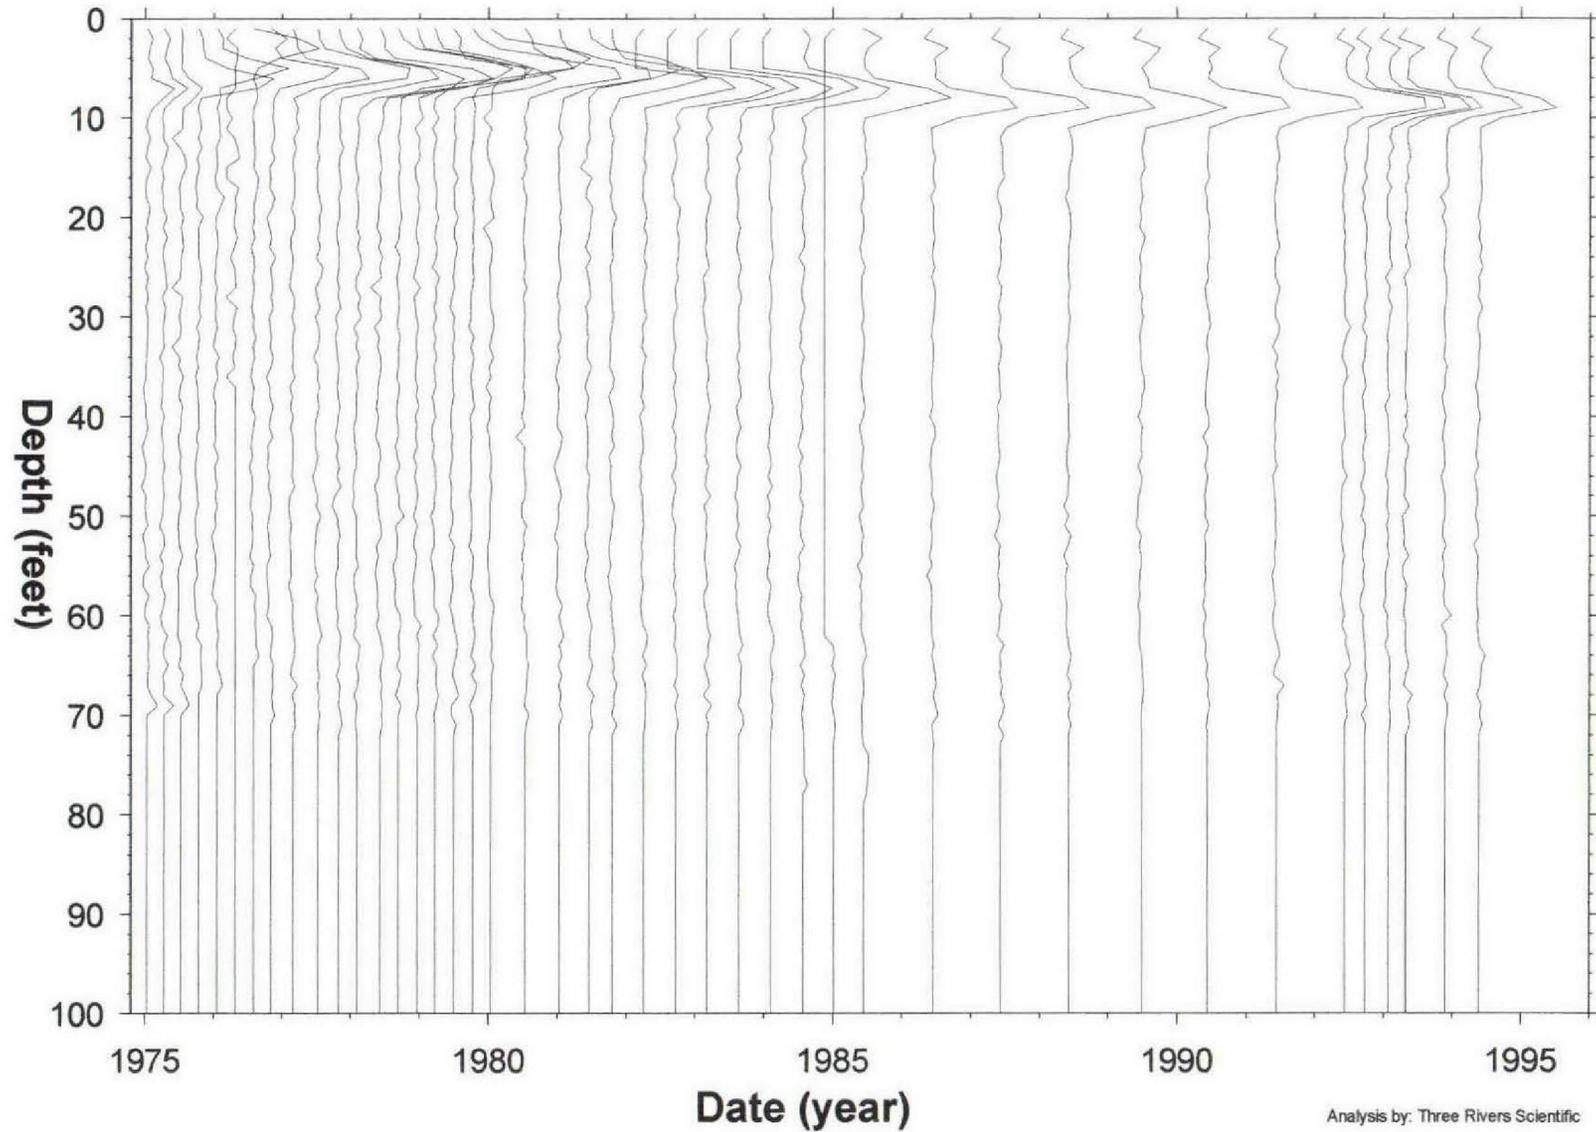
Historical gross gamma-ray data (RPP-8820) and SD-WM-TI-356 indicate that near-surface gamma activity was present before 1975 (see Figures B2-8 and B2-9). Many operational spills occurred that could account for the near-surface contamination (see Table 5-1). Occurrence report 74-130 documents one such surface spill, when a 53-ft-long tube was remotely removed from a 12-in. riser on tank A-104. In 1976, 18 months after tank A-104 was designated an "assumed leaker;" most of the drywells associated with tank A-104 were deepened from 75 to 125 ft. Near-surface  $^{137}\text{Cs}$  activity present around the drywells before 1975 may have been carried downward during the drywell extension activities. Recoverable drywell readings before 1975 are presented in RPP-RPT-54912, Appendix D.1.

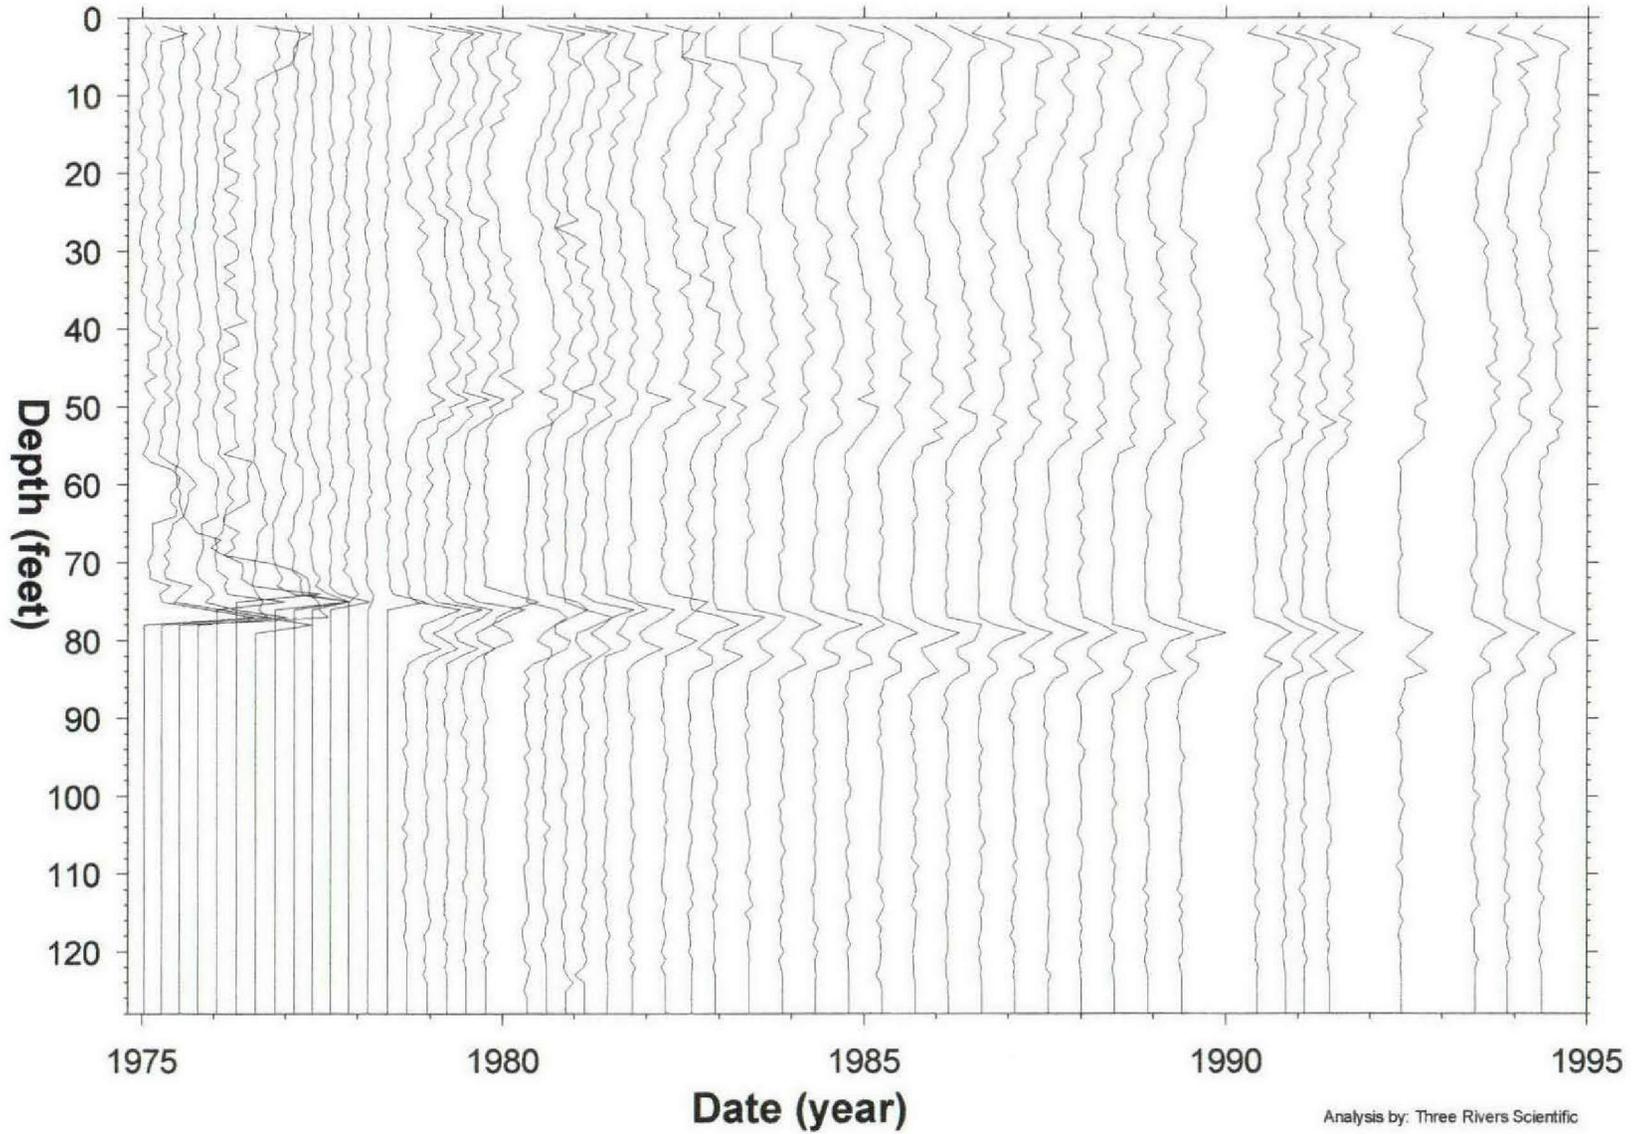
**Figure B2-10. Tank 241-A-104 Historical Gamma Logging Results for Drywells 10-05-10**

Cesium contamination detected in drywell 10-05-09 from 51 to 76 ft bgs may be related to leaks from tank A-104 or tank A-105. This drywell borehole was never deepened and did not show surface contamination until early 1984 (Figure B2-10).

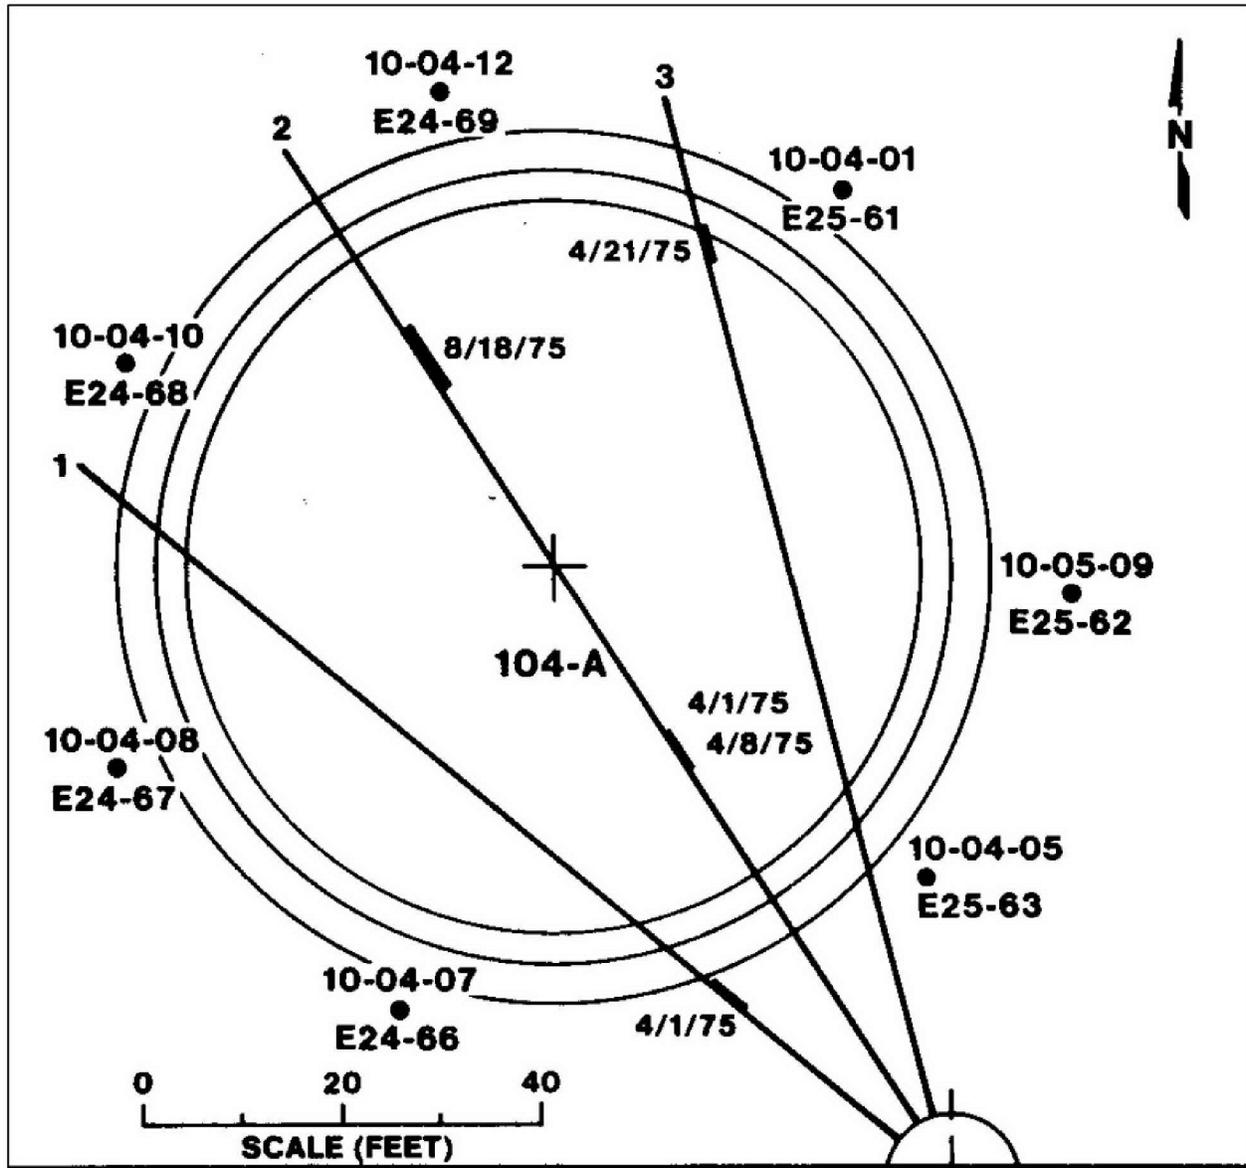
Figure B2-11. Historical Radioactivity for Tank 241-A-104 Laterals

The first indication of a tank A-104 leak occurred in March 1975, shortly after the start of sluicing in September 1974, when radioactivity was detected in lateral 14-04-02 (see Table B2-2). On March 18, 1975, the first indication of a tank A-104 leak was reported at 100 counts per minute (cpm) in lateral 14-04-02 at ~94 ft from the caisson. A week later, counts increased to 305 cpm at that location in lateral 14-04-02. Sluicing was halted April 7, 1975 due to the increase in radioactivity in lateral 14-04-02. The following day on April 8, 1975, additional radiation peaks were recorded, one in lateral 14-04-02 and one in lateral 14-04-01, both along the southeast edge of the tank (see Figure B2-11). On April 8, 1975 ARHCO Occurrence Report 75-39 reported increasing gamma activity in the center of one of the laterals ~18 ft in from the northwest edge of the tank, and a second radiation peak in an adjacent lateral located ~13 ft in from the southeast edge of the tank.

Radiation readings were monitored daily in April 1975 for all three laterals (Table B2-2). Radiation readings continued to increase in laterals 14-04-01 and 14-04-02 throughout April 1975. The first indication of radioactivity in lateral 14-04-03 occurred on April 21, 1975 at a reading of 95 cpm along the northeast edge of the tank and increased to 480 cpm by May 2, 1975. Tank A-104 was declared a “confirmed leaker” in April 1975 and supernate was pumped out of tank A-104 from April 9 through April 19, 1975.

Beginning on May 1, 1975 a new peak was recorded in lateral 14-04-02 at 47 ft from the caisson at 1,200 cpm. A new peak was also recorded in lateral 14-04-01 on May 19, 1975 at 45 ft from the caisson. Gross gamma scans of the drywells around tank A-104 did not indicate radioactivity below the tank above background during this time (ARH-LD-120, *Nuclear Waste Tank and Pipeline External Leak Detection Systems*). In July 1976, Occurrence Report 76-100, *Radiation Increase Exceeding Action Criteria in Two (2) Laterals Under Tank 104-A* reported that “Two of the three laterals monitoring 104-A have developed a new minor peak, expanding the base of older peaks, generated by the tank leak which occurred in April, 1975.”

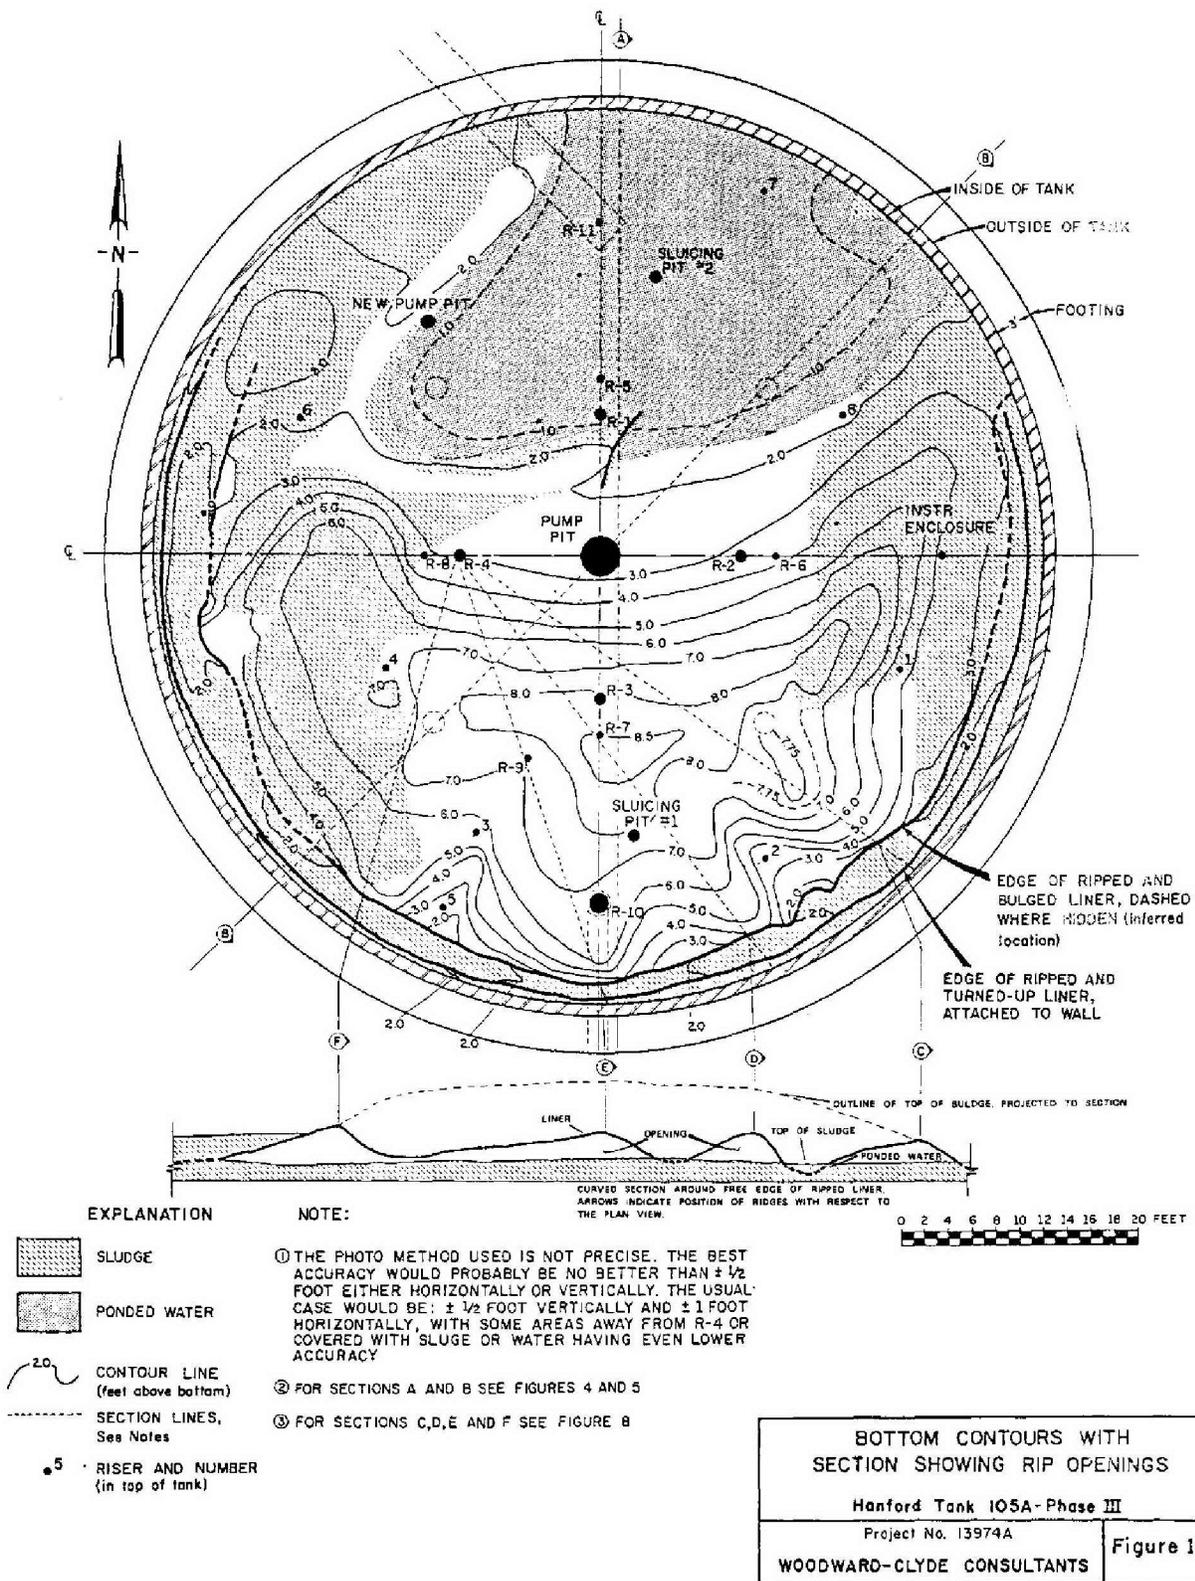
Figure B3-3. Topographical Map of Tank 241-A-105 Bottom (1977)

In 1977, photographs taken inside tank A-105 in 1969, 1970, and 1977 were reviewed to determine the amount of sludge remaining in the tank as well as develop a topographical map of the tank bottom (WCC Project 1397A-0300, *An Estimate of Bottom Topography, Volume and Other Conditions in Tank 105A, Hanford, Washington*). The topographical map of the tank bottom produced in 1977 is shown in Figure B3-3. This topographical map shows the bottom of the steel liner in tank A-105 is ripped and separated from the sidewall along approximately 3/4 of the tank bottom.
