RPP-ENV-37956, Rev. 2

# Hanford 241-A/AX Farm Leak Inventory Assessment Report

# **HANFORD 241-A AND 241-AX TANK FARMS LEAK INVENTORY ASSESSMENT REPORT**

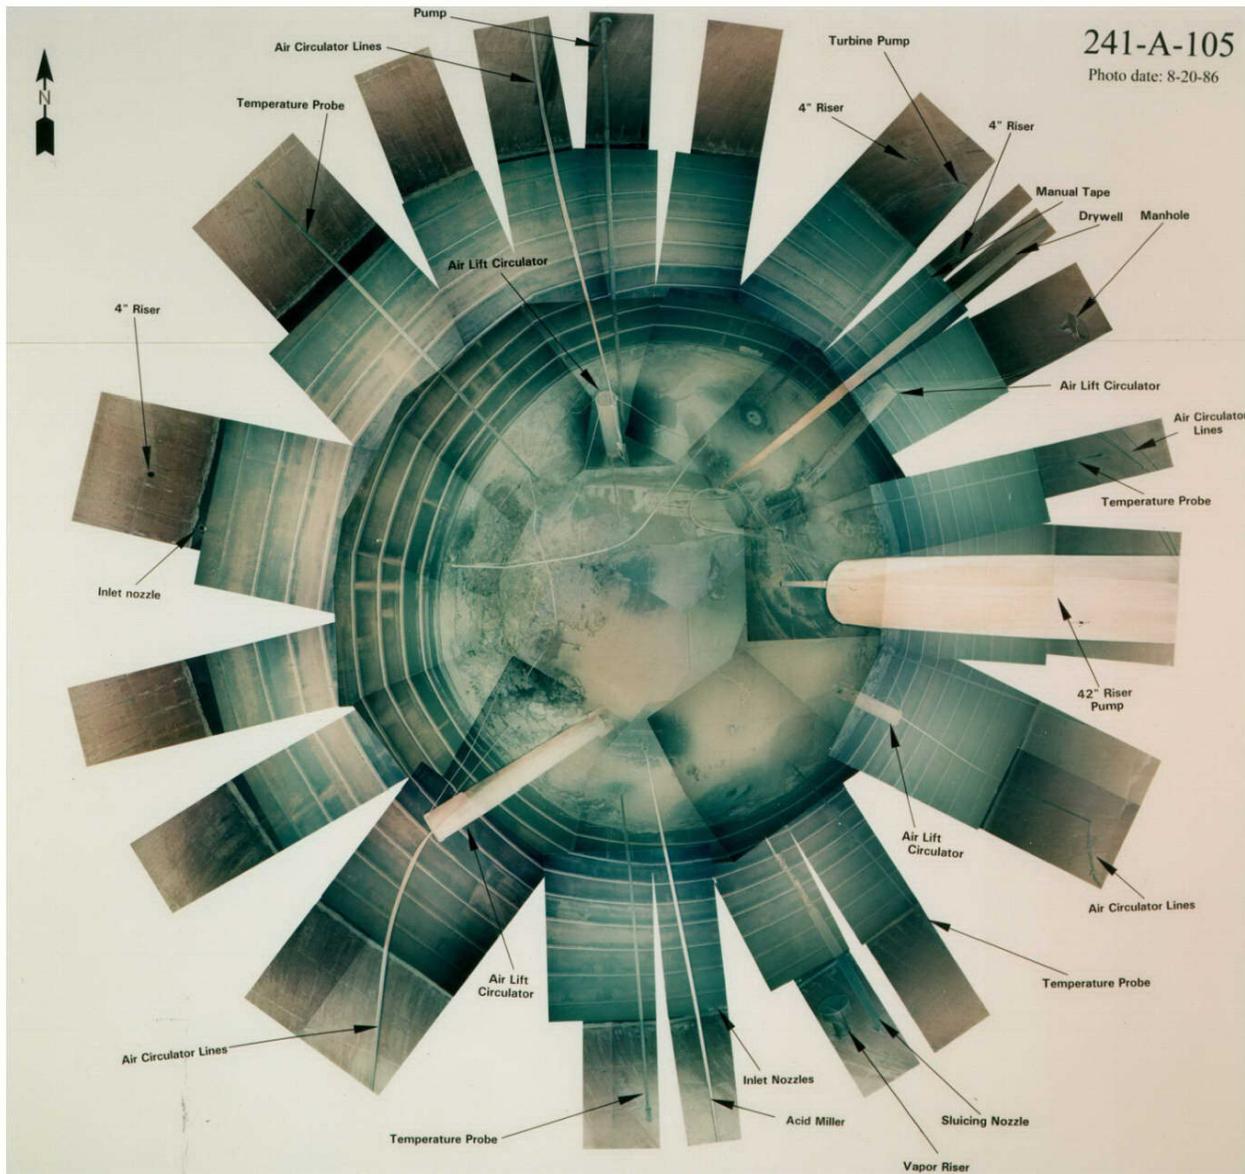
**Figure B3-4. Tank 241-A-105 Waste Surface Photo Mosaic**

Tank A-105 was declared interim stabilized effective July 31, 1979 based on a photograph evaluation dated June 21, 1979. Photographs showed “The surface appears dry with the exception of a wet spot trailing away from a circulator. The floor is approximately 40% bare metal, 30% a thin layer of sludge and the remaining 30% a heavier sludge primarily around the perimeter of the tank. The liner of the tank is almost free of scale except for a small ridge around the lower perimeter.” (HNF-SD-RE-TI-178). Figure B3-4 shows a mosaic of in-tank photographs taken August 20, 1986.

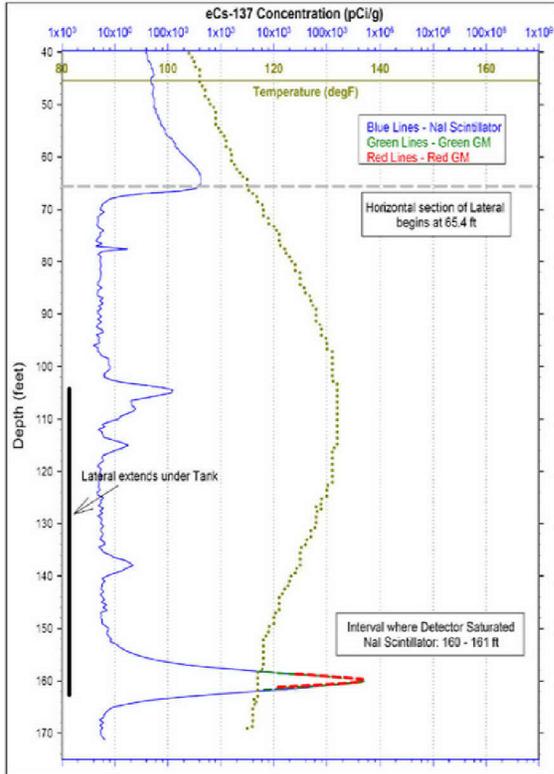
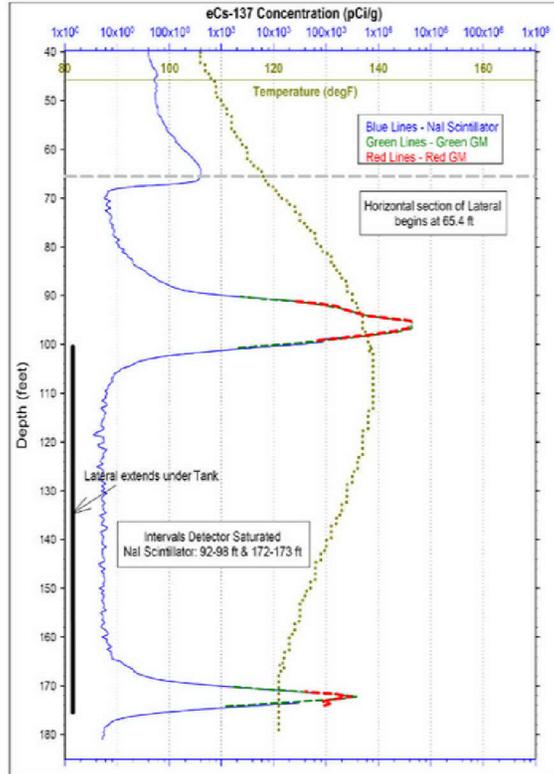
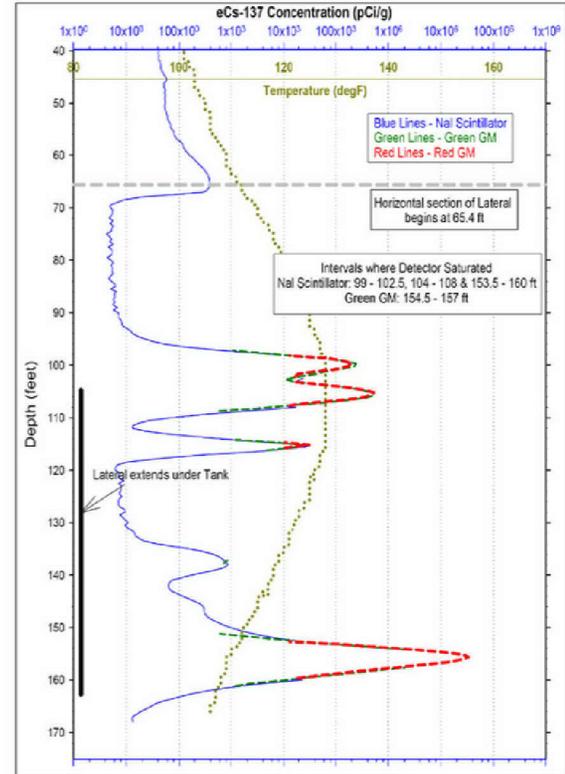
Figure B3-19. Summary Gamma Survey for the Laterals under Tank 241-A-105

Gross gamma, sodium iodine scintillation, and temperature logging of the three laterals beneath tank A-105 was again conducted in April 2005 (RPP-RPT-27605, pp. B-15, B-17 and B-19). The logs for laterals under tank A-105 showed gamma activity along laterals 14-05-02L and 14-02-03L (Figure B3-19). These laterals interrogate the central portion (14-05-02L) and northeastern quadrant (14-05-03L) of the tank. The highest <sup>137</sup>Cs concentrations were found near the distal end of lateral 14-05-03, where cesium activity was estimated to be as high as  $3.4 \times 10^7$  pCi/g, in close proximity to the highest temperature reading of 140 °F at the edge of the tank.

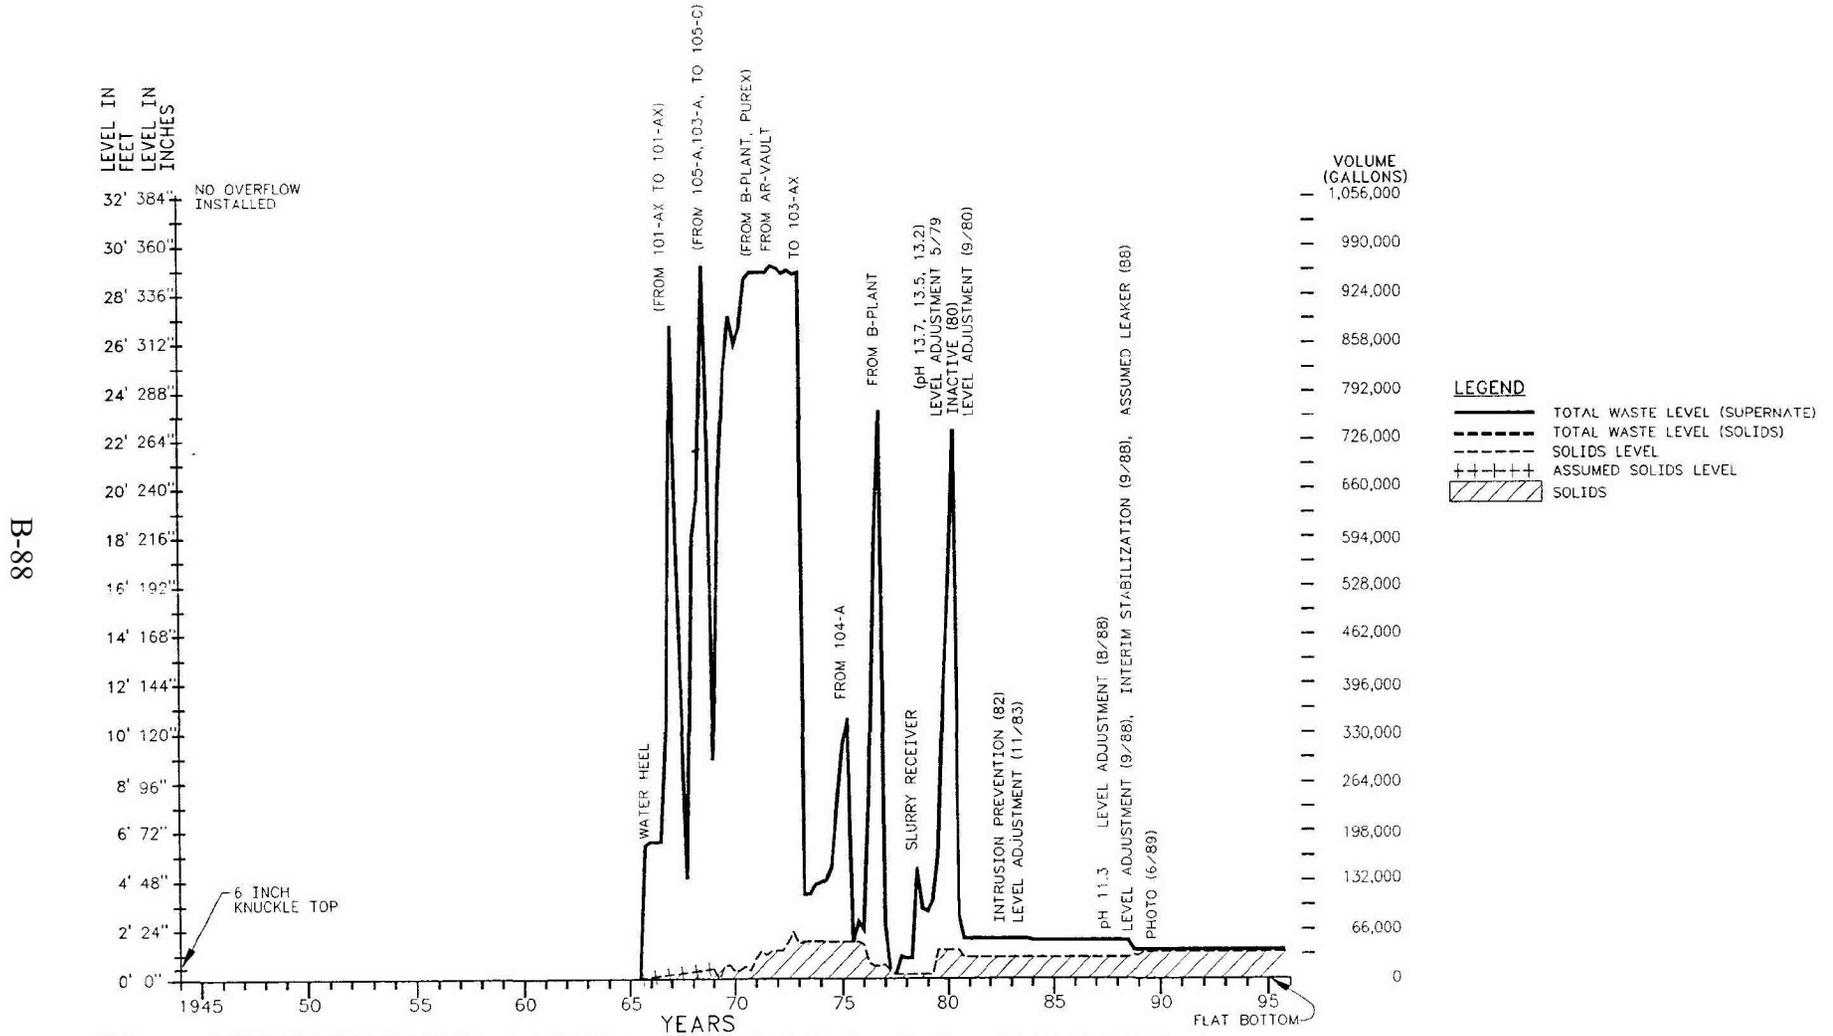
**Figure B4-2. Tank 241-AX-102 Quarterly Waste Fill History**

- The liquid level drop in tank AX-102 was shown to be statistically significant.
- Evaporation could only account for ~25% of the waste level decline.
- The liquid level in SST AX-102 returned to 18.75 in. as of July 7, 1988, but this was discounted by the 1988 tank integrity review team.

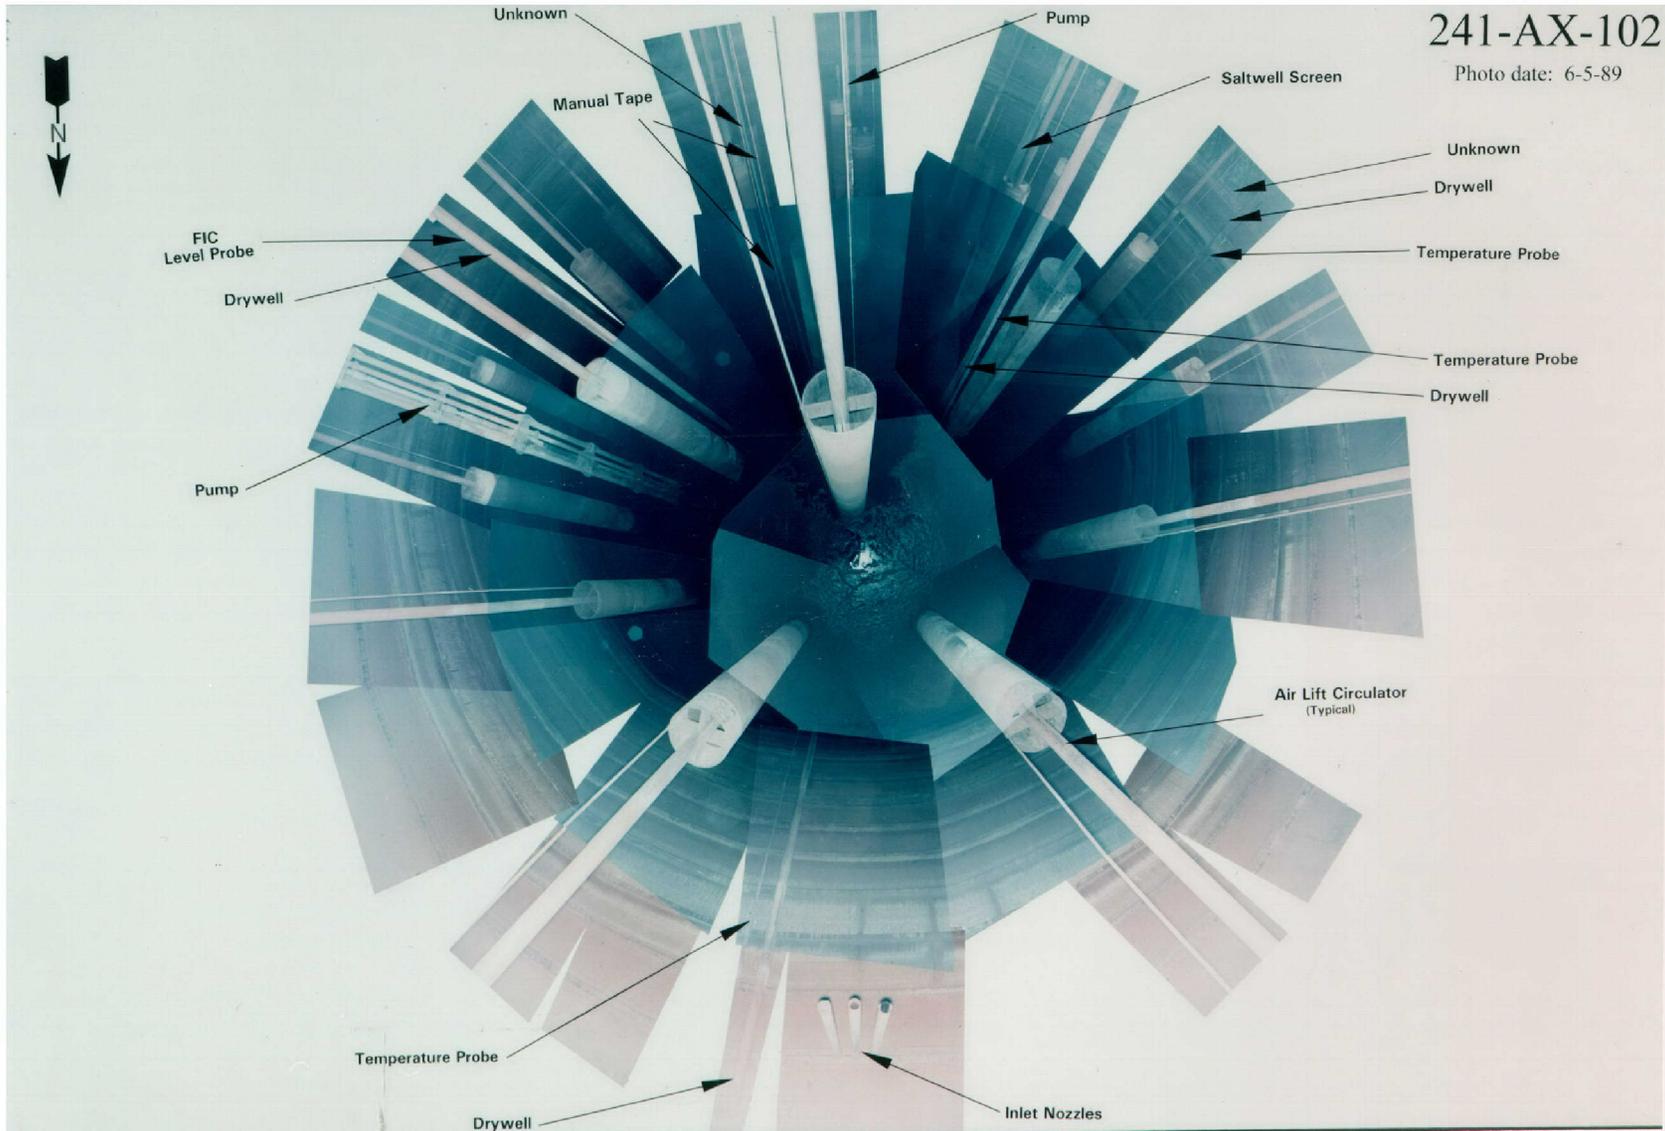
Figure B4-3. Tank 241-AX-102 Waste Surface Photo Mosaic

- In-tank photographs from May 14, 1981, August 18, 1987, and June 6, 1988 all showed a liquid surface covered by a thin film of floating solids. However, only a small portion of the waste surface was visible, with the remainder obstructed by haze and the airlift circulators. The manual tape gauge was on the opposite side of the tank and could not be seen.
- Data for the leak detection pit and 10 external drywells associated with tank AX-102 were reviewed and the 1988 tank integrity review team deemed that the readings were termed not indicative of a typical tank release; however, no values were reported in the reference (TFS&O-EFS-88-092, *Surface Level Measurement Decrease in Single-Shell Tank 241-AX-102*).

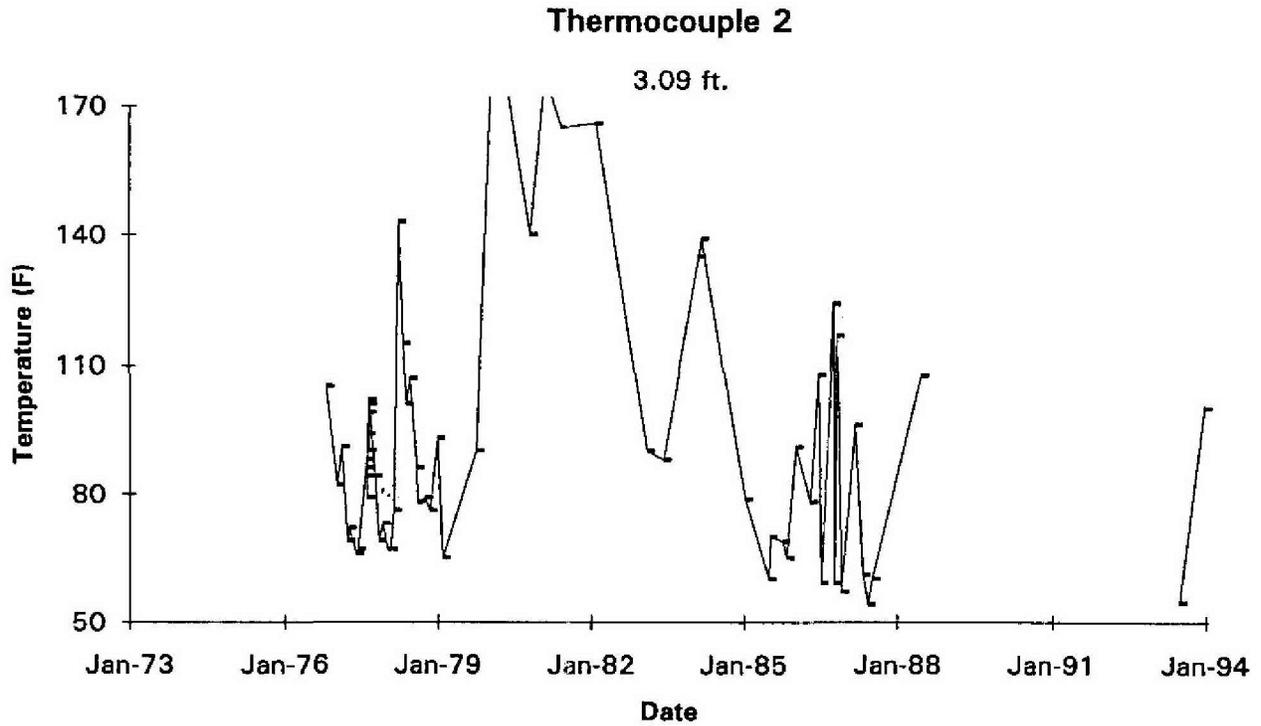
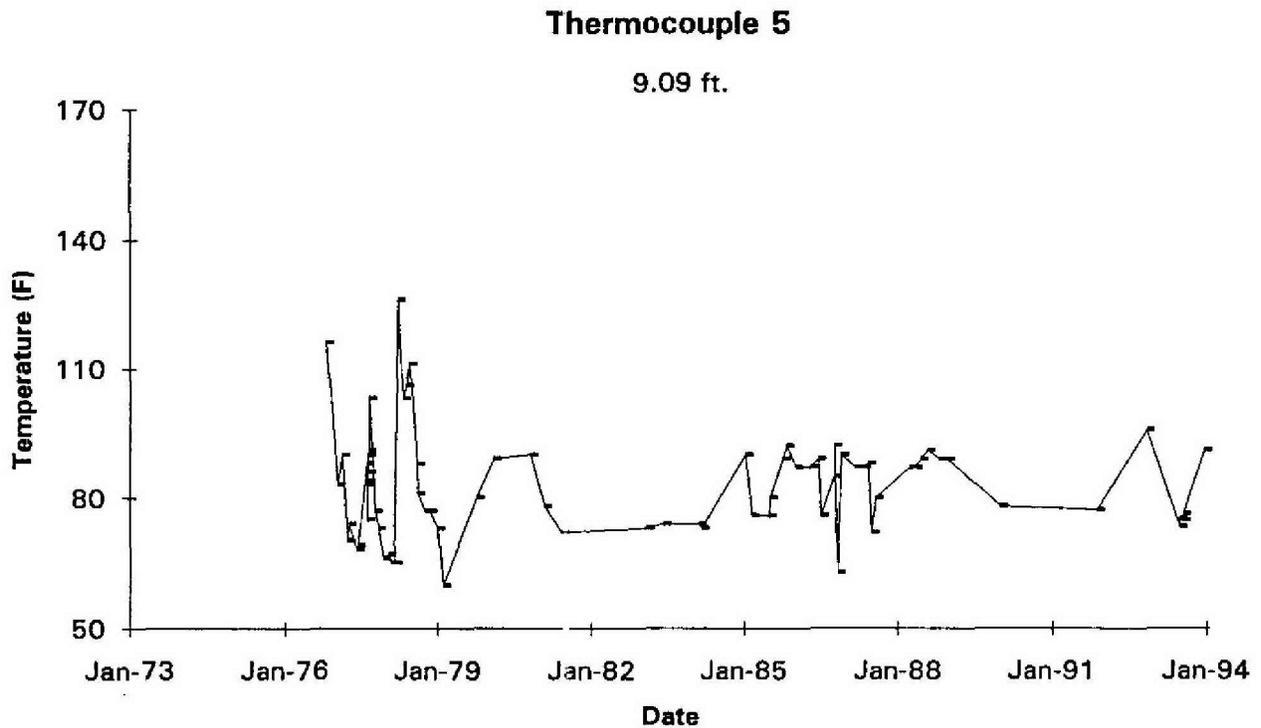
Figure B4-4. Tank 241-AX-102 Temperature, 1976 to 1994

Figure B4-4 shows temperature data from 1976 to 1993 for thermocouples 2 and 5, in the waste near the base of the tank. Figure B4-5 shows Surveillance Analysis Computer System temperatures for the waste in tank AX-102 from 1993 to 2014. During this period the waste temperature was >170 °F between 1980 and 1981. The temperature dropped to < 80 °F after 1993.

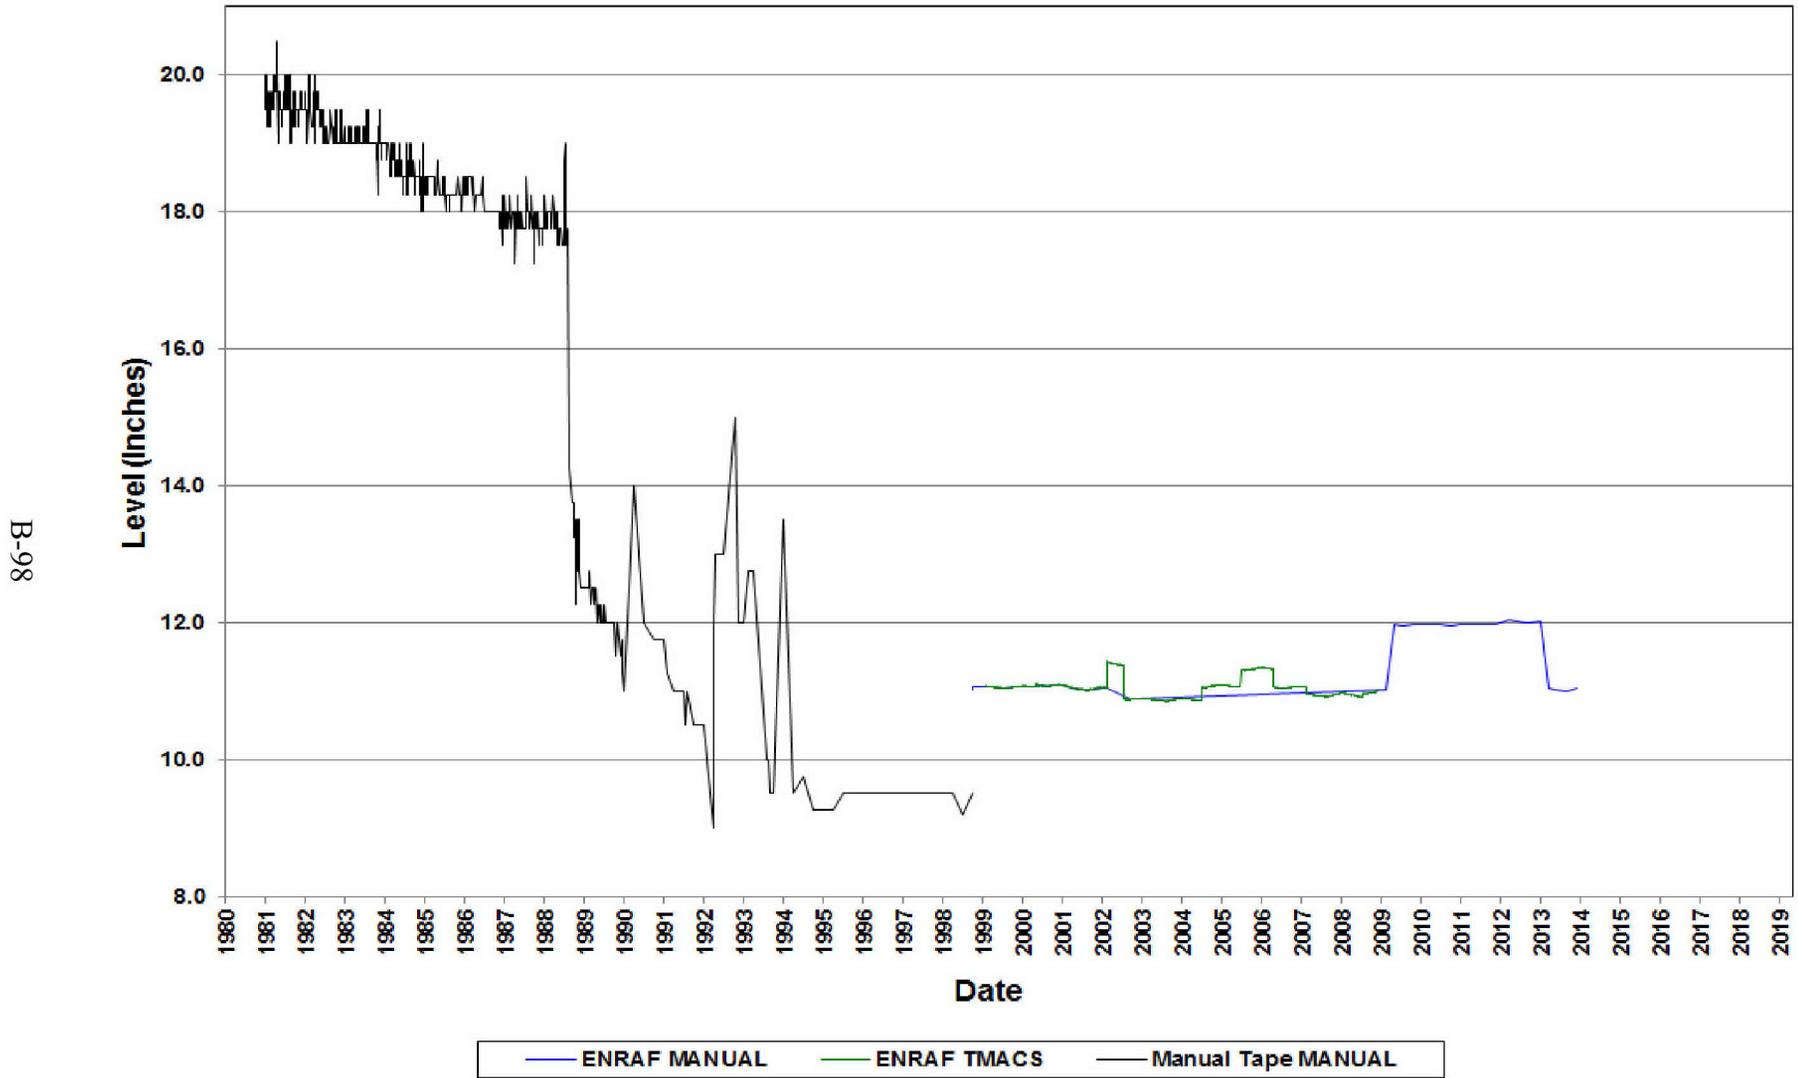
Figure B4-6. Tank 241-AX-102 Waste Surface Level Measurements

The third event was a 1.25-in. liquid level decrease in May 1988 that exceeded the 1.00-in. leak detection criteria. The leak detection pit and the drywells remained stable throughout the period. An analysis (Internal memorandum 13331-88-442, "Engineering Investigation: Liquid Level Decrease in Tank 241-AX-102") determined that self-breathing coupled with the air purge from the FIC amounted to ~1.8 cfm. This corresponded to an evaporative liquid level decrease of 0.26 in. for the 4.4-year evaluation period. Since the evaluation did not show that the decrease was due to evaporation, the tank was declared an "assumed leaker" (WHC-UO-88-029-TF-04).

The passive breathing rate is an important parameter in evaporative calculations, and the 1.8 cfm rate used for the 1988 investigation was very low compared with an actual rate of 17 cfm measured in 1997 (PNNL-11683, *Measurements of Waste Tank Passive Ventilation Rates Using Tracer Gases*). An evaporation study was conducted as part of the 2009 assessment. It indicated that a 16 cfm rate – lower than the 17 cfm measured rate – could potentially explain the liquid level decrease. A review of engineering flow diagrams and construction drawings for AX Farm did not indicate any infrastructure changes that would affect the tank AX-102 passive breathing rate between the time of the calculated passive breathing rate (1988) and the measured rate (1997). It was therefore considered valid to apply the measured rate to the 1984 to 1988 liquid level decrease (see the discussion on passive breathing for details of both breathing rate determinations).

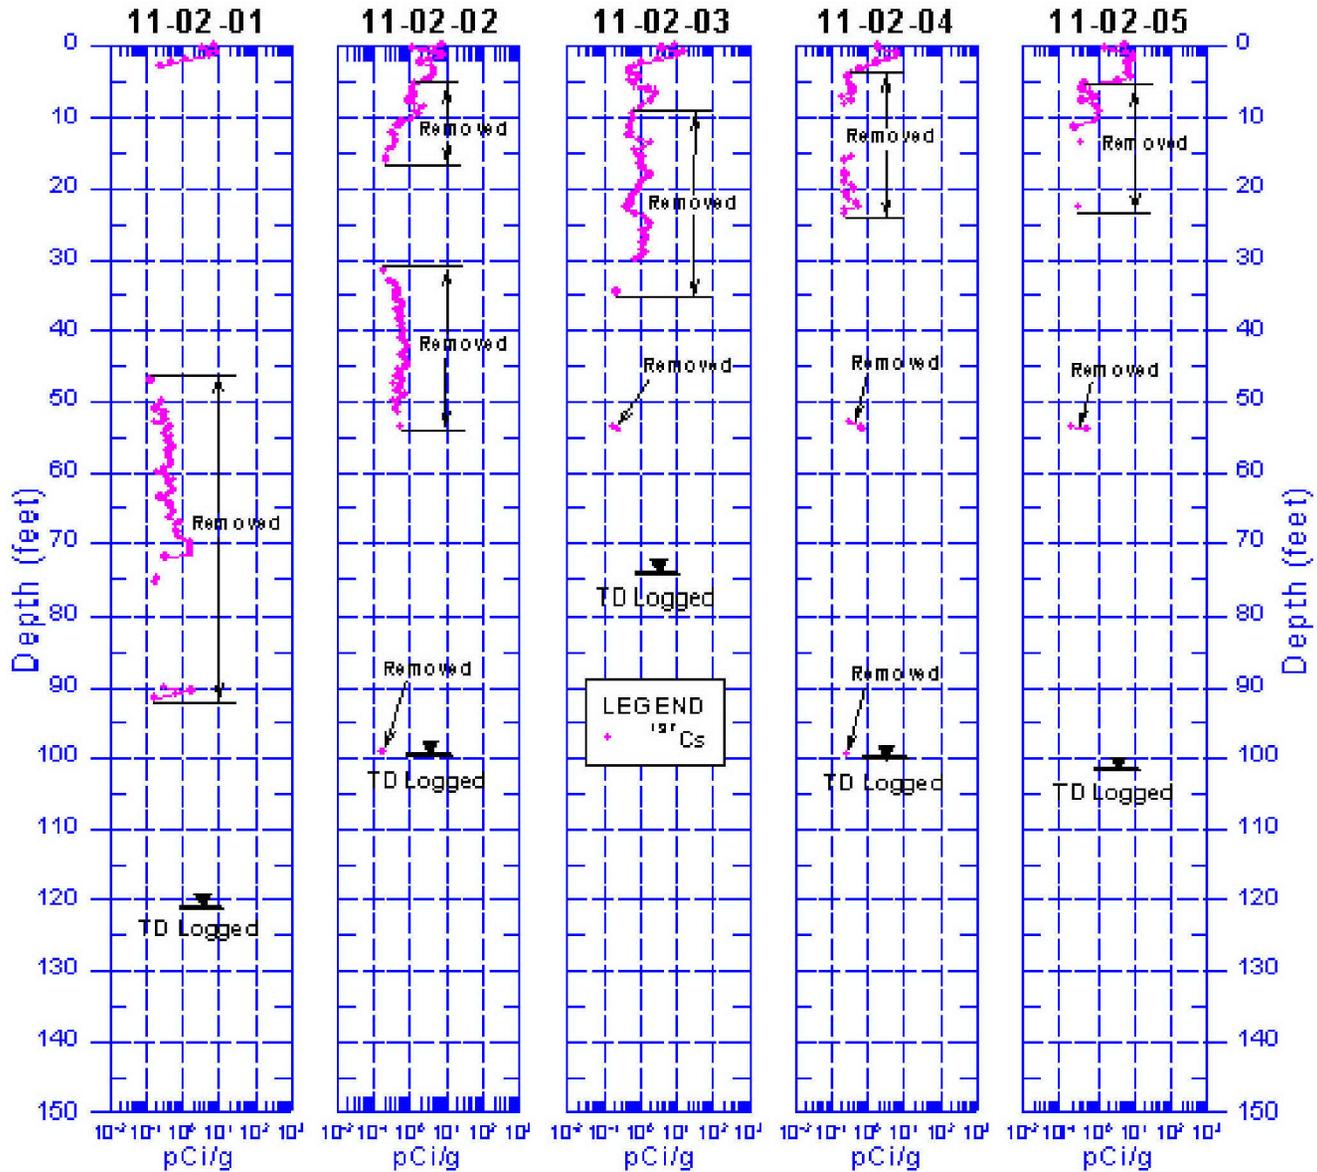
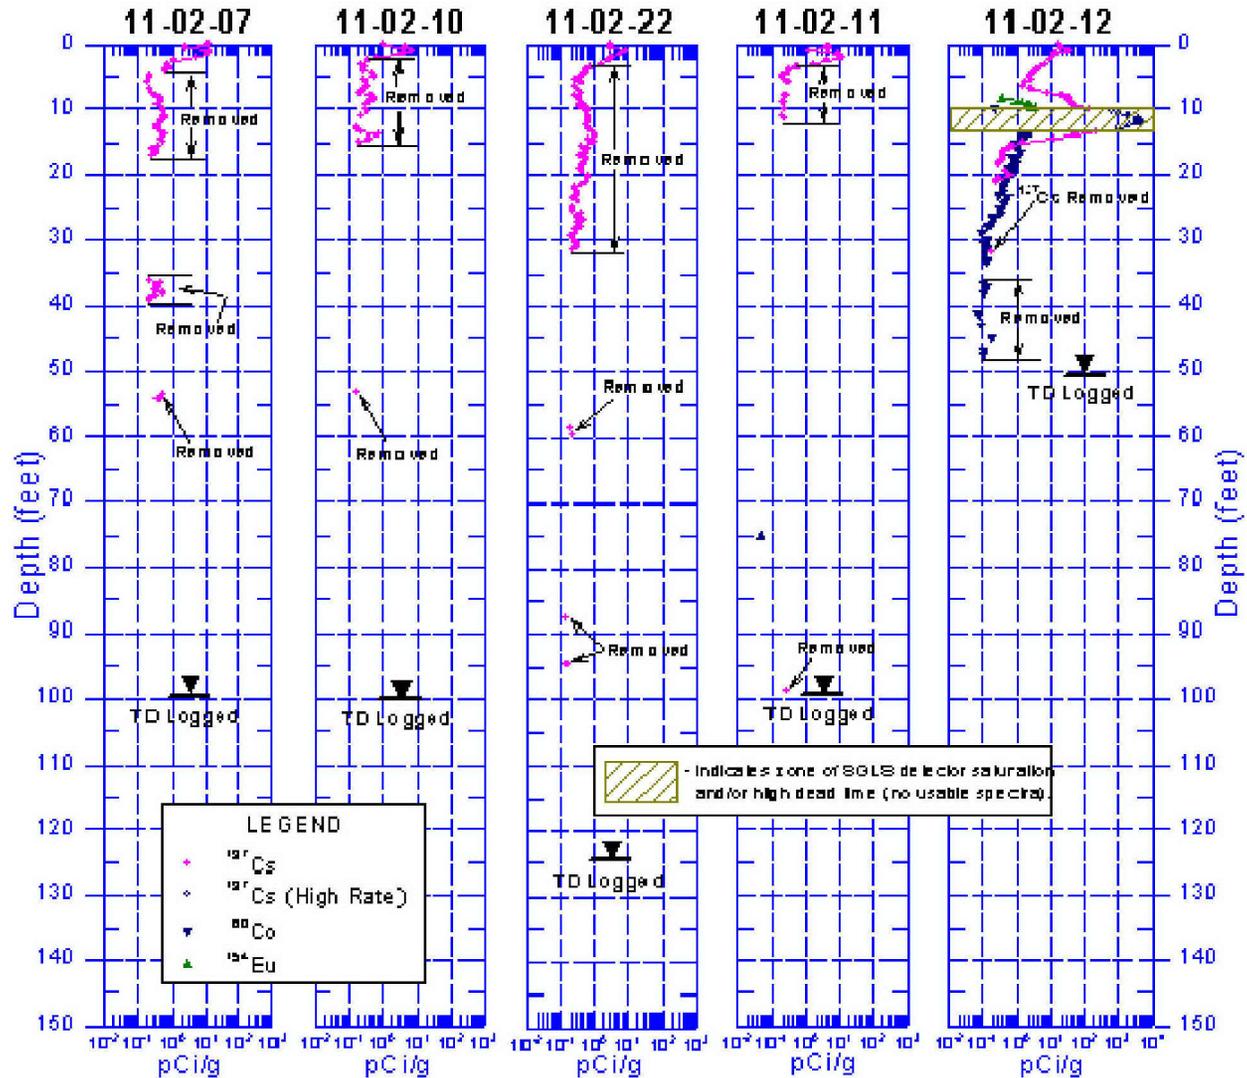
Figure B4-7. 1996 Spectral Gamma Logging Results for Drywells near Tank 241-AX-102 (Sheet 1 of 2).

Other drywells nearby SST AX-102 do not show any significant contamination, as shown in Figure B4-7. Migration of  $^{137}\text{Cs}$  contamination down the inside or outside of the drywell casing is suspected to have affected the distribution of some of the contamination detected in the drywells. Much of the bias of the drywell log data that is due to drywell migration effects was removed from the surveys and is designated as “removed” in these figures.

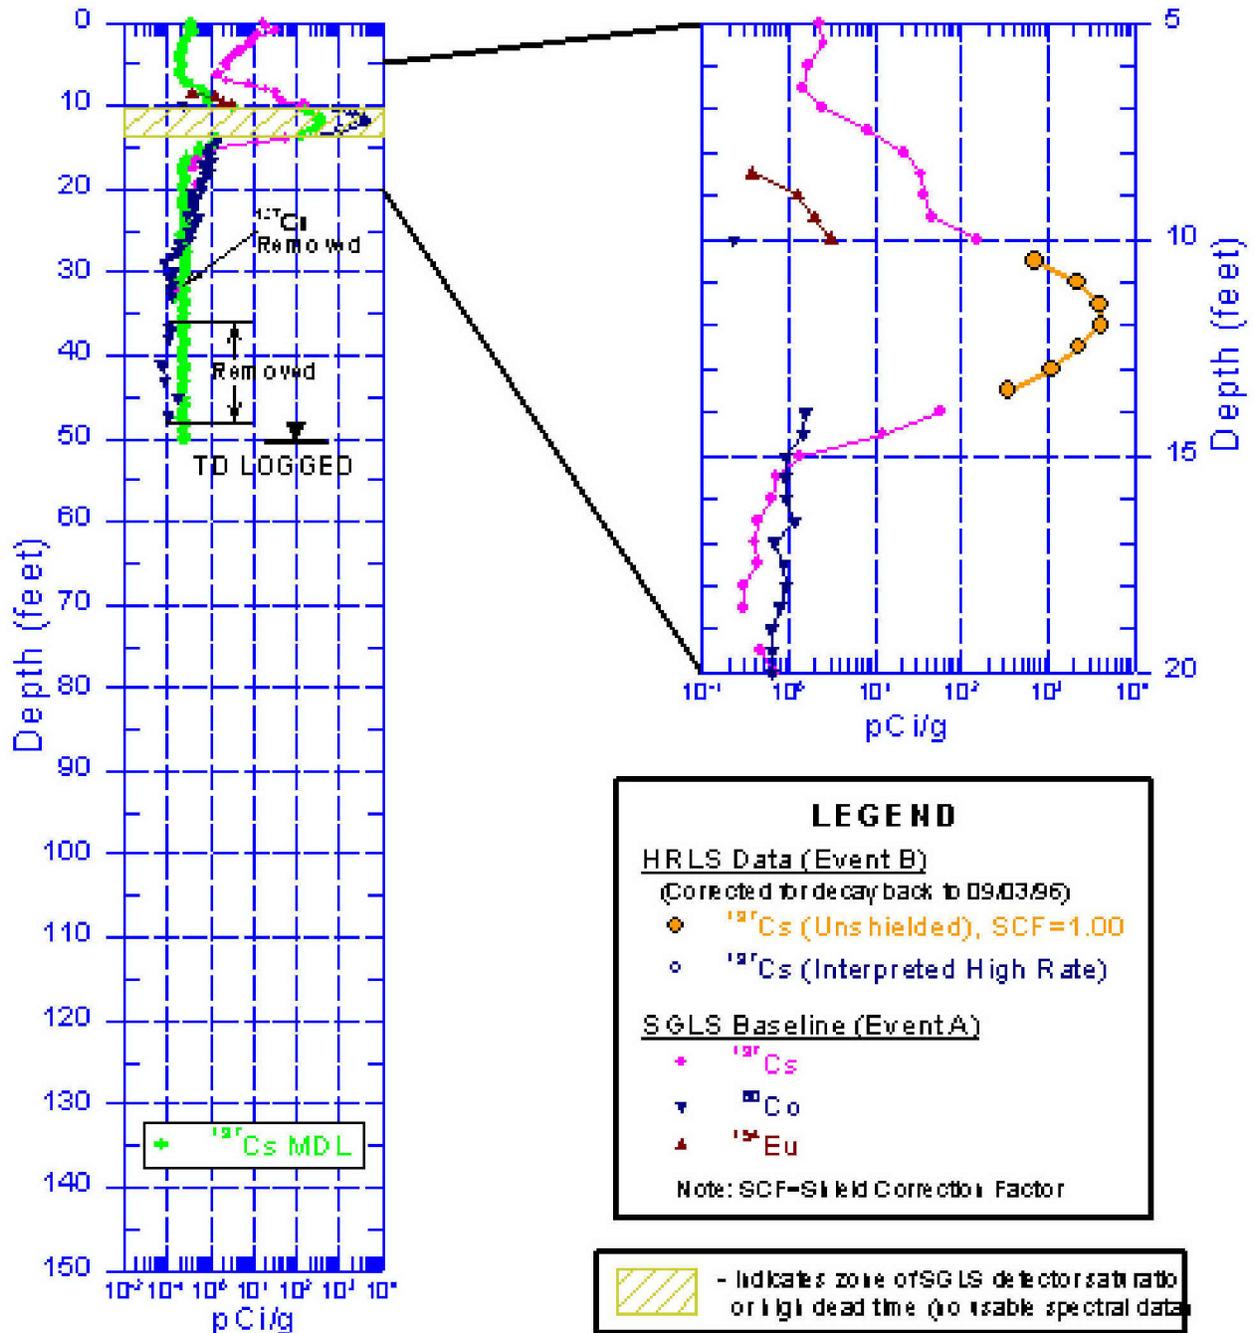
**Figure B4-9. 1999 High Rate Logging System Results for Drywell 11-02-12**

Current spectral gamma analyses for drywells 11-02-12 show  $^{137}\text{Cs}$  as the dominant gamma emitter at ~12 ft bgs and only  $^{60}\text{Co}$  at ~0.1 pCi/g from 30 to 45 ft bgs. Other short-lived gamma emitters present in 1975 would have decayed below detection limits by the mid-1990s, when these measurements were taken. Because the  $^{137}\text{Cs}$  concentration saturated the SGLS detector, drywell 11-02-12 was re-logged in 1999 using a high rate logging system. The high rate logging system showed a peak  $^{137}\text{Cs}$  concentration at 12 ft bgs of ~5,000 pCi/g (Figure B4-9).

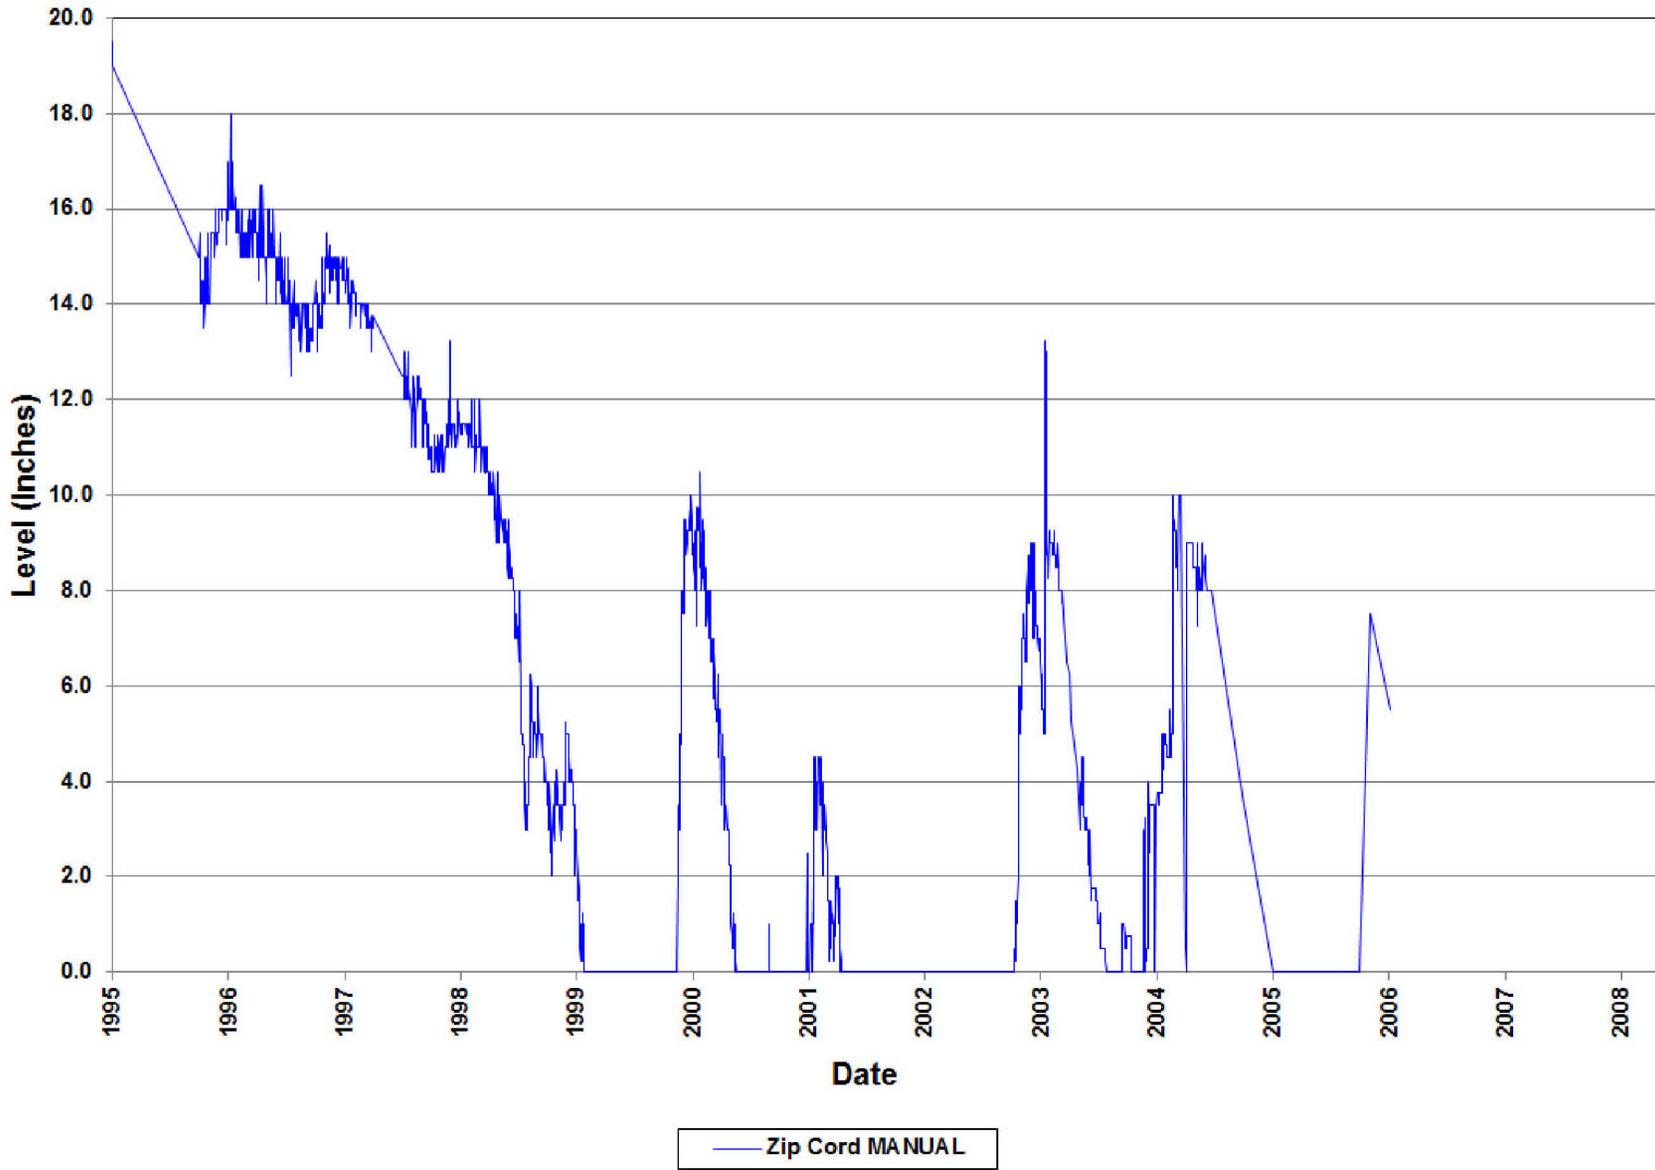
**Figure B4-10. Tank 241-AX-102 Leak Detection Pit Liquid Level (1996 to 2006)**

Both surface level and radiation measurements are available from the leak detection pits. Table B4-3 shows liquid and radiation levels in the AX-102 leak detection pit from 1973 to 1986 and Figure B4-10 shows liquid levels in the leak detection pit from 1995 to 2006. The AX-102 leak detection pit monitoring was discontinued after October 2006.

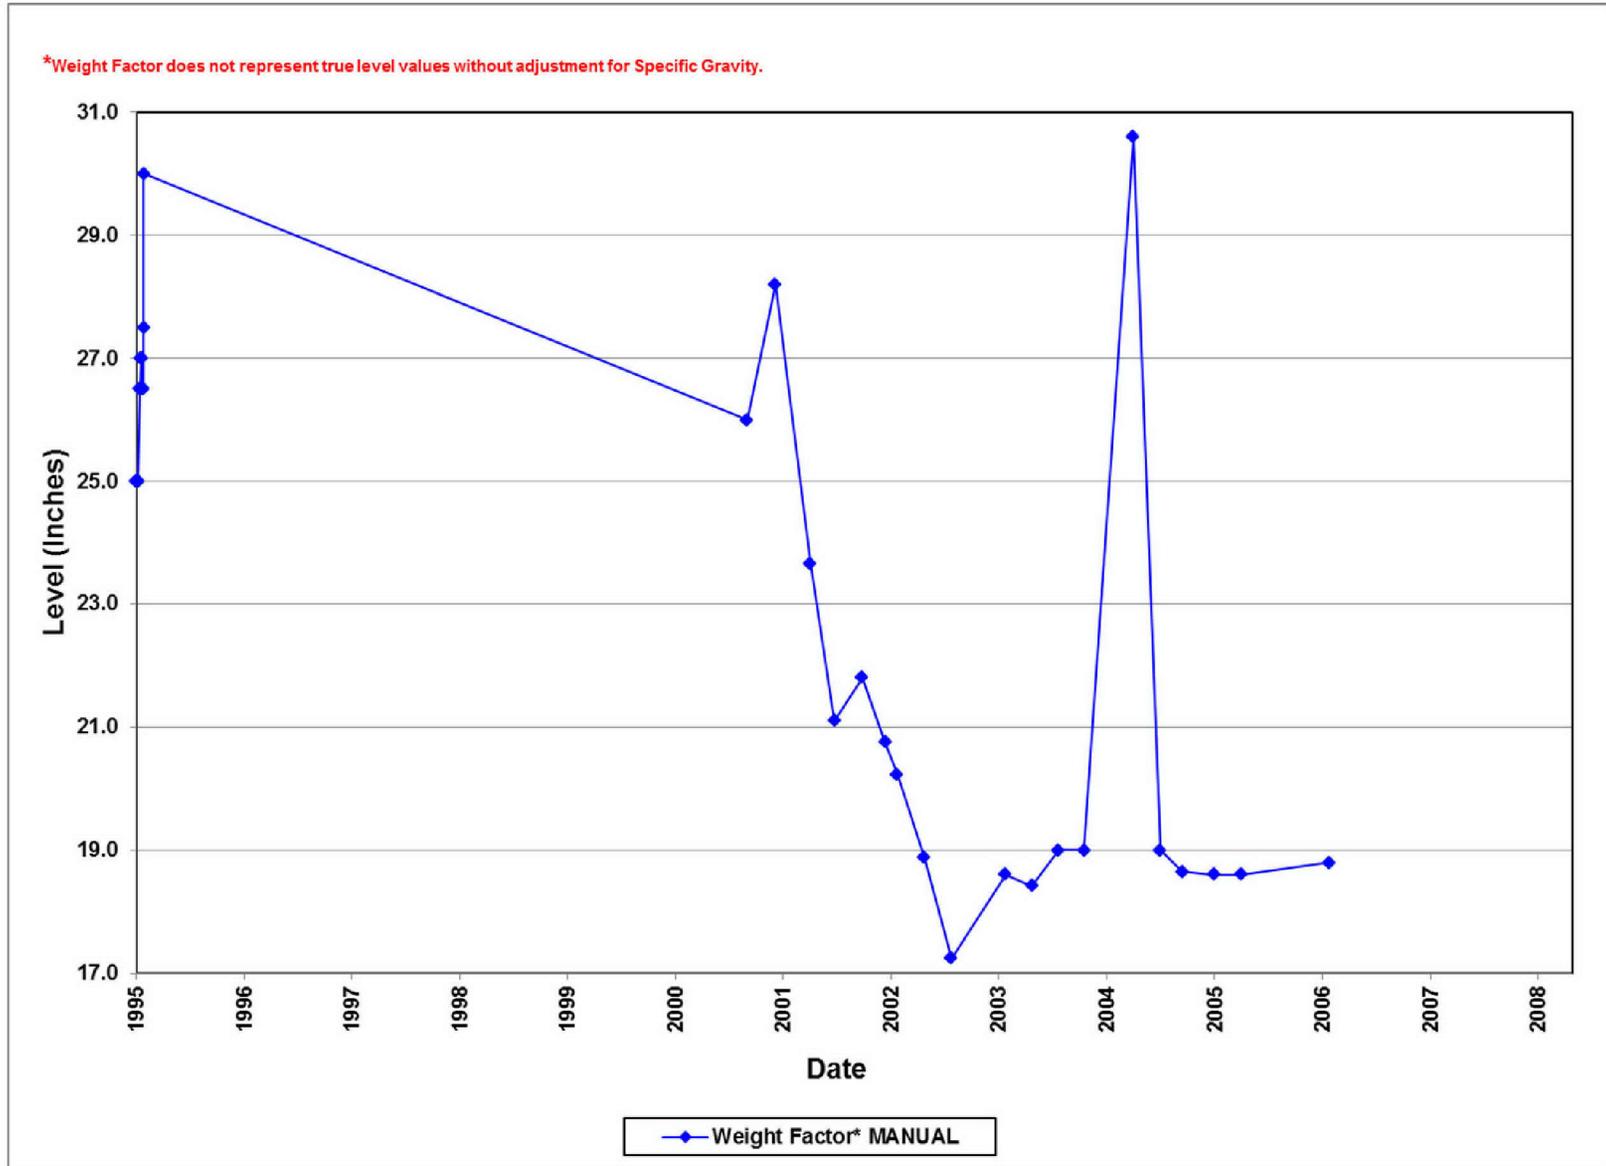
Figure B5-9. Tank 241-AX-104 Leak Detection Pit Liquid Level (1996 to 2006)

In addition to drywell data, AX Farm has leak detection pits as described in Section 3.2. Both surface level and radiation measurements are available from the leak detection pits. Table B5-2 shows liquid and radiation levels in the AX-104 leak detection pit from 1973 to 1986 and Figure B5-9 shows liquid levels in the leak detection pit in 1995 and from 2000 to 2006 based on weight factor measurements. The AX-104 leak detection pit monitoring was discontinued after April 2006. The liquid level spike shown in Figure B5-9 in 2004 appears to be an anomaly.

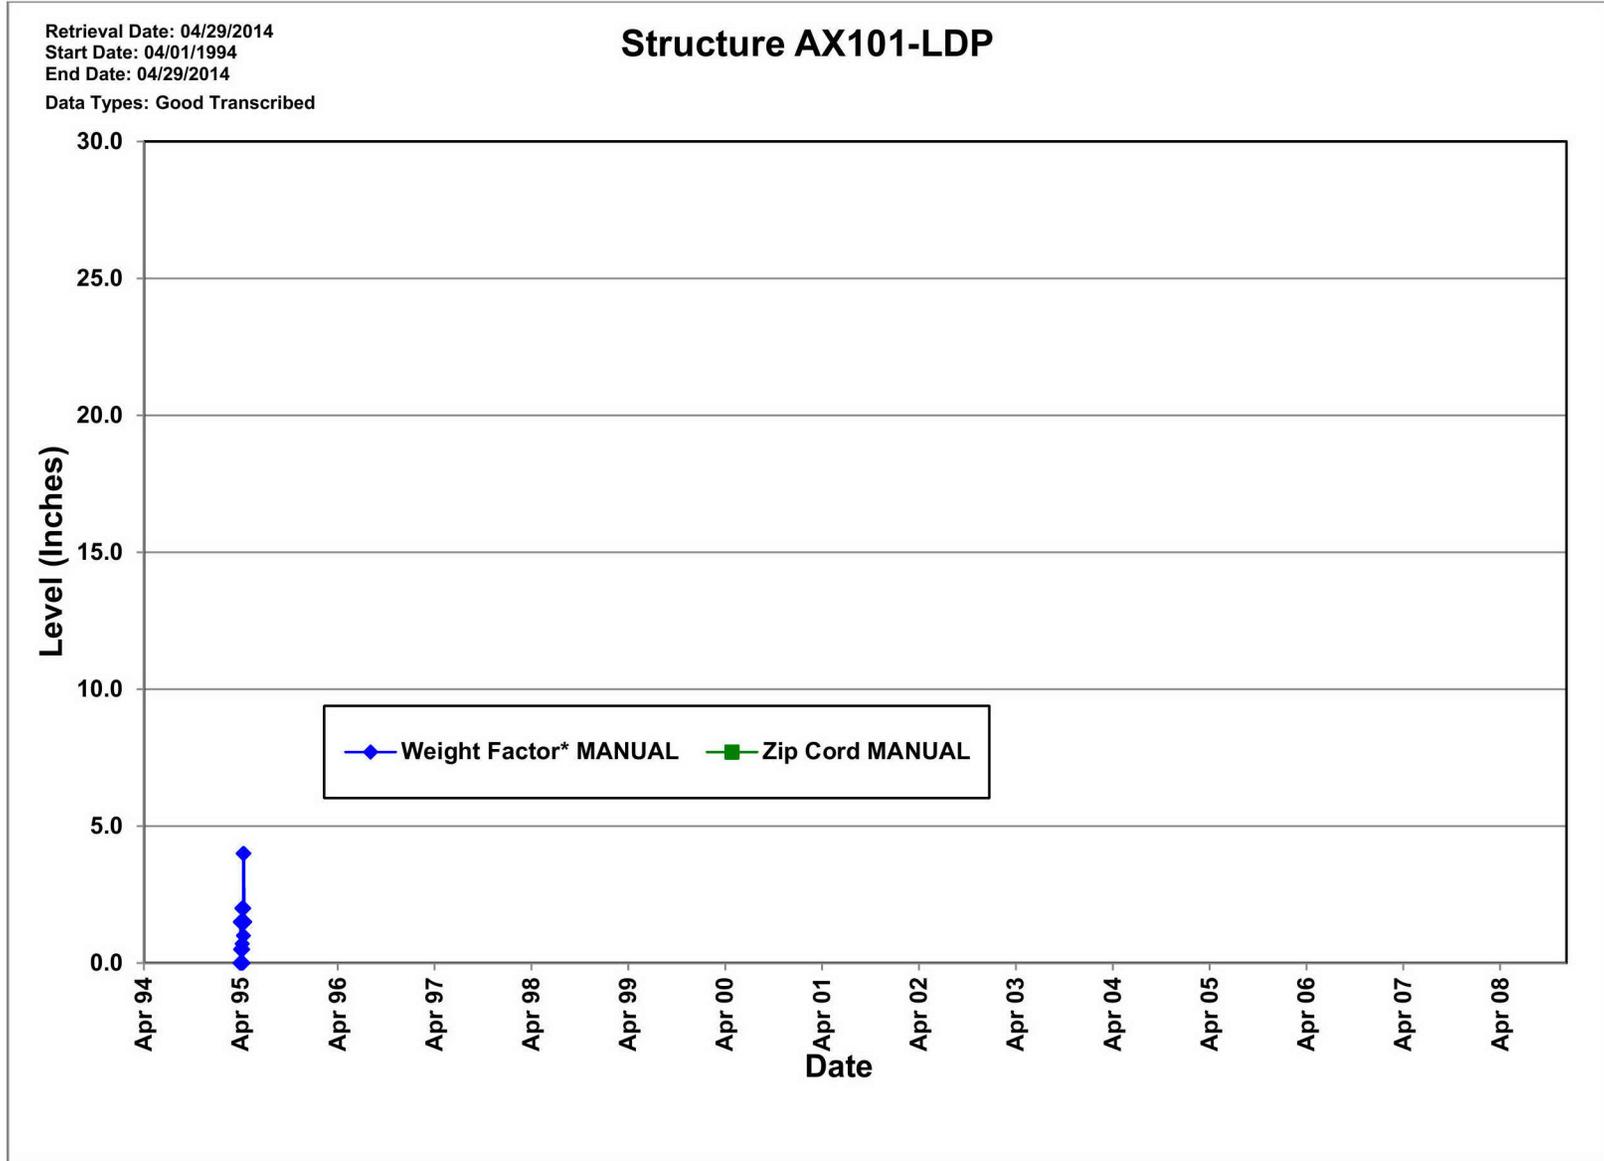
Figure C5-5. AX-101 Leak Detection Pit Liquid Level (1996 to 2006)

In addition to drywell data, AX Farm has leak detection pits as described in Section 3.2. Both surface level and radiation measurements are available from the leak detection pits. Table C5-1 shows liquid and radiation levels in the AX-101 leak detection pit from 1973 to 1986 (SD-WM-TI-356) and Figure C5-5 shows liquid levels in the leak detection pit from 1995 to 2006. The AX-101 leak detection pit monitoring was discontinued after October 2006.
