RPP-ENV-37956, Rev. 2

# Hanford 241-A/AX Farm Leak Inventory Assessment Report

# **HANFORD 241-A AND 241-AX TANK FARMS LEAK INVENTORY ASSESSMENT REPORT**

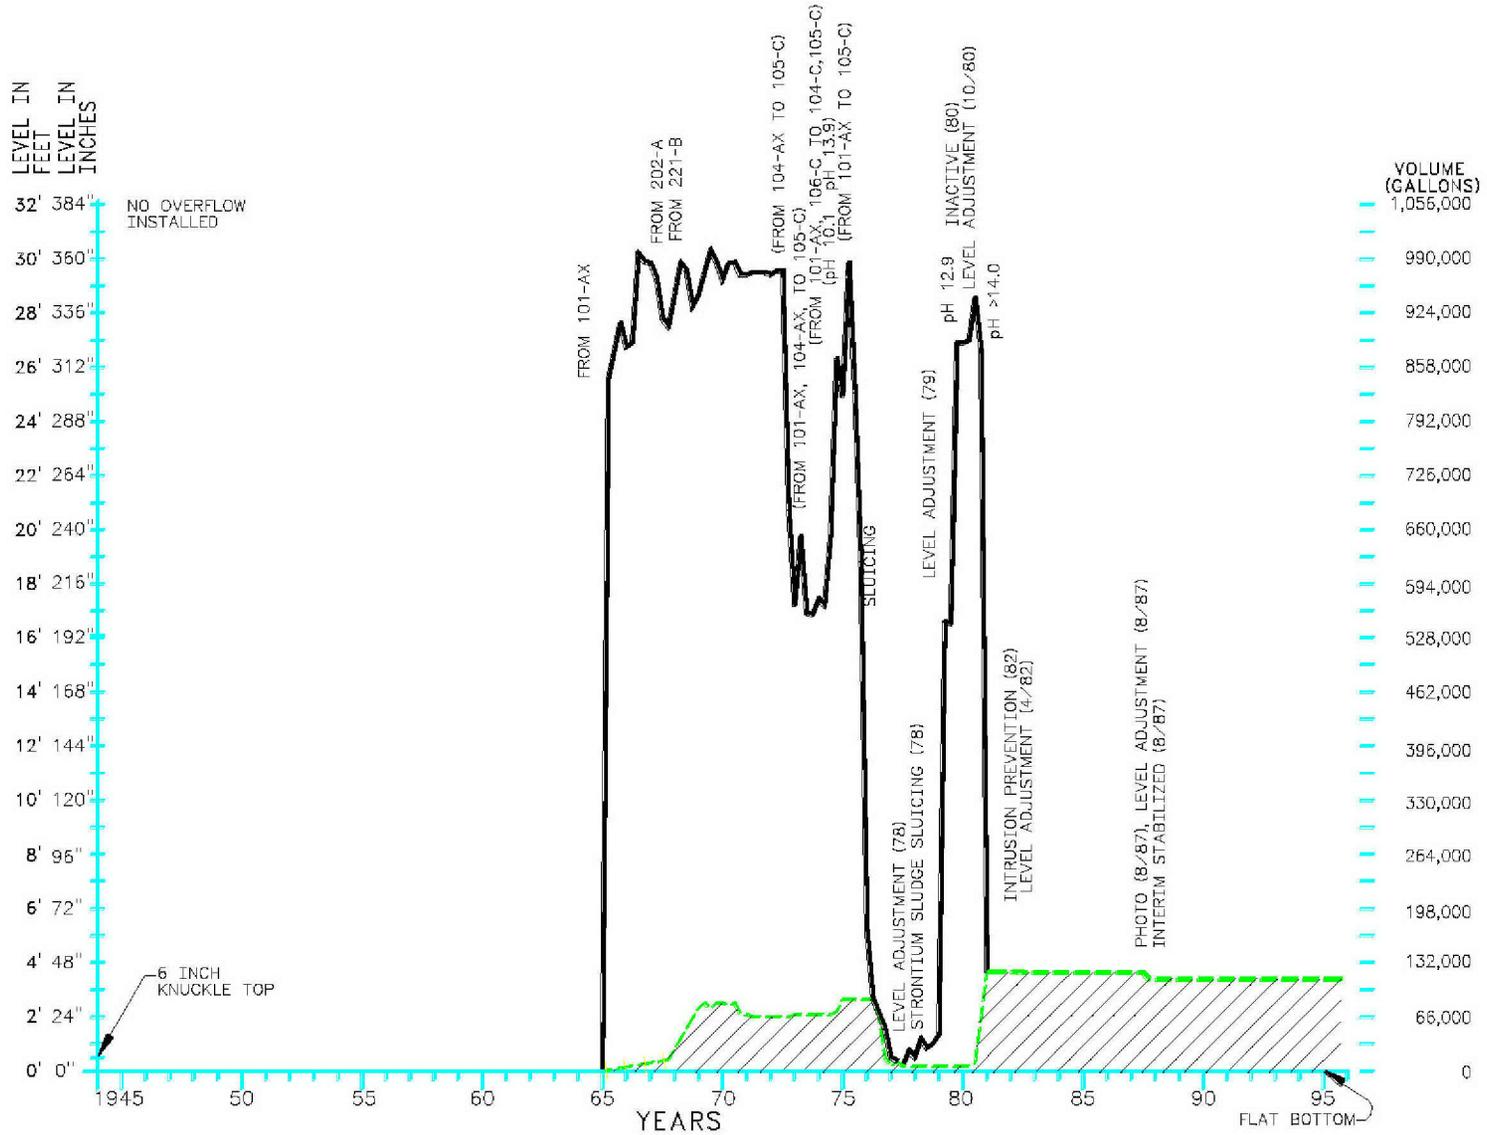
Figure C6-1. Tank 241-AX-103 Quarterly Surface Levels

Figure C6-1 shows historical quarterly waste levels for tank AX-103 from 1946 to 1996 (WHC-MR-0132). Additional surface level data showing more frequent measurements is available for tank AX-103 from 1973 to 1987 (SD-WM-TI-356) and from 1980 to present (Figure C6-2). The tank bottom in tank AX-103 has bulged in several places, and the sludge layer is uneven; however, there are no indications that the tank liner has been breached. Otherwise, there are no unique chemical, physical, historical, operational, or other characteristics of this tank or its contents.

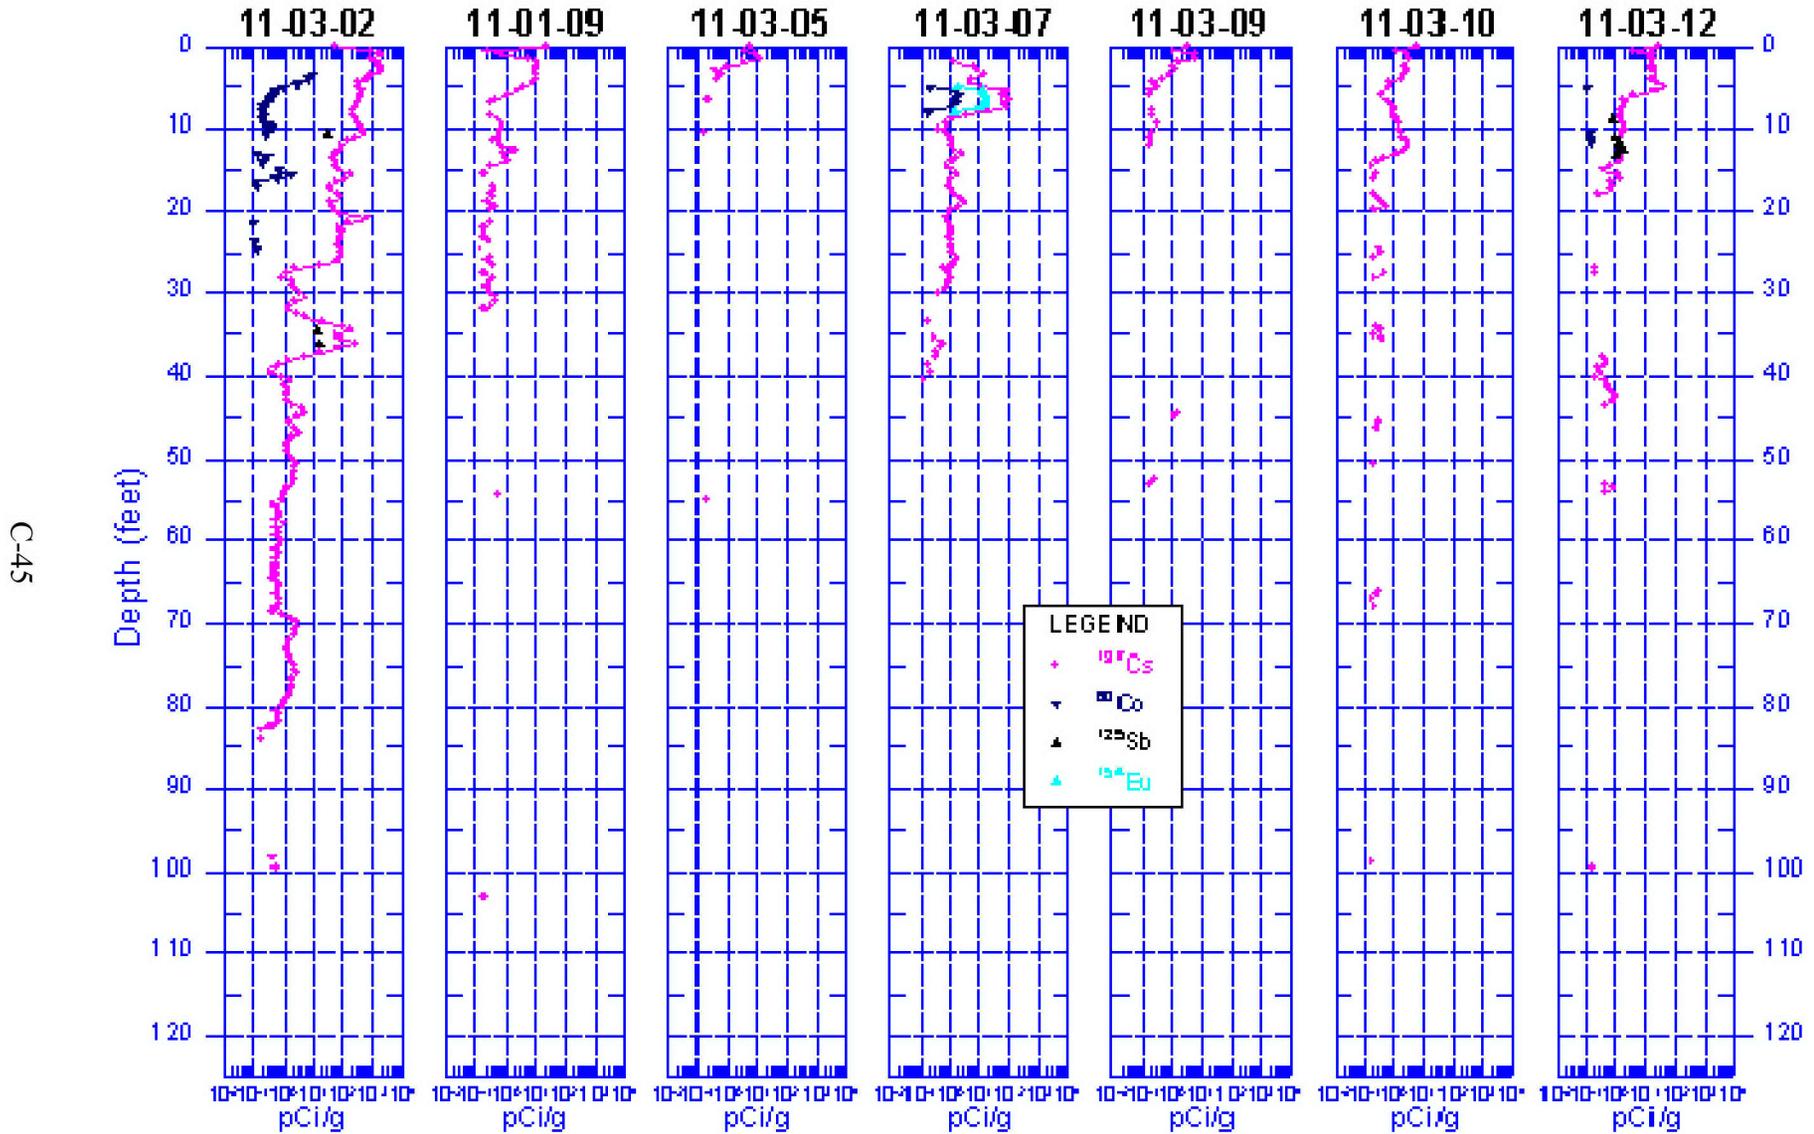
Figure C6-3. 1997 Spectral Gamma Logging System Logging Near Tank 241-AX-103

the contamination existed prior to or shortly after the installation of the drywell (GJ-HAN-51, *Vadose Zone Characterization Project at the Hanford Tank Farms Tank Summary Data Report for Tank AX-103*). Piping about tank AX-103 is shown in Figure C6-4. The measureable peak of activity between 33.5 and 37 ft shown in the readings of borehole 11-03-02 may have been the result of a leak at the approximate level of the transfer line nozzles on the tank.

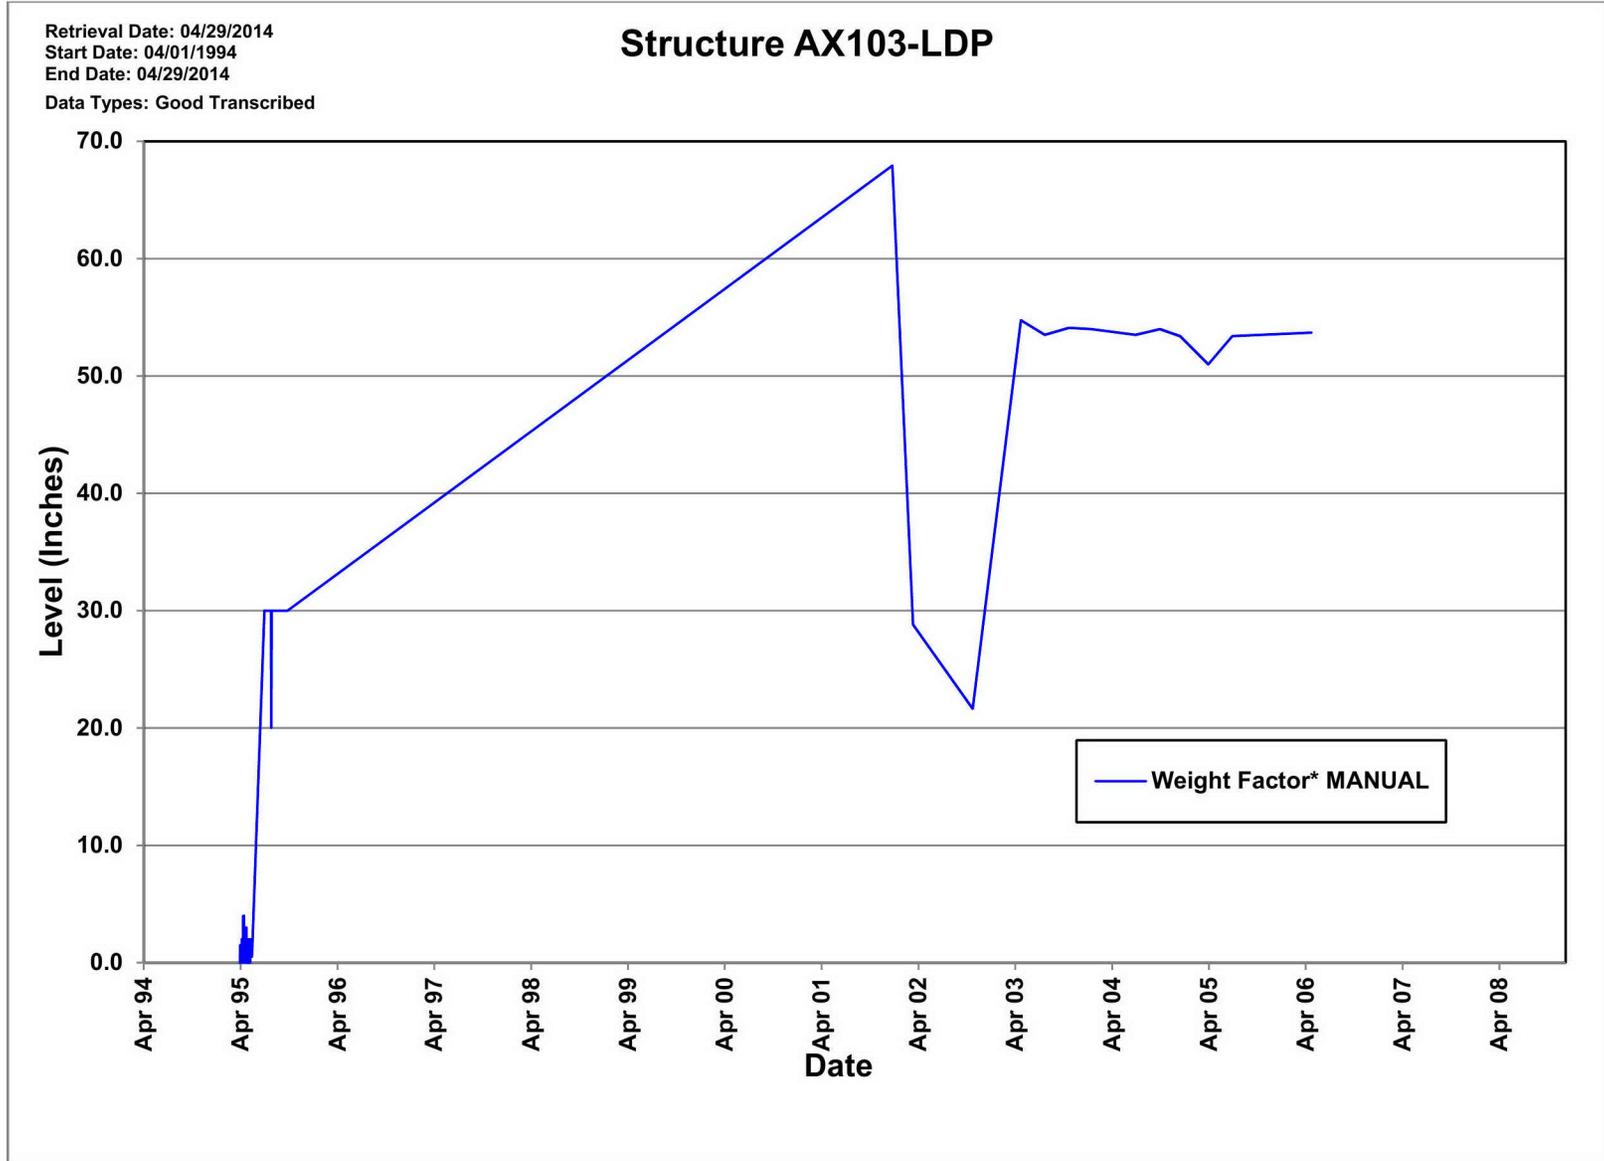
Figure C6-5. AX-103 Leak Detection Pit Liquid Level (1996 to 2006)

In addition to drywell data, AX Farm has leak detection pits as described in Section 3.2. Both surface level and radiation measurements are available from the leak detection pits. Table C6-1 shows liquid and radiation levels in the AX-101 leak detection pit from 1973 to 1986 (SD-WM-TI-356) and Figure C6-5 shows liquid levels in the leak detection pit from 1995 to 2006. The AX-103 leak detection pit monitoring was discontinued after October 2006.
