November 4, 2015

15-NWP-196

Re: Single-Shell Tank Dangerous Waste Compliance Inspection on March 30 and 31, 2015 at the Hanford Site, Resource Conservation and Recovery Act (RCRA) Site ID: WA7890008967, Nuclear Waste Program (NWP) Compliance Index No. 15.518

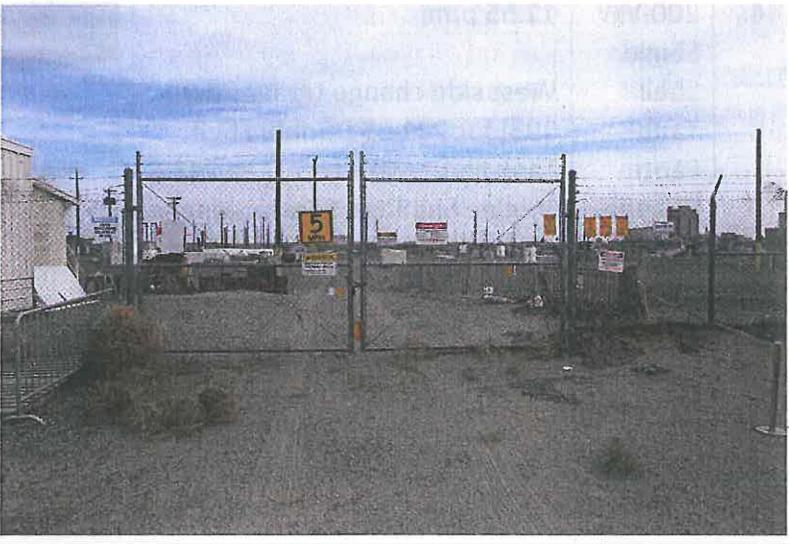
47.	200-W Single Shell Tank Farm 241-SX	1:00 p.m. West side gate for 241-SX Tank Farm. Signage on the gate and both sides of gate.

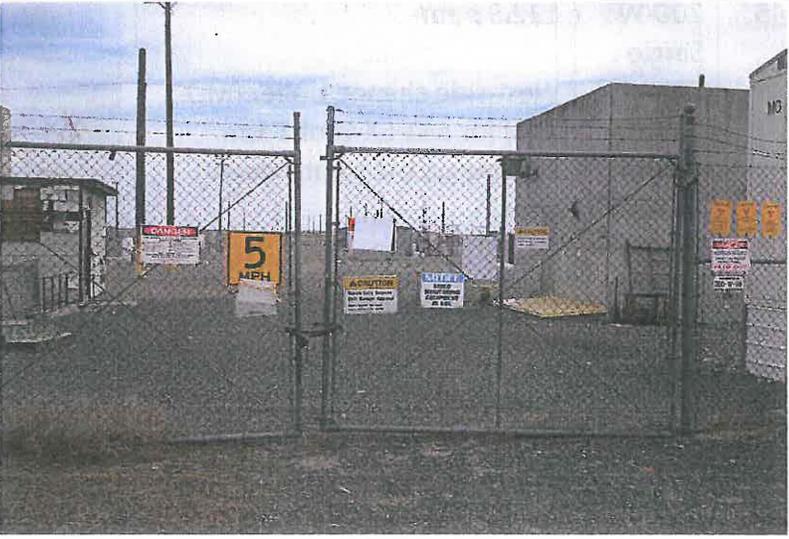
48.	200-W Single Shell Tank Farm 241-SX	1:01 p.m. Second West side gate for 241-SX Tank Farm. Signage on the gate and both sides of gate.

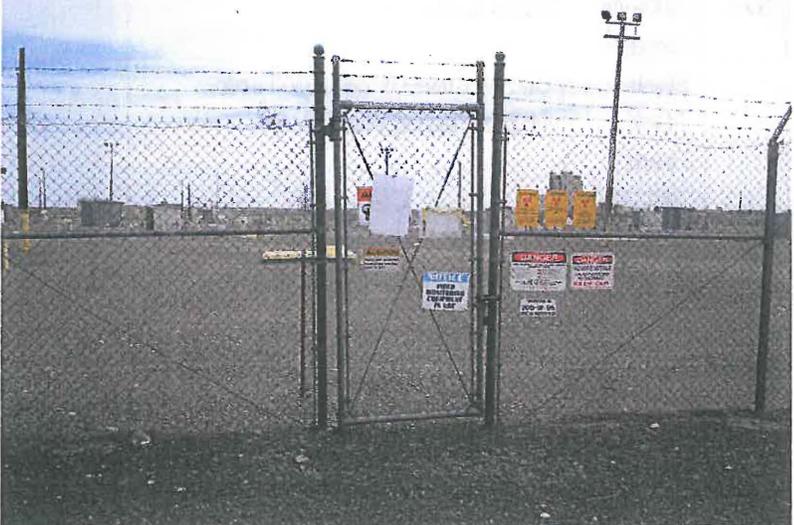
No.	Location	Activity Description/Comment	Photo
49.	200-W Single Shell Tank Farm 241-SX	1:02 p.m. Third West side gate for 241-SX Tank Farm. Signage on the gate and right side of gate.

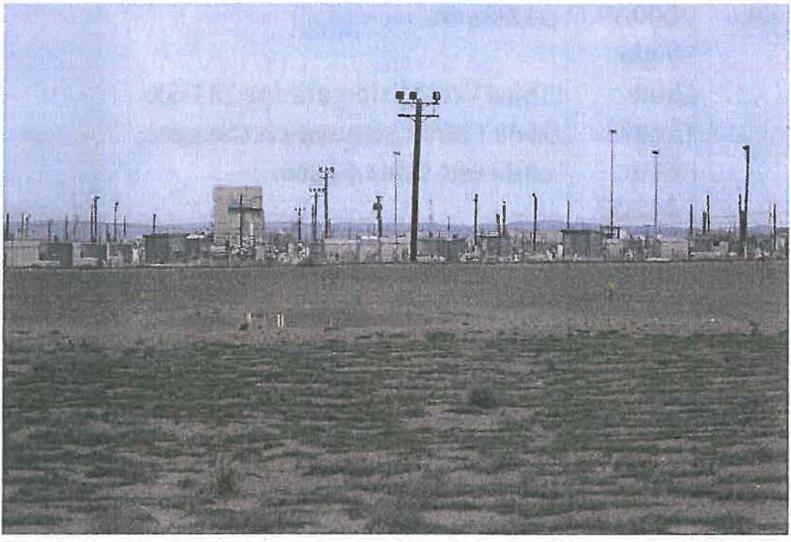
No.	Location	Activity Description/Comment	Photo
52.	200-W Single Shell Tank Farm 241-SX	1:10 p.m. South side of 241-SX Tank Farm, facing North.

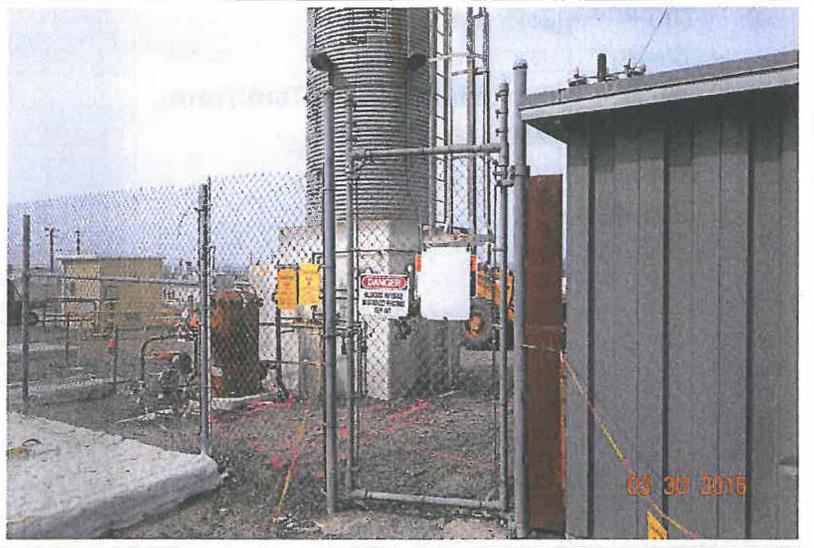
No.	Location	Activity Description/Comment	Photo
55.	200-E Single Shell Tank Farm 241-AX	2:42 p.m. South side gate for 241-AX Tank Farm, facing North Signage on the gate and left side of gate.

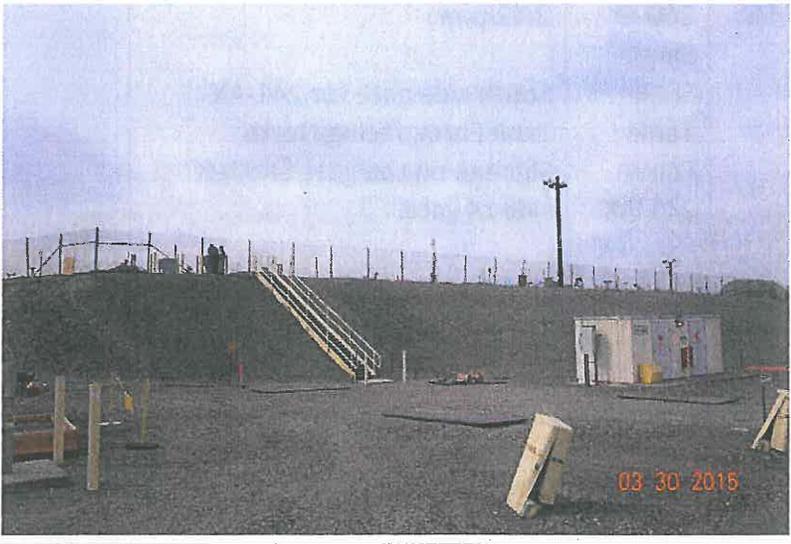
No.	Location	Activity Description/Comment	Photo
58.	200-E Single Shell Tank Farm 241-AX	2:45 p.m. East side of 241-AX Tank Farm, facing Northwest.

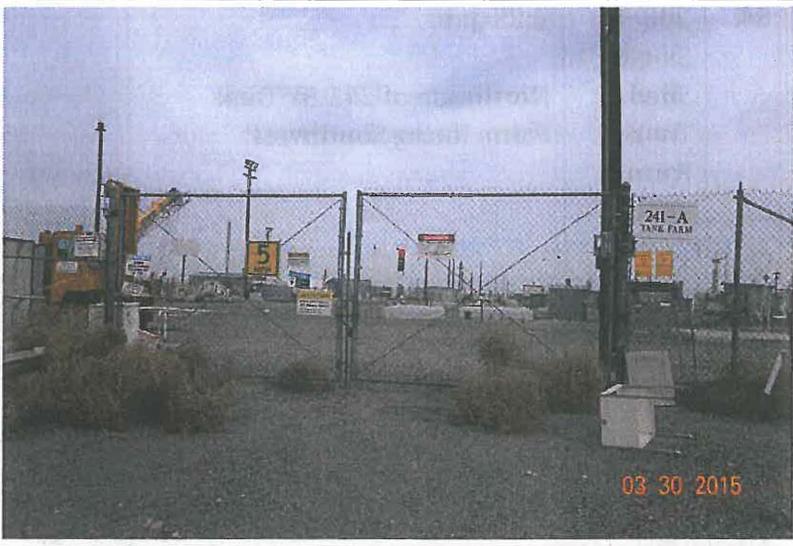
No.	Location	Activity Description/Comment	Photo
61.	200-E Single Shell Tank Farm 241-A	3:00 p.m. West side gate for 241-A Tank Farm, facing East. Signage on the gate and both sides of gate.

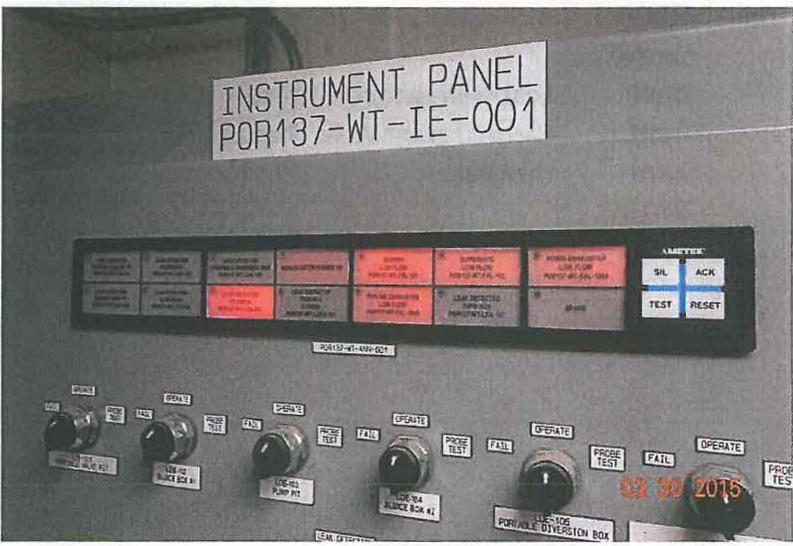
62.	200-E Single Shell Tank Farm 241-C	3:26 p.m. South side of 241-C Tank Farm, in the control room for C-102 operations. Instrument Panel POR137-WT-IE-001.

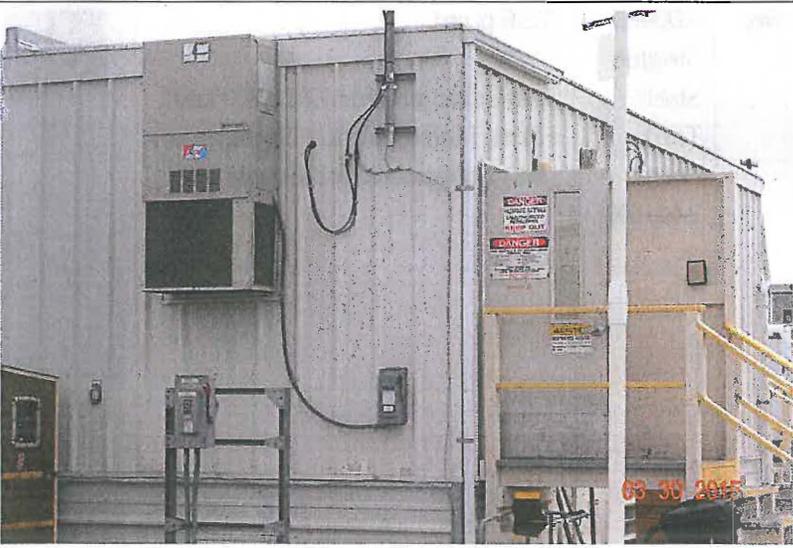
63.	200-E Single Shell Tank Farm 241-C	3:44 p.m. Northwest side of 241-C Tank Farm, ingress change trailer for 241-C.

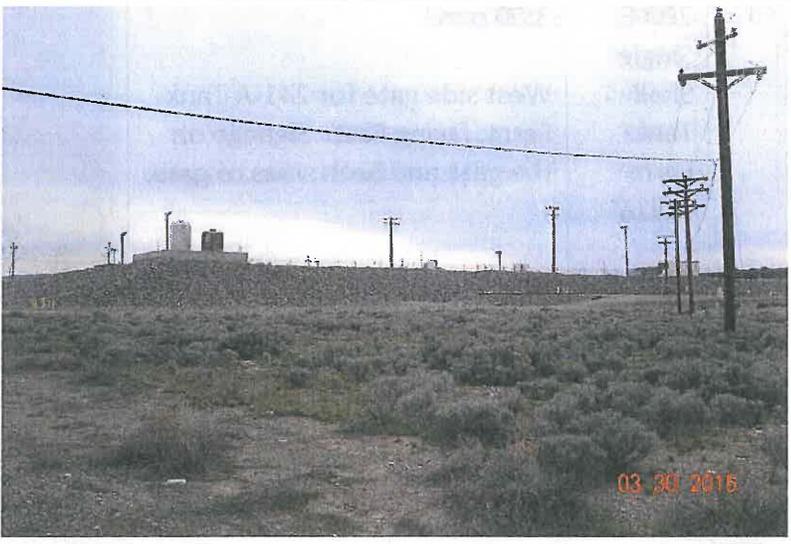
No.	Location	Activity Description/Comment	Photo
64.	200-E Single Shell Tank Farm 241-BY	3:55 p.m. North side of 241-BY Tank Farm, facing Southwest.

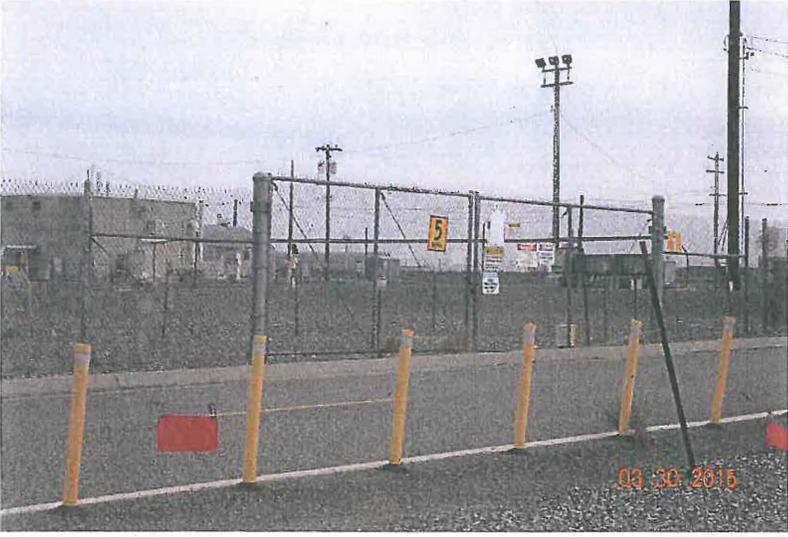
No.	Location	Activity Description/Comment	Photo
67.	200-E Single Shell Tank Farm 241-B	3:57 p.m. West side gate for 241-B Tank Farm, facing Southeast Signage on the gate and right side of gate.
