## FACILITY STATUS CHANGE FORM

<b>Date Submitted:</b> Feb 9, 2011 <b>Originator:</b> David Warren <b>Phone:</b> 539-6040	<b>Area:</b> 100-N Area <b>Facility ID:</b> 153-N Electrical Substation <b>Action Memorandum:</b> 100-N Ancillary Facilities	<b>Control #:</b> D4-100-N-0008 rev.1
--	---	--

SUBJECT: **POST DEMOLITION SUMMARY REPORT FOR THE 153-N ELECTRICAL  
SUBSTATION**

# Post Demolition Summary Report for the 153-N Electrical Substation

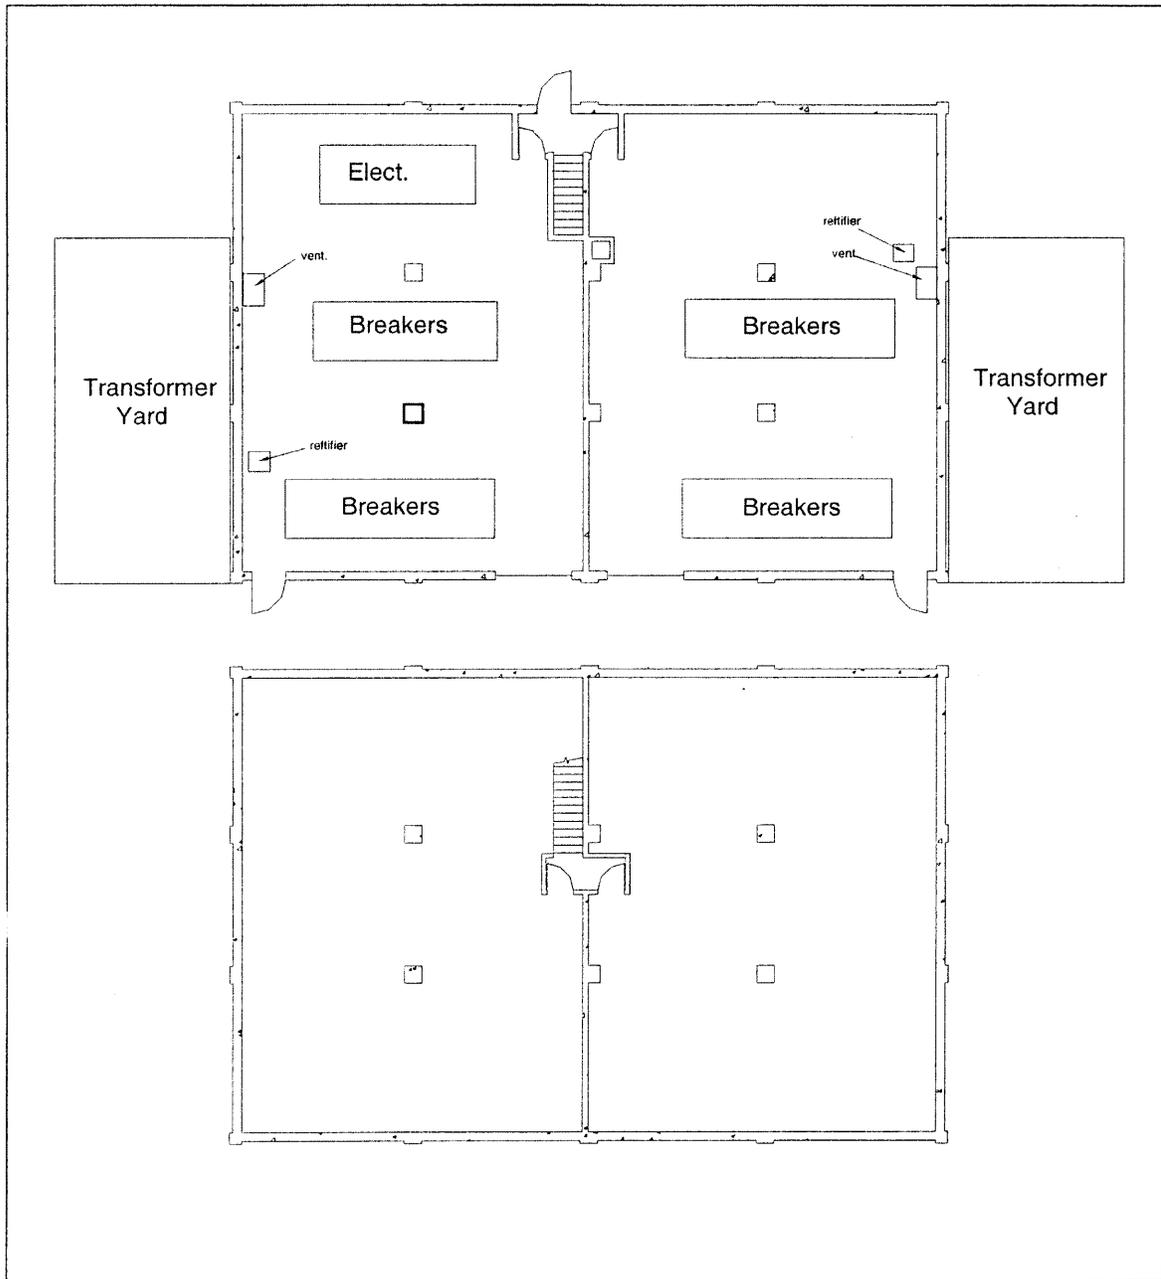
Figure 1

A simplified floor plan of the 153-N prior to its demolition is included as Figure 1.

(Figure 1- Main Floor (top) and Basement Cable Tray Area (bottom))

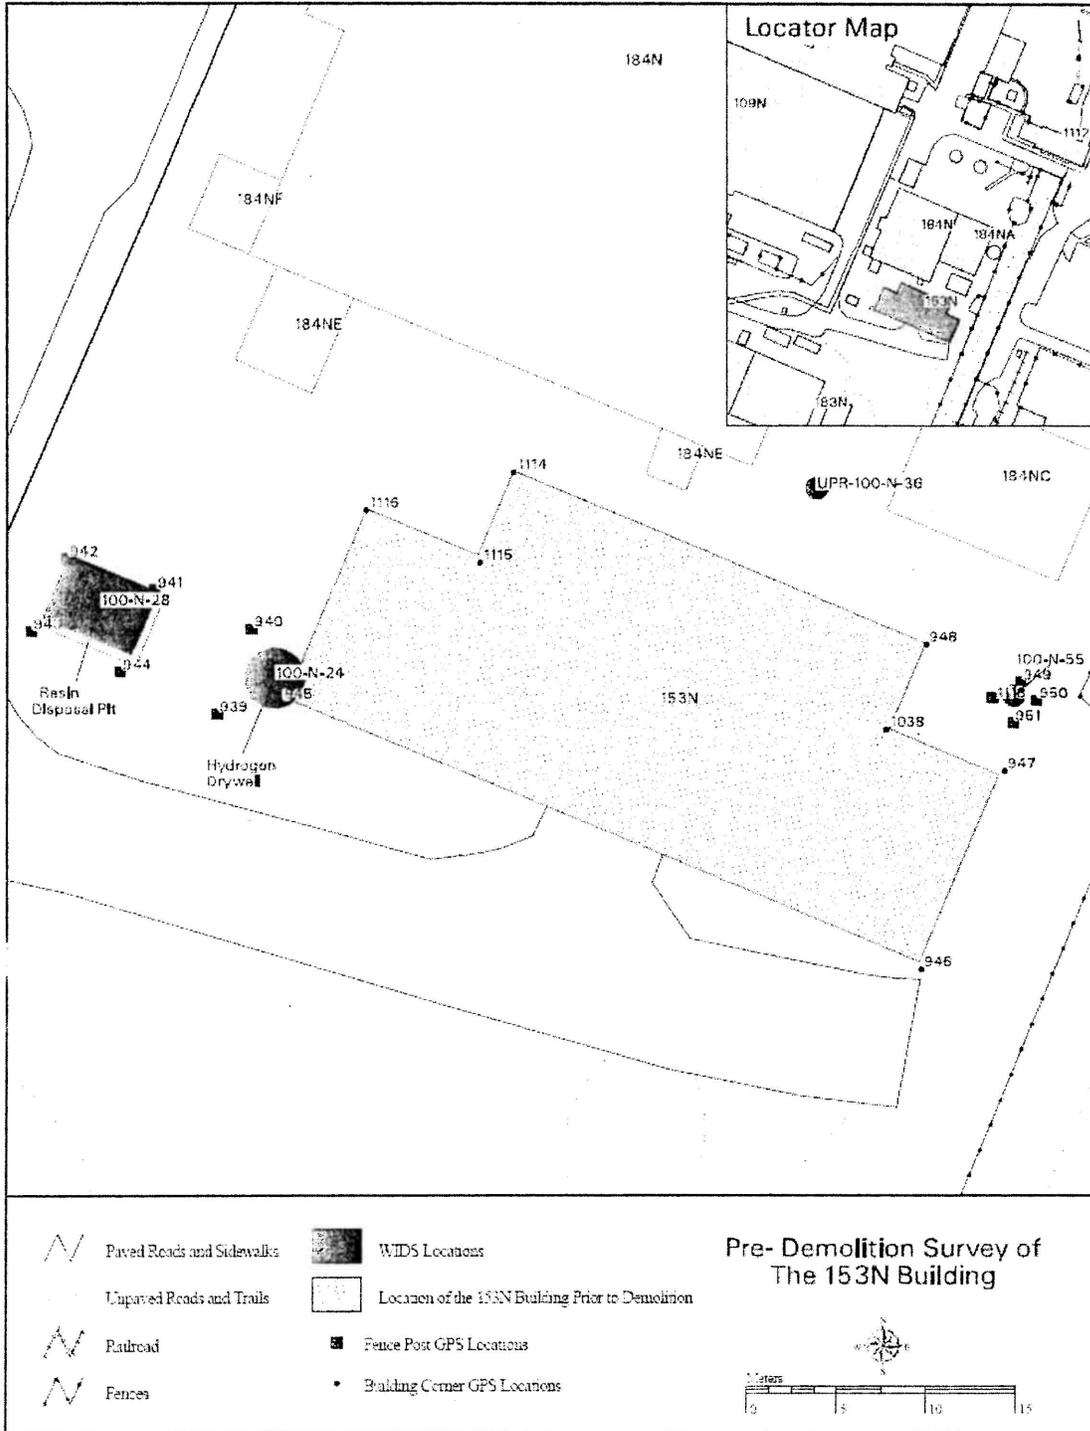
## Attachment 2 - Pre-Demo Civil Survey Map

A GPS civil survey was performed on the 153-N prior to demolition. This survey located the corners of the building and the corners and extents of near-by structures. A post demolition civil survey was performed. This survey documented the extent of the excavation (footprint and depth) as well as remaining structures (electrical conduits and concrete structures) extending into the excavation. It should be noted, that these remaining concrete structures are not from the 153-N facility but rather footings from adjacent structures.
