FACILITY STATUS CHANGE FORM

D4 Project Soils and/or Below Grade Structures Completion Form 1723N Warehouse, 1723NX Laydown Yard, and MO-913 Change Trailer

**WASHINGTON CLOSURE HANFORD D4 FACILITY CHARACTERIZATION
HISTORICAL SITE ASSESSMENT FOR THE 1723-N WAREHOUSE AND 1723-NX
LAYDOWN YARD**

Post Demolition Summary Report for the 1723N Warehouse, 1723NX Laydown Yard and MO-913 Change Trailer

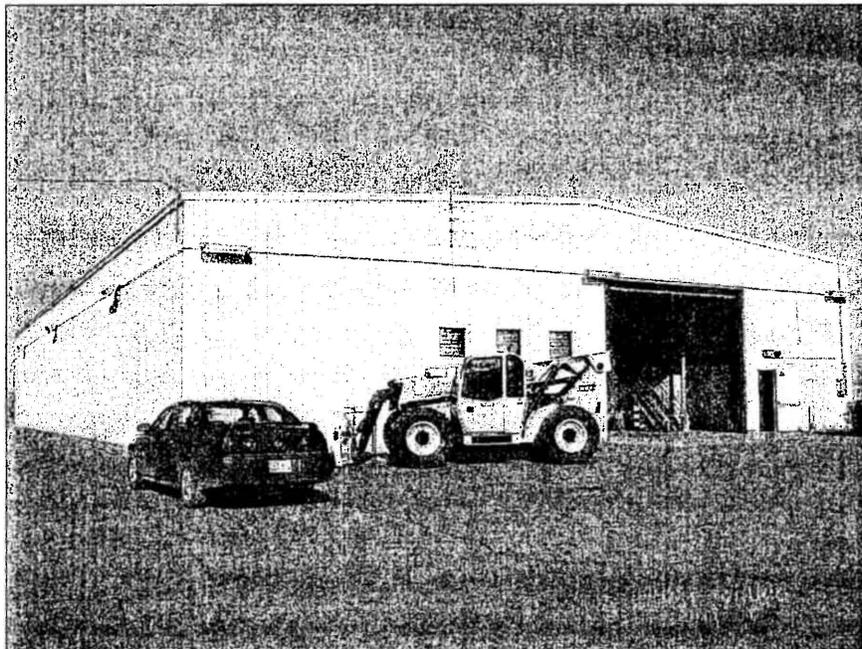
Figure 9.1 - 1723-N Warehouse

1723-N is a warehouse, and has been used for storing a variety of items used to support operations at 100-N. No significant stains or other signs of spills were observed on the concrete pad inside the building. No stains or other signs of spills were observed on the exterior of 1723-N, including the 1723-NX Laydown Yard area. Process knowledge and historical knowledge do not indicate any spills or leaks.

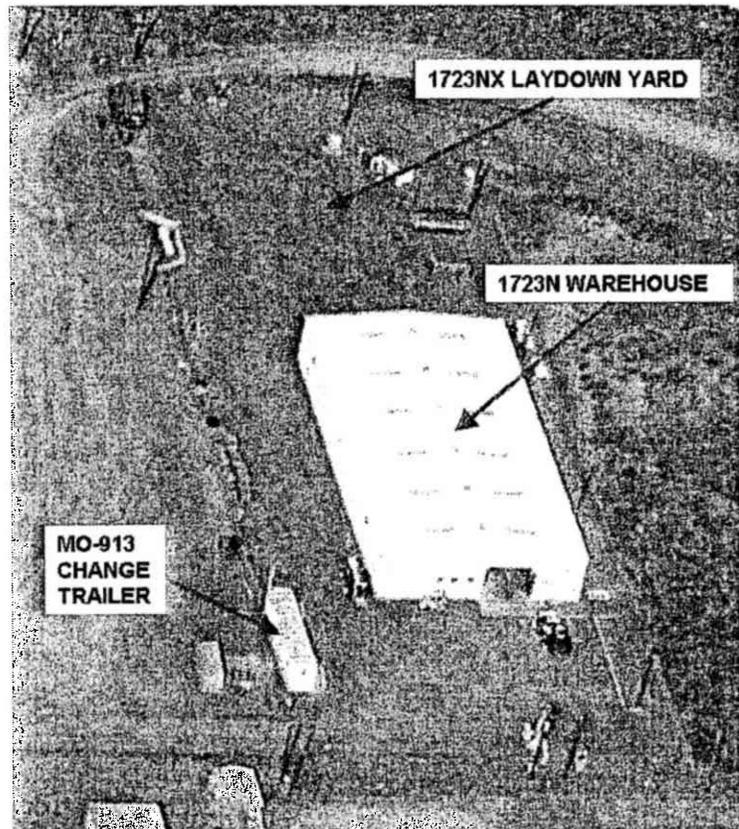
Figure 1 – 1723N Warehouse, 1723NX Laydown Yard, and MO-913 Before Demo (top of image pointing west)
