Re: Department of Ecology's Dangerous Waste Compliance Inspection at Hanfords 242-A  
Evaporator RCRA ID# WA7890008967 on November 13, 2012

**Washington Department of Ecology  
Hazardous Waste & Toxics Reduction Program  
Compliance Report**

**Site: 200 Area Hanford Permit, 242-A Evaporator Dangerous Waste  
Management Unit  
RCRA ID#: WA 7890008967**

Inspection Date: November 13, 2012 - 9:00 am to 4:30 pm

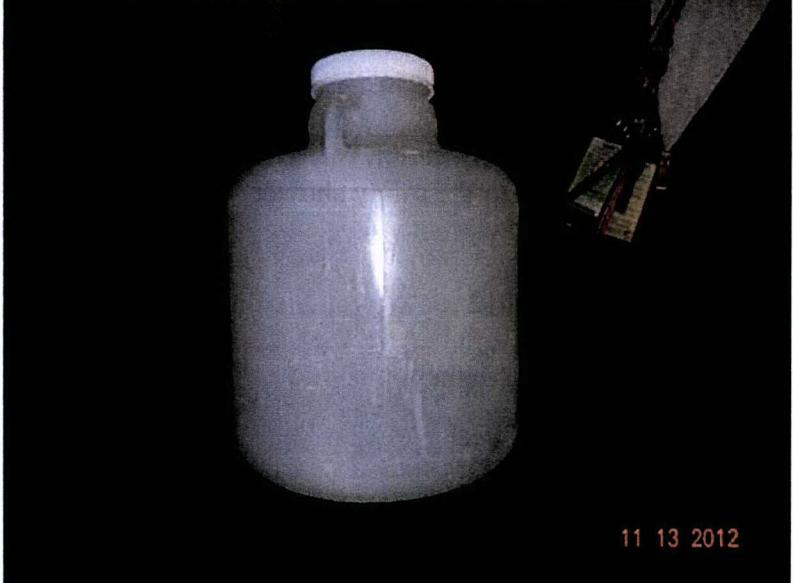
<p>A photograph showing a safety shower drain area in a tiled room. The floor is covered in small, dark mosaic tiles. Two circular floor drains are visible, one in the foreground and one further back. The walls are tiled with larger, light-colored tiles. A date stamp '11-13-2012' is visible in the bottom right corner of the photo.</p>
<p>#4 – Container typically used to add weekly water additions to the safety shower drain to seal loop in building 272-AW.</p> <p>Photo Taken: 11/13/2012</p> <p>Photo taken by: Jared Mathey</p>

- 1) A significant amount of O&M records for the 242-A Evaporator seal loop and floor drain water additions were missing from April 2011 to September 2012. These missing records are associated with O&M requirements for adding water to seal loops and floor drains in the 242-A Evaporator condenser room. These seal loops, when properly filled and maintained, provide a protective barrier from mixed-waste vapors between the head space of DST 241-AW-102 and the 242-A condenser room.

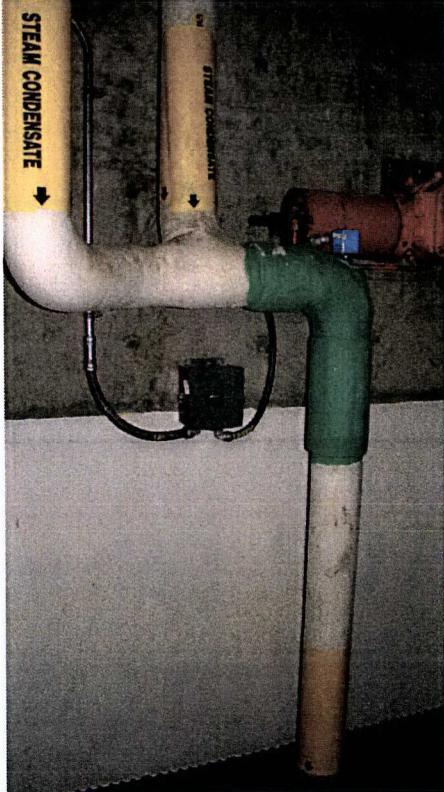
Area & Description	Photographs
<p>#11 – 242-A condenser room conductivity alarm LEL C103-2 for seal loop C-103-2</p> <p>Date photo taken: 11/13/2012</p> <p>Photo taken by: James Hamilton –WRPS</p>

- 2) The 242-A Inhibited Alarm Logbook Data Sheets, provided by the facility, indicated that the conductivity alarm LEL C-103-2 had a "bad sensor" on April 14, 2007. These records showed that the alarm was not replaced and continued to be in a cycle "of being inhibited and/or returned to service" from April 14, 2007 to April 7, 2010.

As a part of the actions during the subsequent investigation and causal analysis for this event, it was noted that the creation of preventative maintenance actions and datasheets are necessary to address the following instrumentation: LEL-C103-1, LEL-C103-2, LEL-C100-1, and LEL-SP-1. These instruments are associated with the following alarms: LSL-C1031, LSL-C1032, LSL-C1001, and LSL-SP-1, respectively. The actions associated with the development of the preventive maintenance activity and datasheets are scheduled for issuance by December 19, 2012.

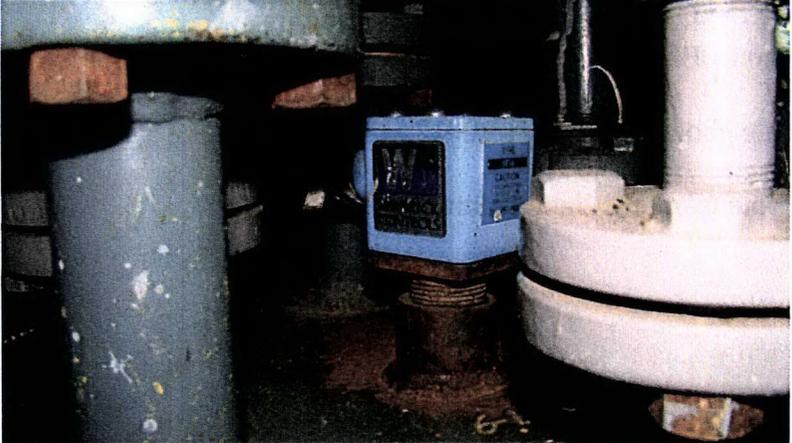
Area & Description	Photographs
<p>#17 – 242-A condenser room conductivity alarm LEL SP-1</p> <p>Date photo taken: 11/13/2012</p> <p>Photo taken by: James Hamilton –WRPS</p>
