## FACILITY STATUS CHANGE FORM (for DOE/RL-2010-34 Facilities)

<b>Date Submitted:</b> March 26, 2014 <b>Originator:</b> Clay McCurley <b>Phone:</b> 942-8928	<b>Area:</b> 100-B <b>Facility ID:</b> 151B Primary Electrical Substation <b>Action Memorandum:</b> General Hanford Site Decommissioning Activities	<b>Control #:</b> D4-100B-004
--	--	----------------------------------

**Photographs of the 151B Primary Electrical Substation (2 pages)**

## Visual Inspection of 151-B Switch Yard March 6, 2014

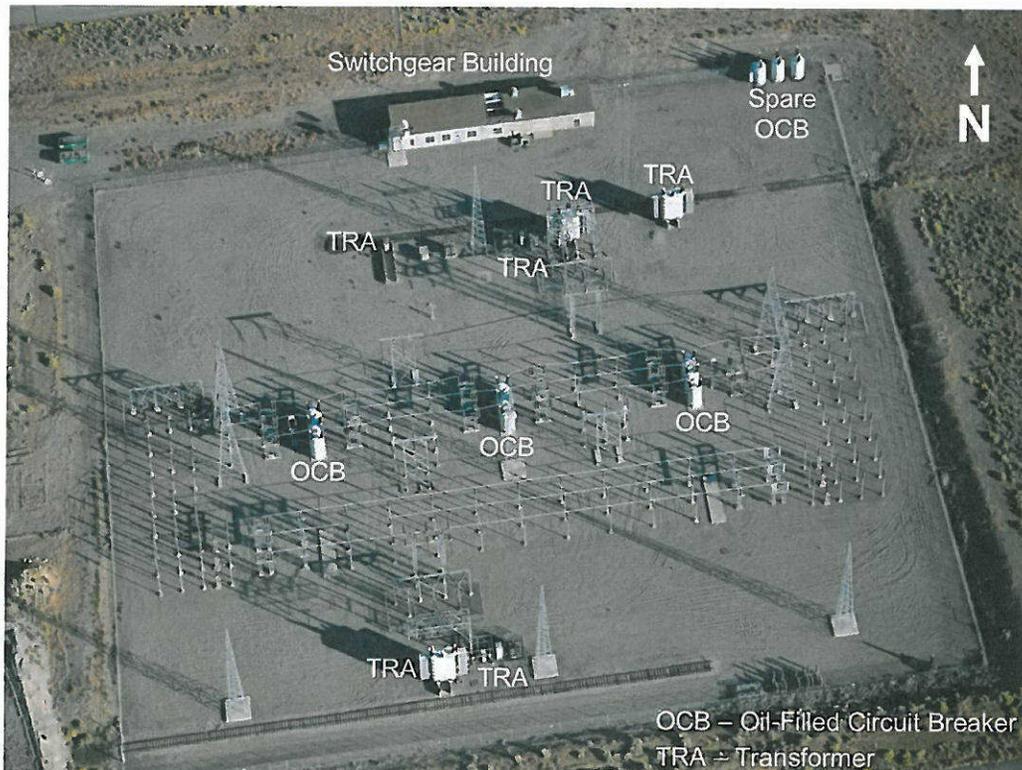
Figure 2. 151B Switch Yard in June 2012 (facing north)

The 151B switch yard (also known as A2) shown in Figure 2 (Attachment 2) served as the primary source of electrical power for all facilities in the 100-BC Area. It consisted of a fenced, gravel-bed yard that originally measured approximately 430 feet by 303 feet and was expanded in 1952 to support new facilities associated with the 105-C Reactor. The 151B switchgear building, which was demolished in April, 2013, was located on the northern fence line. It is not addressed in this document. The Facility Status Change Form (FSCF) documenting D4 of the 151B switchgear building is found in Document No. D4-100B-001.
