## FACILITY STATUS CHANGE FORM (for DOE/RL-2010-34 Facilities)

<b>Date Submitted:</b> June 9, 2014 <b>Originator:</b> Clay McCurley <b>Phone:</b> 942-8928	<b>Area:</b> 100-B <b>Facility ID:</b> 183B Clear Wells <b>Action Memorandum:</b> General Hanford Site Decommissioning Activities	<b>Control #:</b> D4-100B-003
--	--	----------------------------------

SUBJECT: **183-B Clear Well Structural Evaluation**

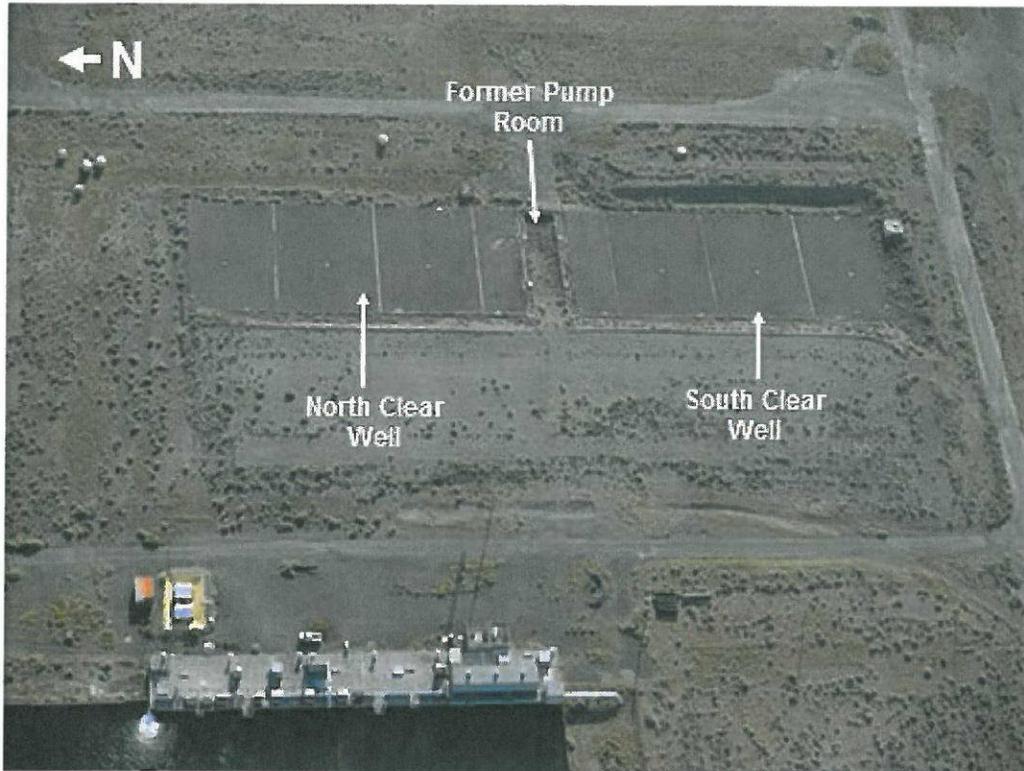
**Figure 3. 183B Clear Wells in September 2013**

This document provides information regarding the history, characterization, and final status at the completion of deactivation, decontamination, decommissioning, and demolition (D4) activities of the 183B clear wells and associated valve pits located in the 100-B Area as shown in Figure 1 (Attachment 2). The 183B clear wells were part of the former 183B water treatment plant constructed in the 1940s approximately 1,300 feet west of the 105B Reactor to support its operation. A photo of the former water treatment plant is provided in Figure 2 (Attachment 2). The water treatment plant consisted of a headhouse, flocculators, sedimentation basins, filter building, and a pump room that separated the clear wells. In 1987, the water treatment plant was demolished leaving only the clear wells intact. Clean rubble from demolition was placed in the sedimentation basins and the area was backfilled with soil and compacted to provide a minimum of 18 inches of cover. The site was graded to provide a smooth contour matching surrounding terrain. The clear wells were left intact with intentions of using them for future use as a landfill for demolition debris. The roof of the pump room, which supported the electrical building, was collapsed, partially filled, and graded. A 2013 photo of the clear wells, prior to D4, is provided in Figure 3 (Attachment 2).

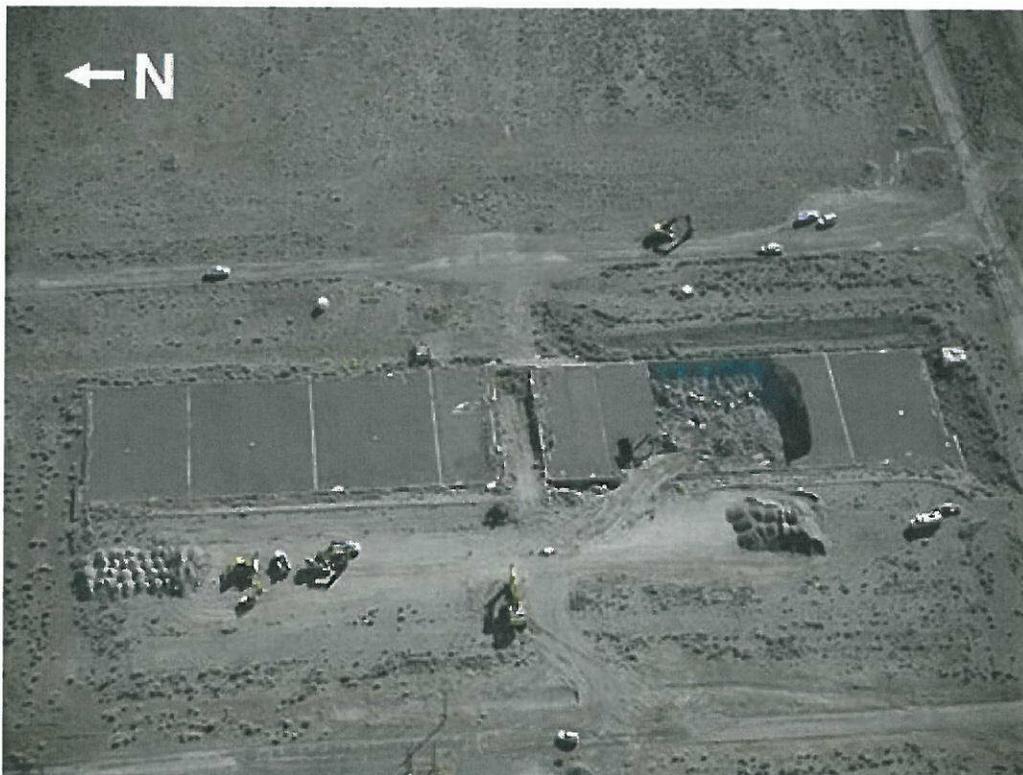
**Figure 4. 183B South Clear Well in March 2014**

The D4 of the clear wells began in March 2014 with the installation of a ramp on the west side of the south clear well as shown in Figure 4 (Attachment 2). The concrete roof and roofing materials were demolished, size reduced, transported to and disposed of daily under asbestos controls at the Environmental Restoration Disposal Facility (ERDF) as they were generated. D4 then proceeded to the north clear well in April 2014 as shown in Figure 5 (Attachment 2). The concrete columns that held up the roof were cleared size reduced, cleared to the sides, and left in place on the floor of the clear wells. Each clear well was visually inspected for stains and anomalies prior to backfill. Photographs were taken to document the observations and the information was compiled into the *Visual Inspection of the 183B Clear Wells* provided in Attachment 7. D4 activities were completed in May 2014. An aerial photo of the site in June 2013, provided in Figure 6 (Attachment 2), shows the area after the completion of backfill activities. A post-demolition Global Positioning System (GPS) survey of the area was not performed. The pre-demolition GPS survey provided in Attachment 8, documents the location of the walls and floors or the clear wells that were left in place. The berm on the west side of the clear wells was left in place. Clean fill from a nearby borrow pit was brought in and built up (over the clear wells) to the level of the berm rendering the surface over the clear wells consistent with the surrounding terrain.

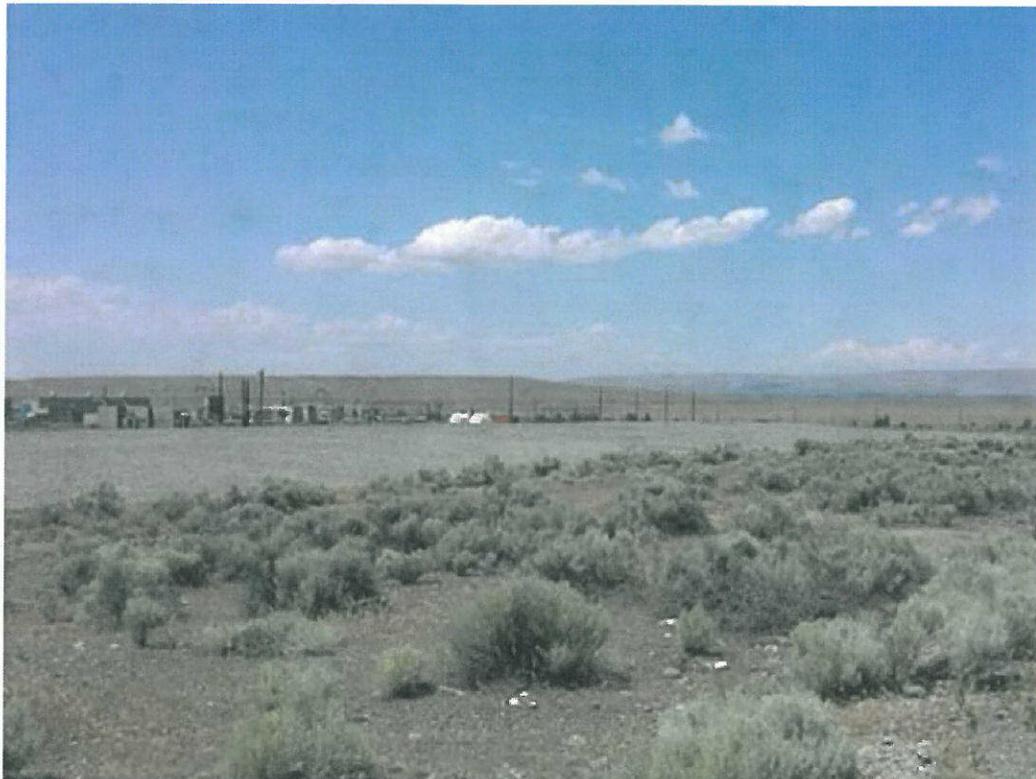
**Figure 6. 183B Clear Wells After Backfill in June 2014**

**Demolition:** The 183B clear wells were demolished in place in the 100-B Area from March to June, 2014. The debris was managed under asbestos controls and loaded out/disposed at the ERDF. The walls and floors of the below-grade facilities were left in place, inspected for stains and anomalies, and backfilled to a grade consistent with surrounding terrain with clean fill material from a nearby borrow pit.

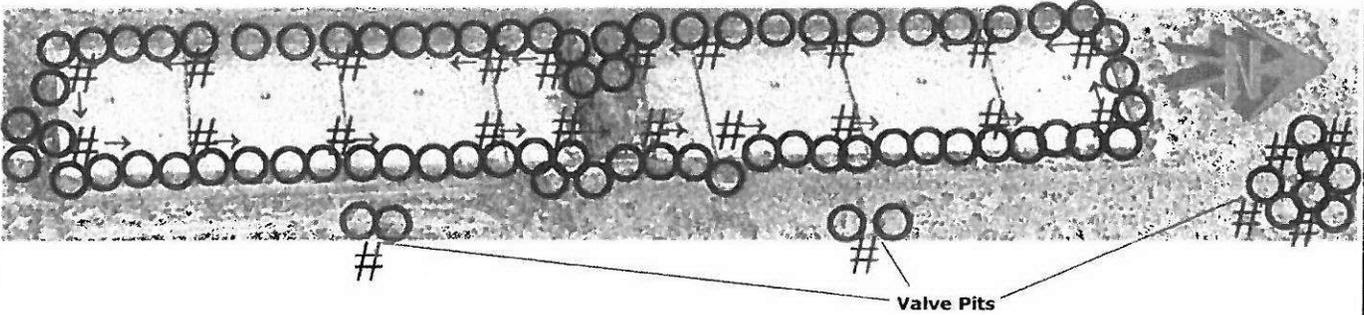
Valve Pits

183D Technical smears depicted below. Direct scans were performed in the same area. Six additional valve pits were also surveyed in like manner. No access was permitted to the valve pits. No fixed or removable contamination was found.

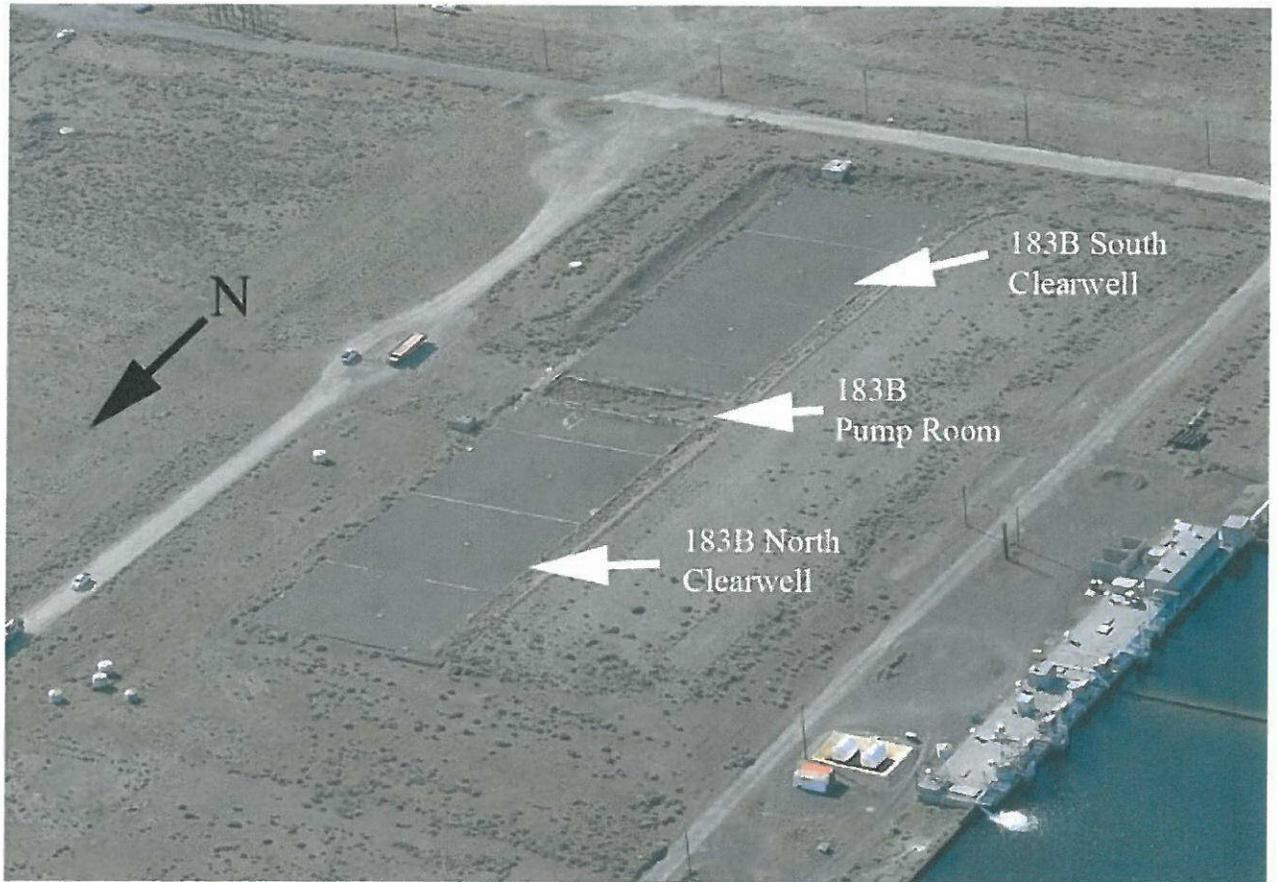
183B Clear-Wells, April 2013

Radiological scoping surveys completed October 8, 2013 detected no radiological activity above background (RSR-100N-13-1221).

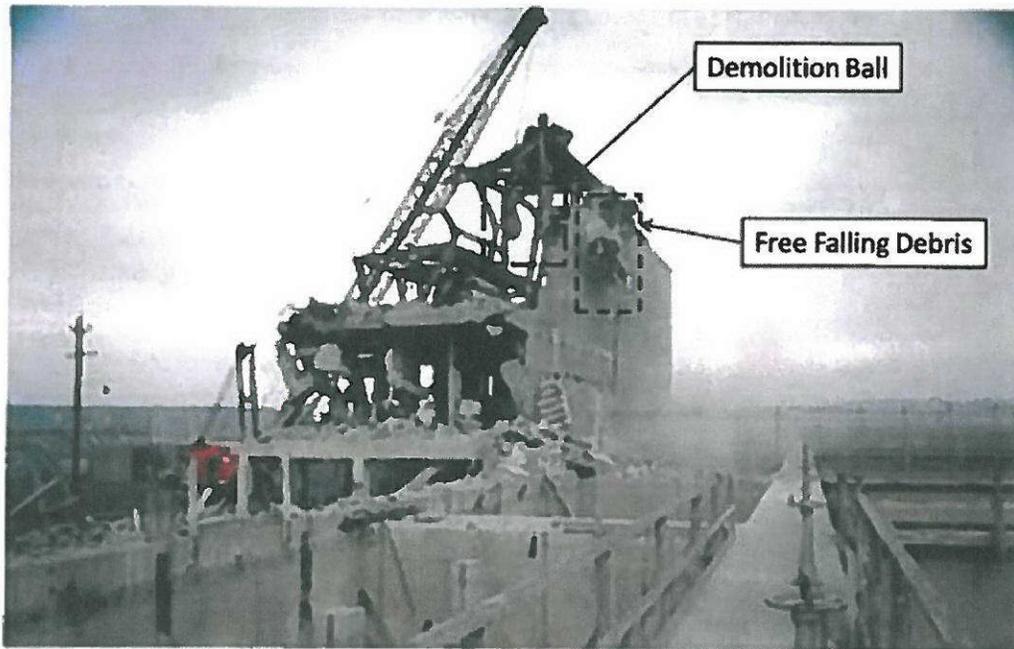
In-process demolition of Head House using Demolition Ball, (circa 1987)

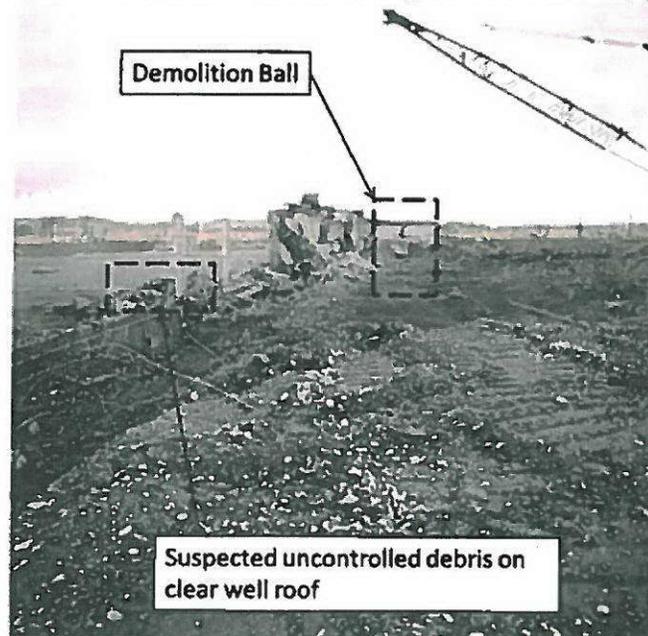
In-process demolition of the Filter Building/Pipe Gallery/Clear Well wall using demolition ball, (circa 1987)

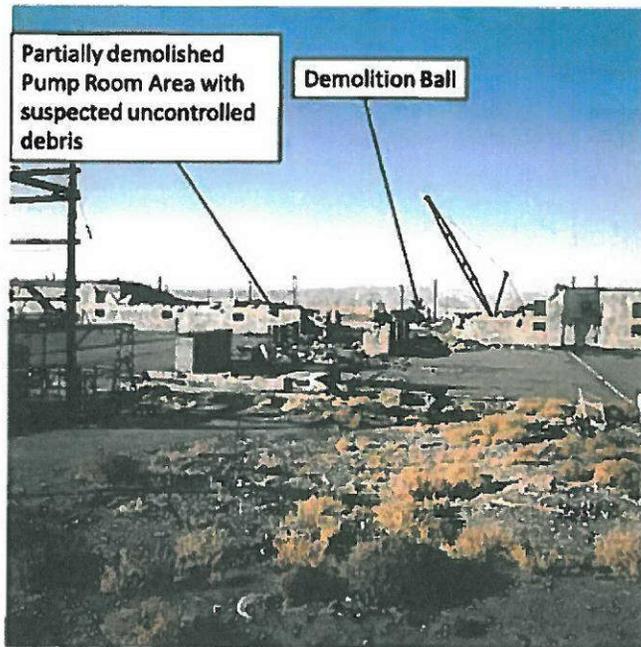
In-process demolition of the Pump Room/Clear Well wall using demolition ball,  
(circa 1987)
