DOE/RL-94-30
Rev. 0

Riverland Expedited Response Action Assessment

Date Published
June 1995

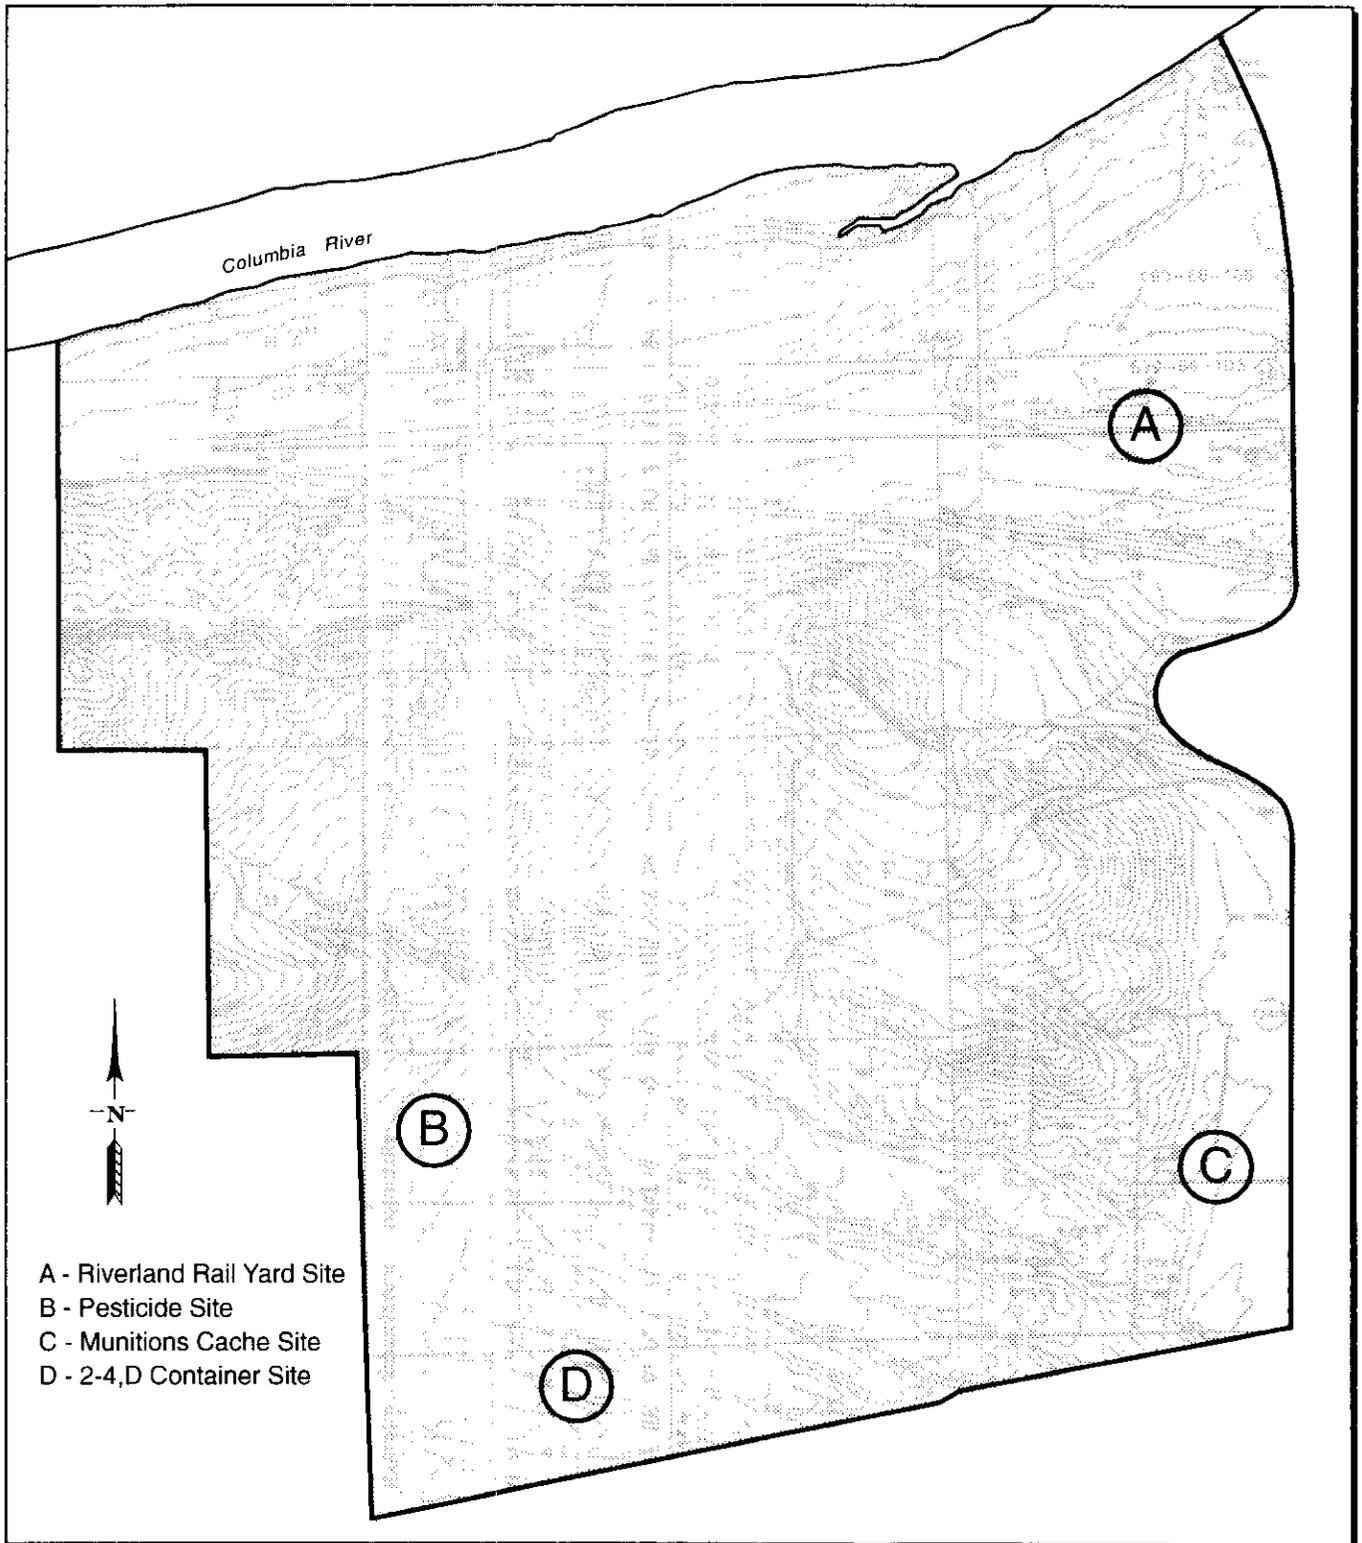
Figure 2. Waste Site Locations (USGS 1986).

The Riverland Rail Yard (Figure 2, Location A), built in 1943, supported the Hanford Site construction and operation activities. This yard received all rail freight destined for the Hanford Site during the early years of the Hanford Manhattan Engineering District Project.

An operable unit visual inspection found one homestead site containing a pile of empty pesticide containers (Figure 2, Location B). The condition of the containers suggest they were placed there after the Hanford Project was well underway. Characterization activities identified aldrin and dieldrin as contaminants of concern. Aldrin and dieldrin are carcinogenic and relatively immobile in soils. The chemicals were produced for about 10 years, from the early 1950s to early 1960s.

The munitions cache (Figure 2, Location C) received various military explosives in the 1970s. The explosives were remnants left from various military exercises in the area. The site consisted of a wooden box placed in a hole in the ground about 0.6 m by 0.9 m by 0.6 m (2 ft by 3 ft by 2 ft) deep. On May 22, 1986, the box with contents went to the Yakima Firing Range for destruction (DOE-RL 1992). The empty hole is all that remains at the site.

The 2-4,D Container Site (Figure 2, Location D) was discovered in July 1994 during an archaeological survey performed by Pacific Northwest Laboratories. Two 5-gal containers were found on the surface among some sage brush. In addition, nine 5-gallon containers, with just the pour spouts exposed, were found buried among the sage brush. Only one buried container contained liquid. Partial container markings indicate that the containers may have contained 2-4,D. The condition of the containers and surrounding vegetation indicate that the containers were buried after the Hanford Project was well underway.
