Evaluation of Cracking in the 241-AZ Tank Farm Ventilation Line

WHC-SD-WM-TI-478 Rev. 0

**EVALUATION OF CRACKING IN THE
241-AZ TANK FARM VENTILATION LINE**

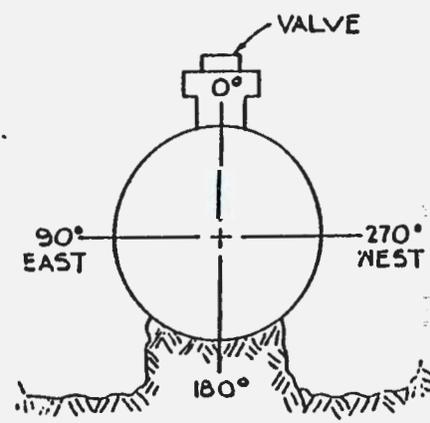
Figure 1: Regions of AZ Tank Farm Ventline Examined by Visual and Liquid Penetrant Methods.

Examination of the excavated ventilation line progressed in several stages. Figure 1 is a map showing all the areas examined by visual and liquid penetrant methods. In the eight areas examined (identified as Regions B through I, in Figure 1) only Regions D and E exhibited a consistent pattern of cracking. Figure 2 presents a schematic illustration of the observations in these two areas.

241-AZ VENT HEADER

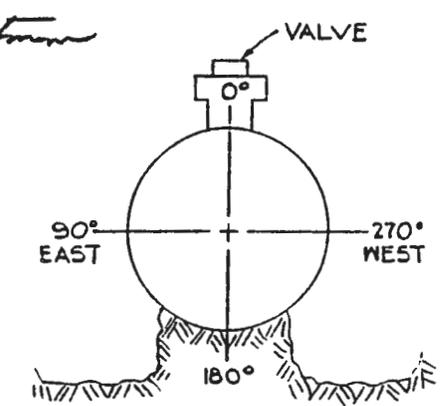
FERRITE CONTENT
241-AZ VENT HEADER
INSPECTION RECORD

FERRITE INDICATOR: SEVERN ENGINEER CO.
 # 5049
 KEH INVENTORY # 328
