FACILITY STATUS CHANGE FORM

Date Submitted: 1/14/2013	Area: 100-N	Control #: D4-100N-0024
Originator: David Warren	Facility ID: 108-N Chemical Unloading Facility	
Phone: 539-6040	Action Memorandum: 100-N Ancillary Facilities

D4 Project Facility Completion Form

Attachment 1: Facility Information (10 pages)

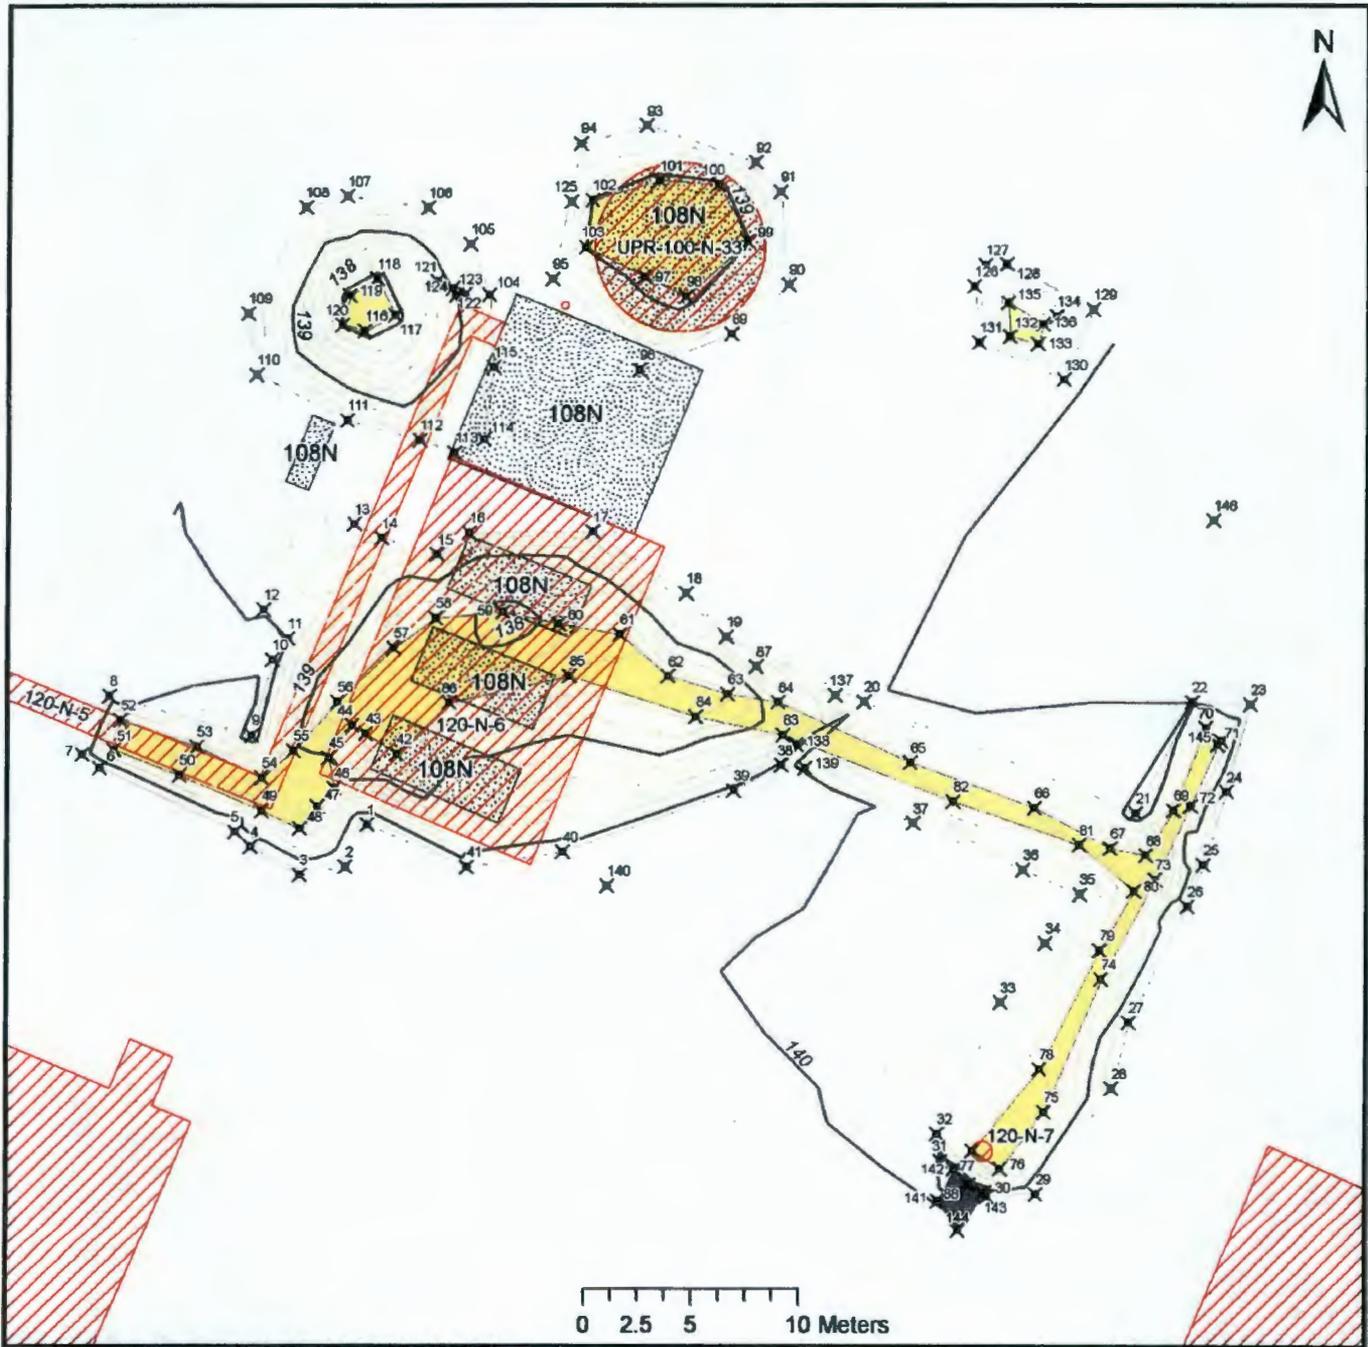
Post Demo GPS Report For 108N

Three anomalous substances were discovered during demolition of the 108-N Chemical Unloading Facility: asbestos-containing insulation within a French drain, stained soil at a French drain, and soil containing sulfuric acid and sodium hydroxide beneath the 108-N railcar unloading station. Samples were taken of the asbestos insulation and French drain stained soil, as summarized in Tables 2 and 3 of this attachment. The excavation permit for 108-N removal was revised to allow for removal of the soil containing sulfuric acid and sodium hydroxide, as these compounds were not expected to be present within the soil at the level at which they were discovered.
