Asbestos NESHAP Thorough Inspection Report at
234-5ZA Change Room Addition Zone 1 of 234-5Z

Document Number: CWR-PFP-00021

Asbestos NESHAP Thorough Inspection Report at 234-5ZA Change Room Addition

Zone 1 of 234-5Z

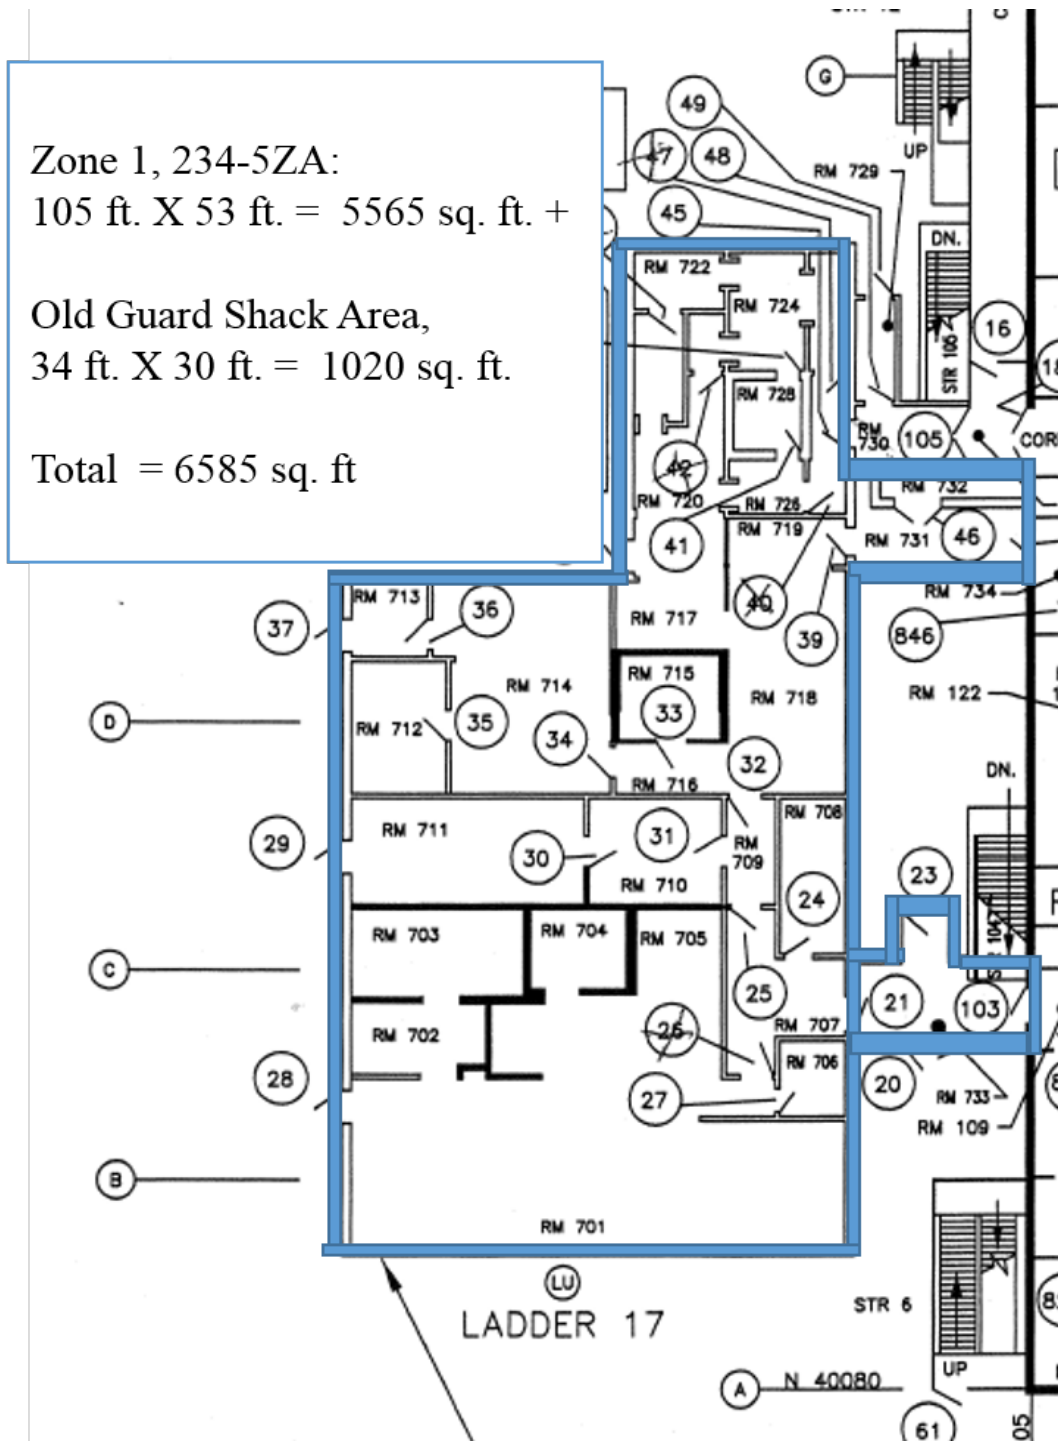
Figure 1. 234-5ZA Zone 1

| Area | Room/Location | Field Description | Results | Category: Cat I/Cat II | Aerial Extent (ft² or linear ft) |
|---|---|---|---|---|--|
| 234-5ZA | All rooms in Figure 1 | None; no asbestos containing materials or suspect materials identified | None | N/A | N/A |
