FACILITY STATUS CHANGE FORM (for DOE/RL-2010-34 Facilities)

Date Submitted: 4/12/2012 Originator: David Warren Phone: (509) 539-6040	Area: 100-N Facility ID: 1119-N (MO-403) Action Memorandum: General Hanford Site Decommissioning Activities	Control #: D4-100N-0029
--	---	-----------------------------------

This document provides information regarding the history, characterization, and final status at the completion of deactivation, decontamination, decommissioning, and demolition (D4) activities of the 1119-N Facility (MO-403 Mobile Office Trailer) at the 100-N area.

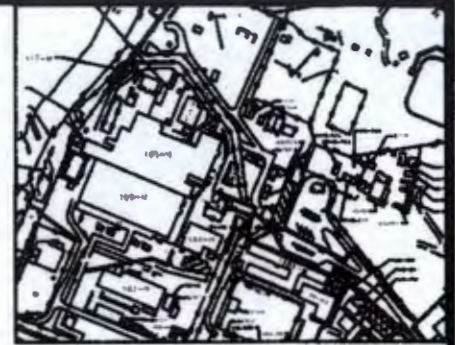
100N Field Remediation 1119-N GPERS Radiological Survey Beta Track Map

Coverage File: N074C
Number of Data Pnts: 58
Type of Survey: beta
Max GCPM: 775
Avg Bkg CPM: 410
Survey Date: 3/14/2012
Area Surveyed: 100 m²
Project File: ESRFRM120039B
Pdf File: ESRFRM120039BC

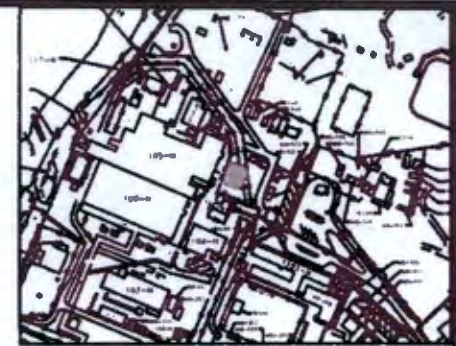
100N Field Remediation 1119-N GPERS Radiological Survey Gamma Track Map

Coverage File: N074C
Number of Data Pnts: 677
Type of Survey: gamma
Max GCPM: 2679
Avg Bkg CPM: 1332
Survey Date: 3/14/2012
Area Surveyed: 100 m²
Project File: ESRFRM120039G
Pdf File: ESRFRM120039GC
