Asbestos NESHAP Thorough Inspection Report at 291Z

Document Number: CWR-PFP-00027

The purpose of this report is to disclose the results of an asbestos thorough inspection of 291Z structure and associated 291Z001 stack located in the Plutonium Finishing Plant Complex. Note: Revision 0 was never issued.

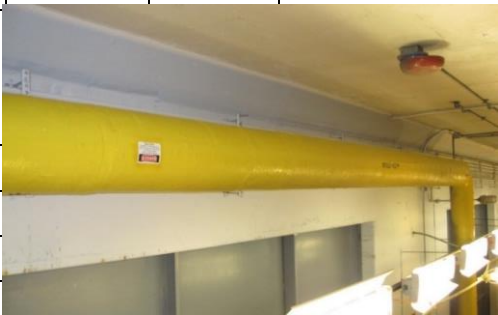
Visual verification. AHERA trained inspector cuts sheathing to reveal insulation material; joints and elbows along with horizontal and vertical pipe runs.	Visual Verification of TSI	Condition of material sampled: Good or Poor	Photograph of sample location(s) taken?		
Vertical Run from 90 degree to 291Z: 30 linear ft.	TSI				
Elbows/joints (length included in vertical run estimate)	TSI				
Figure 4: Vertical run from 291Z to 234-5Z main steam line					
Horizontal Runs/	TSI	Abated

Elbows/joints	TSI				
Vertical	TSI

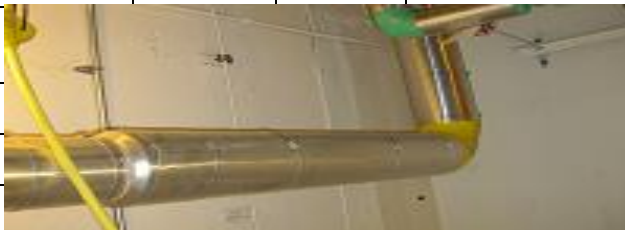
Vertical	TSI	Abated			
Horizontal	TSI				
Elbows/ joints	TSI				
Small piping	Fiberglass				
Figure 6: Green aluminum clad piping should be non-asbestos. Visual verification of elbow and straight runs required. If other than fiberglass; three samples each.

Straight run	Fiberglass				
Elbow/ joint	Fiberglass

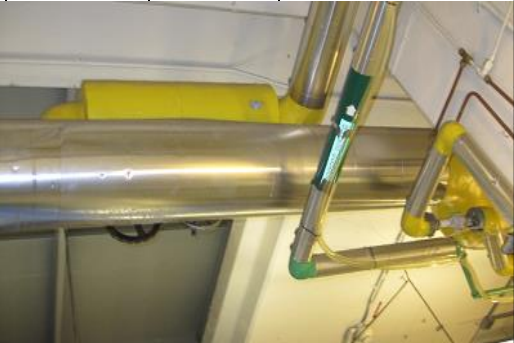
Figure 10: Miscellaneous piping (2). Visual verification for each change in piping size. Assumption: the larger clad piping (yellow arrow) will have already been characterized by previous sampling.

Valve body; large pipe	TSI	Abated

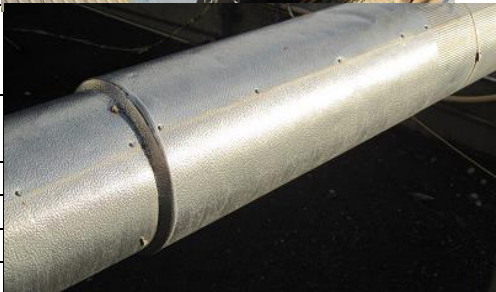
Straight runs	TSI	Abatement required	
Joints	TSI		
40 linear ft.			
Figure 16: NW corner exterior of 291Z. Note change in pipe size. Interview with insulators indicates that the smaller side is fiberglass and the large asbestos TSI. Conduct visual inspection.

Small pipe straight run	TSI	Abatement required	
Small pipe joints/elbows	TSI		
Large pipe; straight run	Fiberglass		
Large pipe; elbows/joints	Fiberglass		
Length included in previous estimate.
