Re: Department of Ecology (Ecology) Assessment Report for Field Monitoring Activities of the Waste Material near Riser 83 of the 241-AY-102 Double Shell Tank (DST)

ASSESSMENT REPORT

Field Monitoring Activities

Project: 241-AY-102 Field Monitoring, Riser 83 Video
 Project Contact: Jeremy Johnson (ORP) Phone: (509) 376-1866
 Review Date: 3/14/2013
 Reviewer: Michelle Hendrickson, CHMM, PE
 USDOE Project: US Department of Energy-Office of River Protection (USDOE-ORP)
 USDOE Contact: Tom Fletcher/Jeremy Johnson
 Prime Contractor: Washington River Protection Solutions (WRPS)
 Project Manager: Michael Hardesty Phone: (509) 373-4573
 Location: 241-AY-102, 200 East Area, Hanford
 Scheduled Start Date: 3/14/2013 Actual Start Date: 3/14/2013 Completion Date: 3/14/2013
 Contract Amount: Approximately \$75,000 for 4 Riser Visual Inspections
 Sub-Contractor: N/A
 Location: 200 East Area, Hanford Nuclear Reservation, Richland, WA

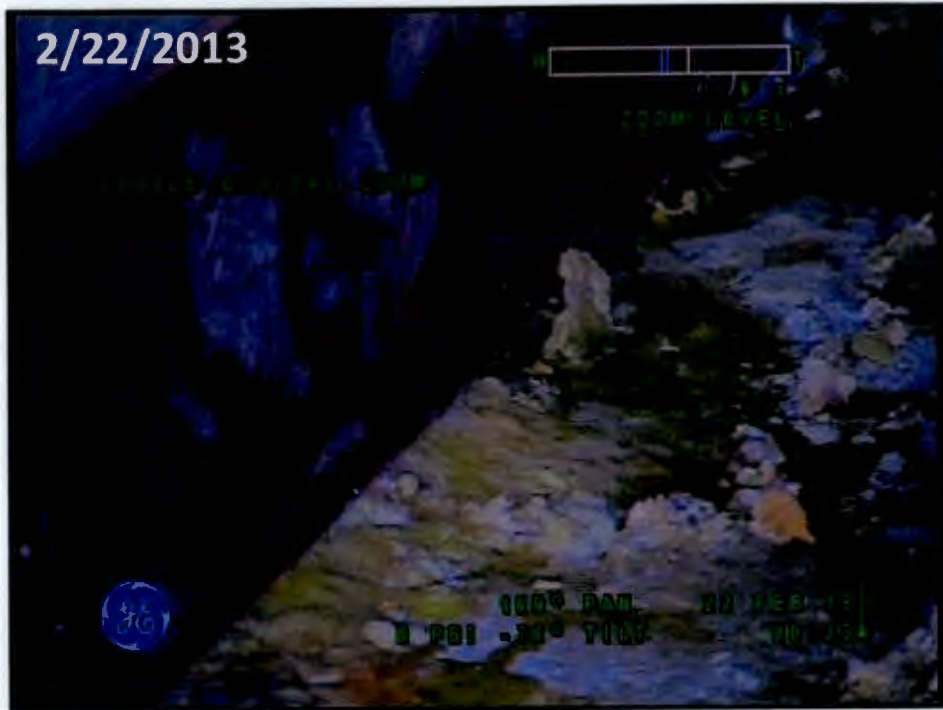
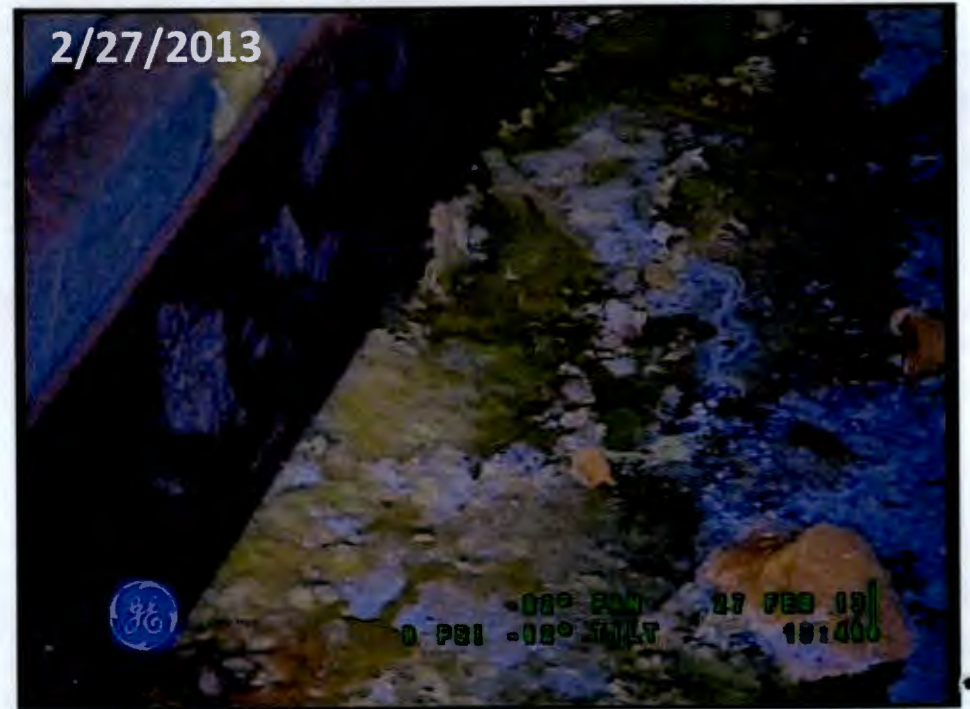
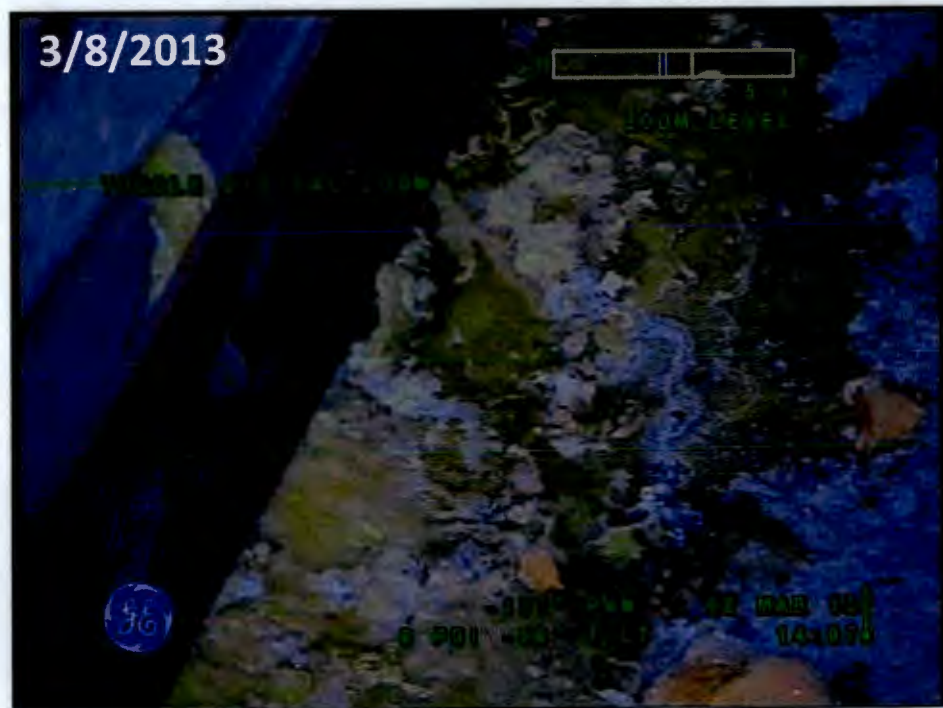
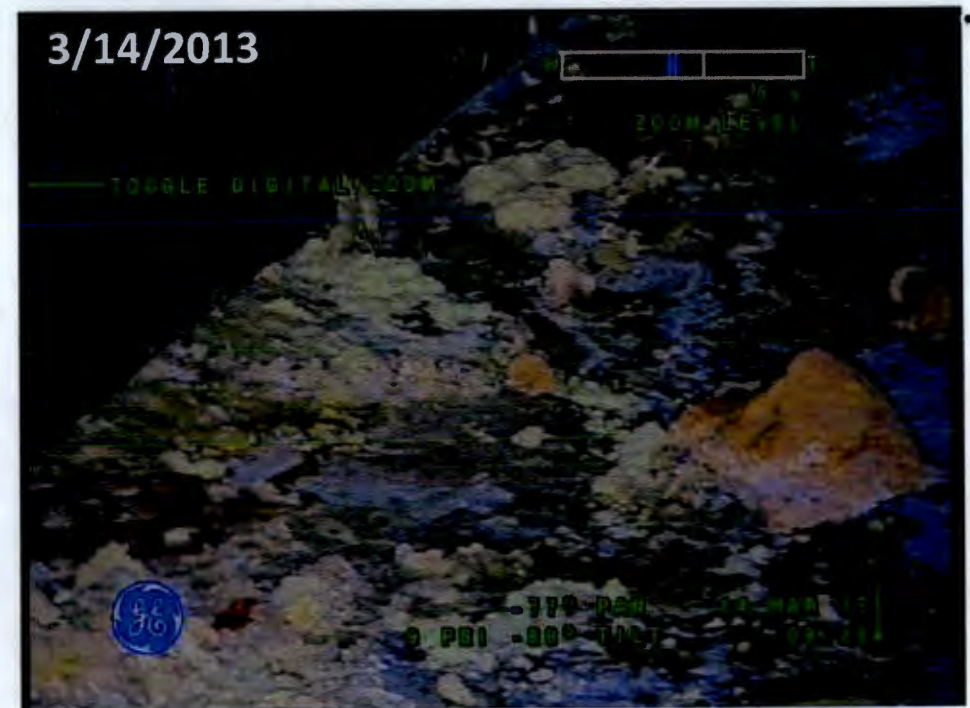
3/14/2013

- Vertical and horizontal increase of the size of the leak was discovered where the waste material extends outward in "finger channels" and near the smaller piece of orange insulation/foam. The edges of the waste in this location appeared to be very wet. Further past the waste were salt streaks. It appeared that the horizontal extent was now past the center of the annulus for the salt streaks.

- Ecology did not note a change in the size or condition of the waste material in the ventilation slot during this visual inspection. The top of the material appeared to have dried where it contacted the concrete. However, moisture streaks on either side of the waste material within the ventilation slot were again visible.
