FACILITY STATUS CHANGE FORM

Date Submitted: 1/14/2013 Originator: David Warren Phone: 539-6040	Area: 100-N Facility ID: 108-N Chemical Unloading Facility Action Memorandum: 100-N Ancillary Facilities	Control #: D4-100N-0024
--	--	-----------------------------------

Attachment 1: Facility Information (10 pages)

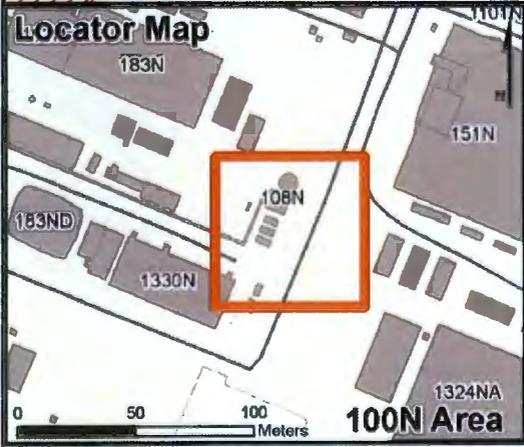
Post Demo GPS Report For 108N

- Stained soil was discovered at a French drain at the 108-N facility. This soil was sampled to ensure that it met the parameters of the applicable waste profile. Table 3 of this attachment summarizes the samples that were taken for waste management purposes.
