Re: Washington State Department of Ecology (Ecology) Assessment Report for Field Monitoring Activities Conducted December 27, 2012, of the Waste Material Near Riser 83 of the 241-AY-102 Double Shell Tank (DST)

## ASSESSMENT REPORT

### Field Monitoring Activities

Project: 241-AY-102 Field Monitoring, Riser 83 Video  
 Project Contact: Jeremy Johnson (ORP) Phone: (509) 376-1866  
 Review Date: 12/27/2012  
 Reviewer: Michelle Hendrickson, CHMM, PE  
 USDOE Project: US Department of Energy-Office of River Protection (USDOE-ORP)  
 USDOE Contact: Tom Fletcher/Jeremy Johnson  
 Prime Contractor: Washington River Protection Solutions (WRPS)  
 Project Manager: Michael Hardesty Phone: (509) 373-4573  
 Location: 241-AY-102, 200 East Area, Hanford  
 Scheduled Start Date: 12/27/2012 Actual Start Date: 12/27/2012 Completion Date: 12/27/2012  
 Contract Amount: Approximately \$75,000 for 4 Riser Visual Inspections  
 Sub-Contractor: N/A  
 Location: 200 East Area, Hanford Nuclear Reservation, Richland, WA

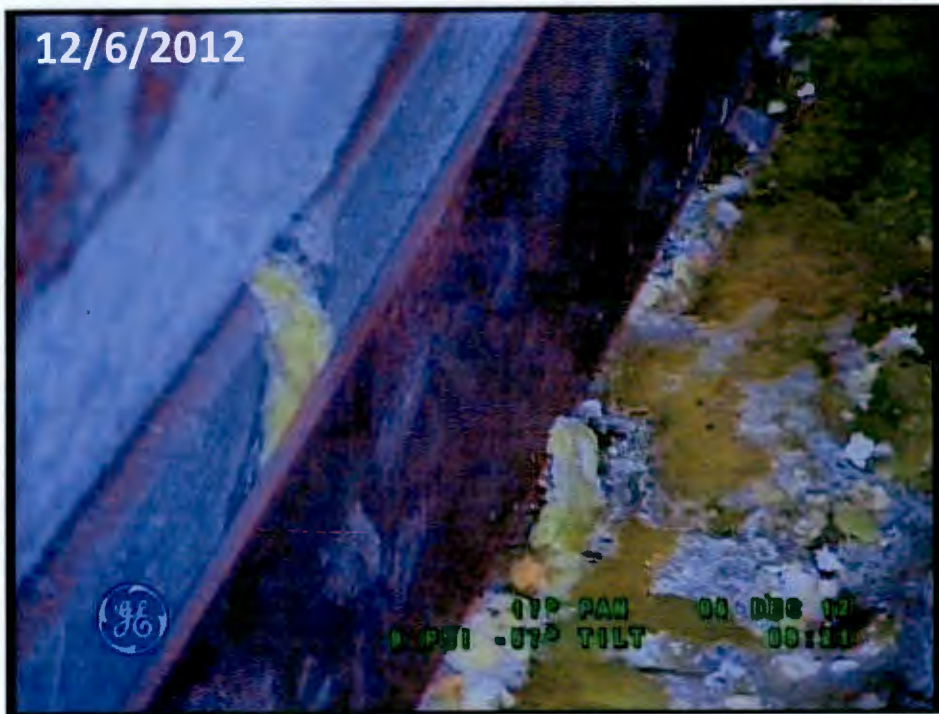
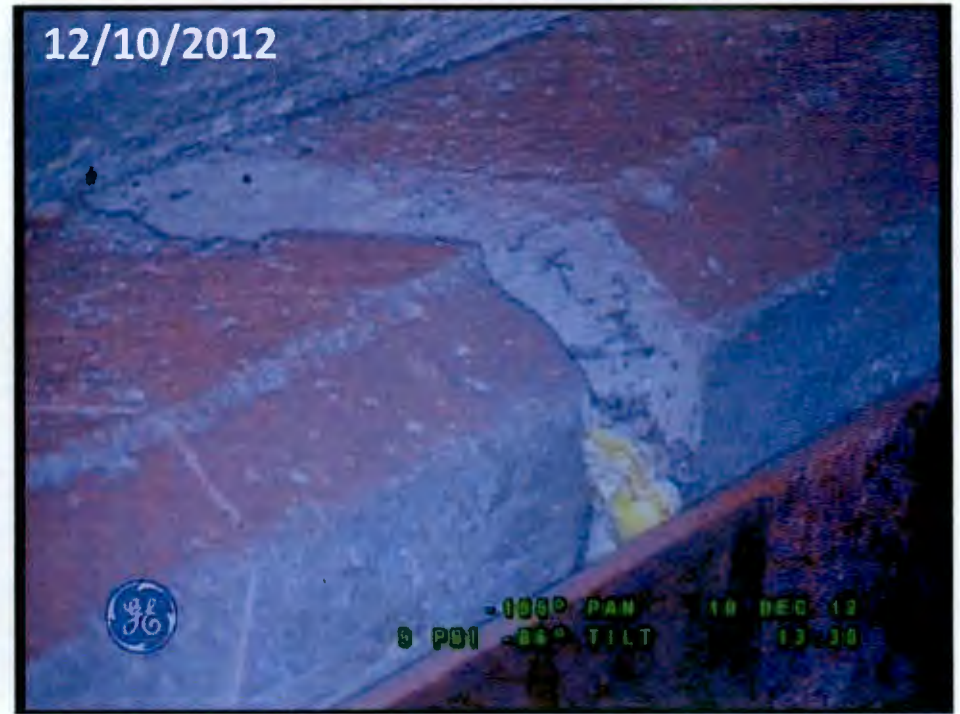
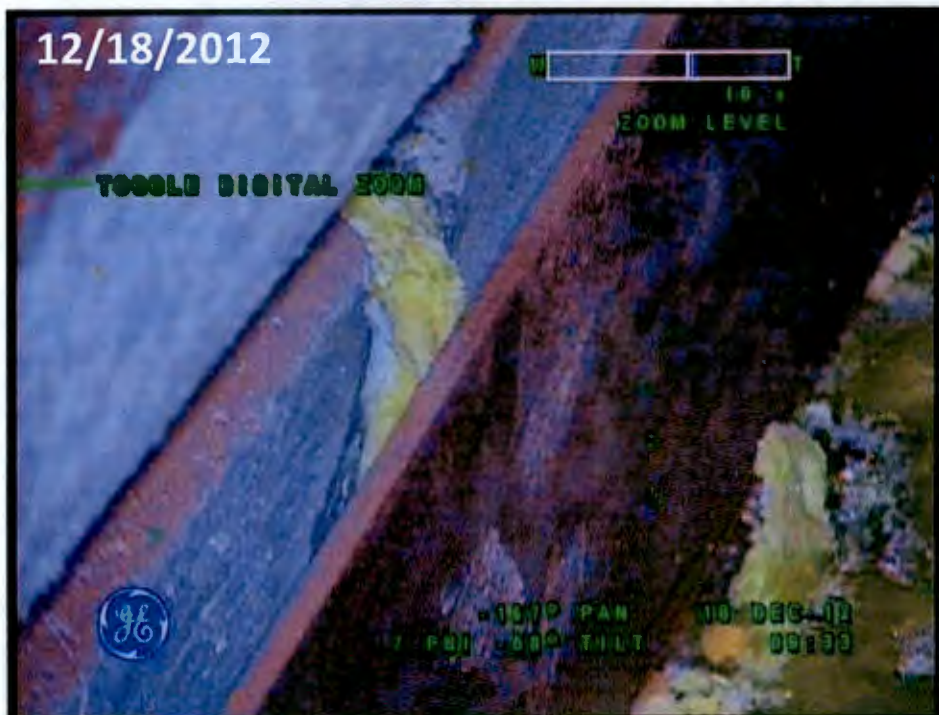
- All witnessing the inspection noted that the color of the waste appeared to be changing. The dark green was changing to a lighter green in some locations. The lighter green was becoming a dark yellow. The darker yellow was changing to a lighter yellow. The lighter yellow was turning to a white color along the waste perimeter. Ecology also noted that some of the waste material that was white in color was now yellow. This indicates that some of the waste material may be drying, most likely due to the ventilation.

- The camera viewed the waste in respect to the different in-annular space "landmarks" including the black dot or rock, two white pebbles, orange pieces of insulation/foam, and ventilation slots. It was noted by all witnessing the video that the size of the area of the waste material did appear to have slightly increased in size, near the upper portion of the leak where the waste material extends outward in "finger channels" and near the smaller piece of orange insulation/foam. The extent of the leak seemed to slowly expand as compared to the amount of waste material viewed during the visual inspection conducted on 10/25/12 and 11/12/2012.

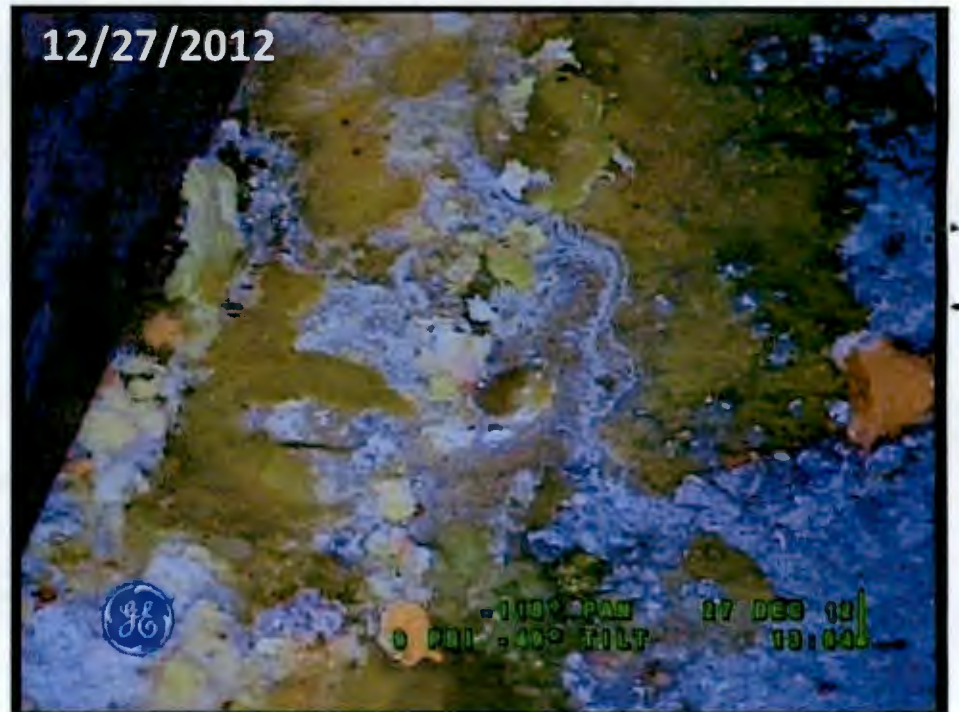
12/27/2012

- Ecology noted that the waste material in the ventilation slot appeared to be wider and thicker, especially on the base near the 6 ½ inch ring. The top of the material appeared to have dried where it contacted the concrete. However, moisture streaks on either side of the waste material within the ventilation slot were again visible.

- Ecology also noted that the waste material the finger channels of the waste or pools of waste (that are dark green, light green, and yellow) appear to look deeper, extend in length, and had split to flow toward another direction creating an additional finger channel.
