FACILITY STATUS CHANGE FORM

Date Submitted: Feb 9, 2011 Originator: David Warren Phone: 539-6040	Area: 100-N Area Facility ID: 153-N Electrical Substation Action Memorandum: 100-N Ancillary Facilities	Control #: D4-100-N-0008 rev.1
--	---	--

SUBJECT: **POST DEMOLITION SUMMARY REPORT FOR THE 153-N ELECTRICAL
SUBSTATION**

Post Demolition Summary Report for the 153-N Electrical Substation

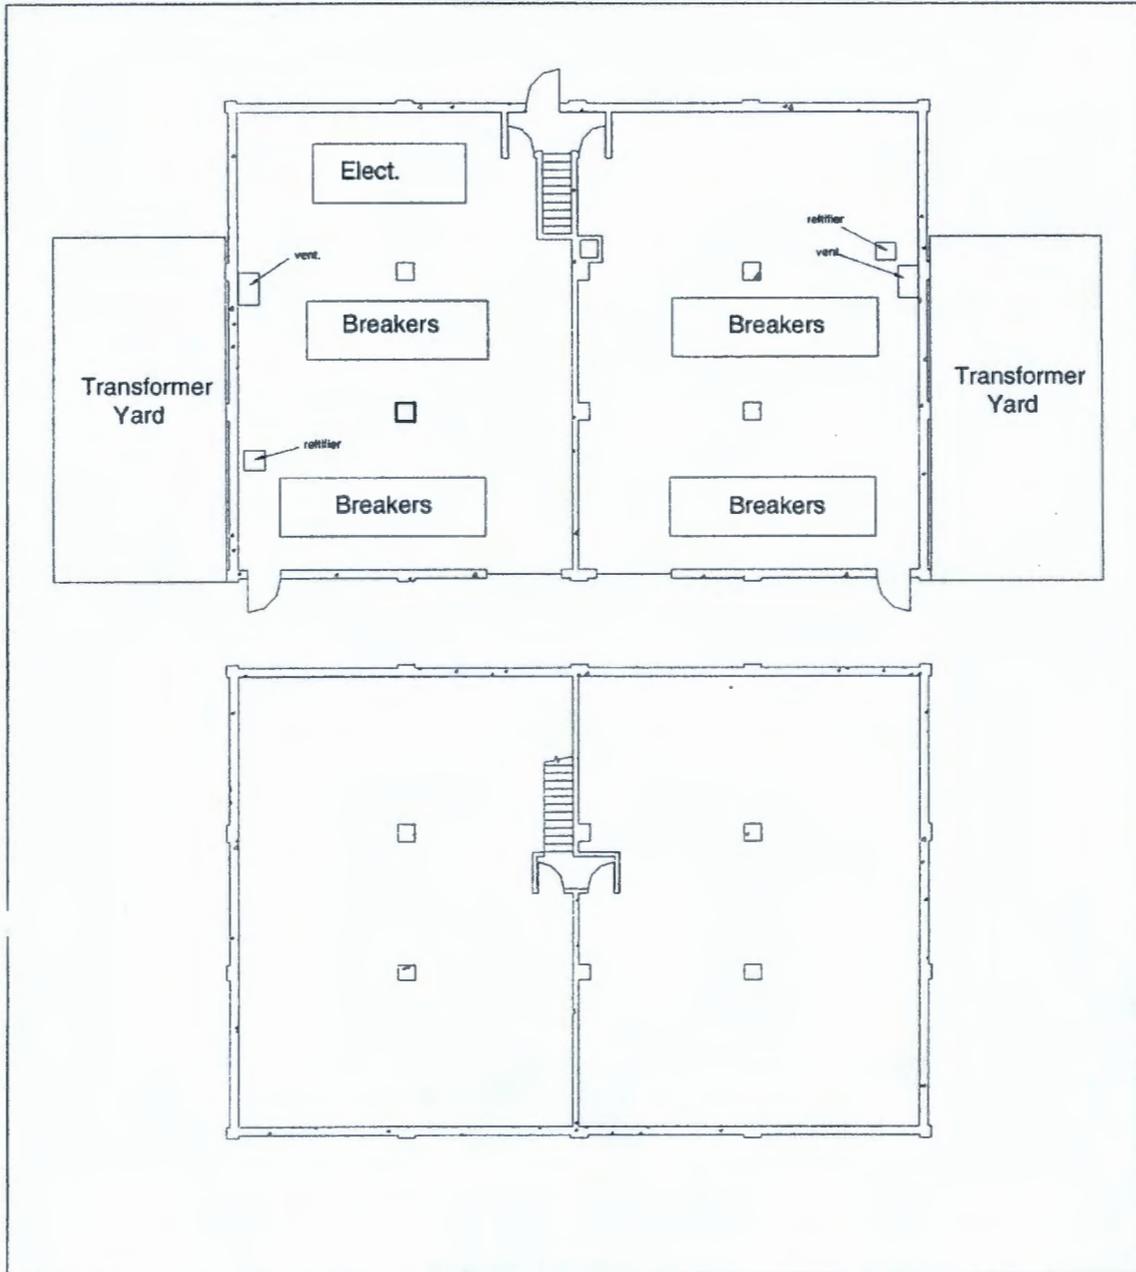
Figure 1

(Figure 1- Main Floor (top) and Basement Cable Tray Area (bottom))

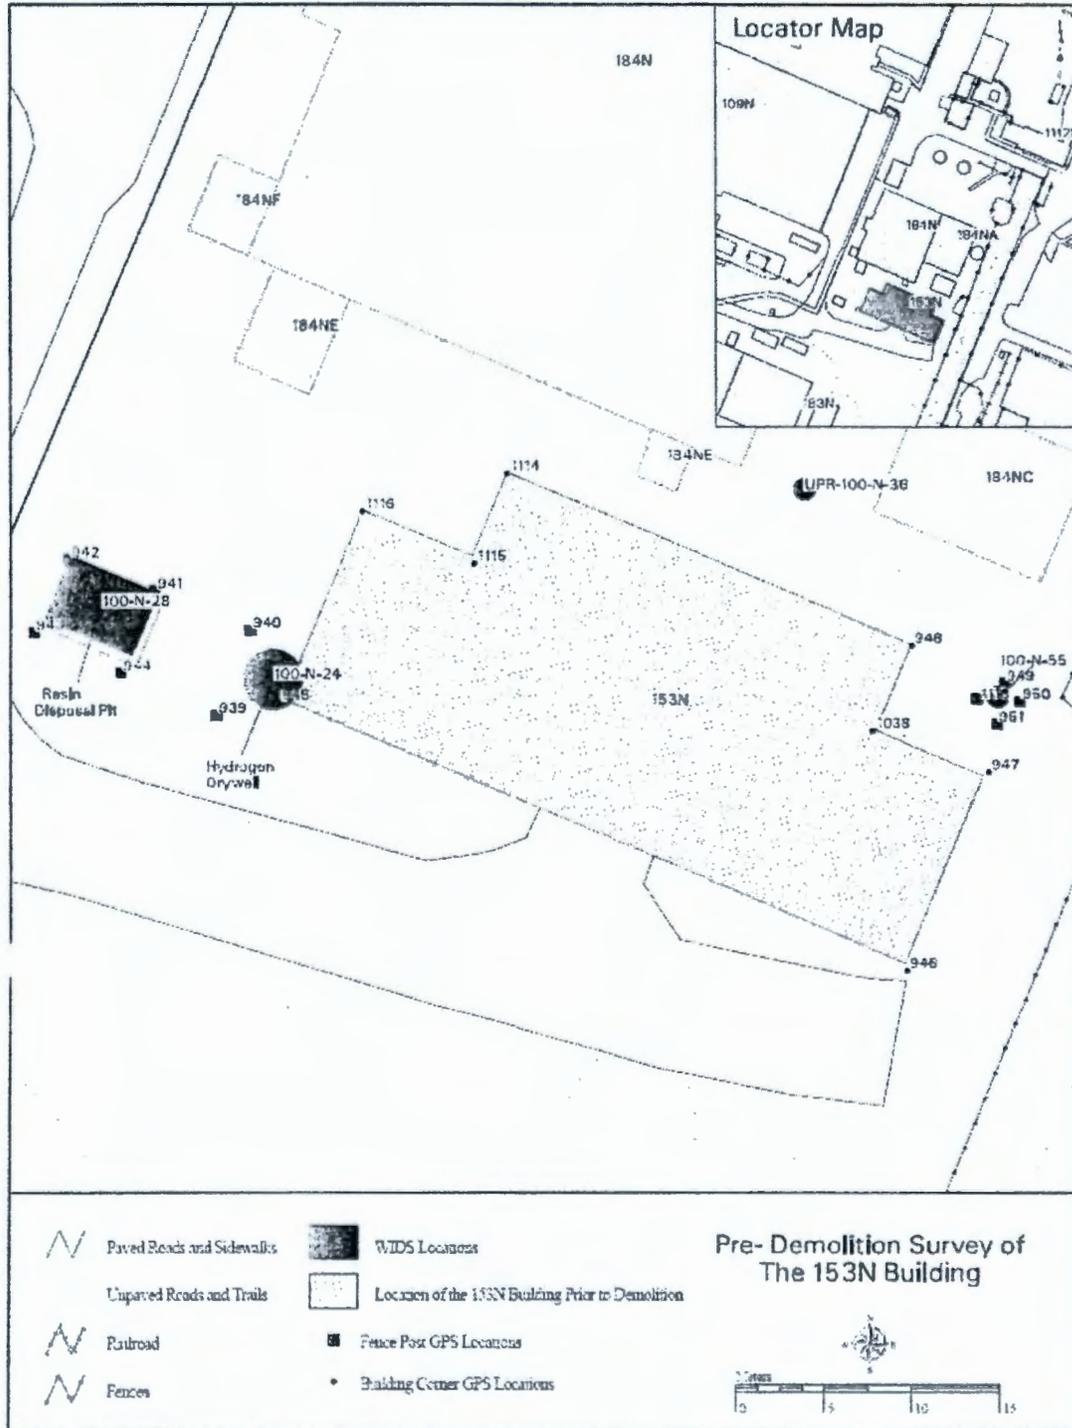
Attachment 2 - Pre-Demo Civil Survey Map

A GPS civil survey was performed on the 153-N prior to demolition. This survey located the corners of the building and the corners and extents of near-by structures. A post demolition civil survey was performed. This survey documented the extent of the excavation (footprint and depth) as well as remaining structures (electrical conduits and concrete structures) extending into the excavation. It should be noted, that these remaining concrete structures are not from the 153-N facility but rather footings from adjacent structures.
