09-AMRC-0199

COMPLETION OF TRI-PARTY AGREEMENT MILESTONE M-094-03, "COMPLETE DISPOSITION OF THE FOLLOWING SURPLUS FACILITIES: 303M, 332, 333, 334, 334A, 3221, 3222, 3223, 3224, 3225"

FACILITY STATUS CHANGE FORM

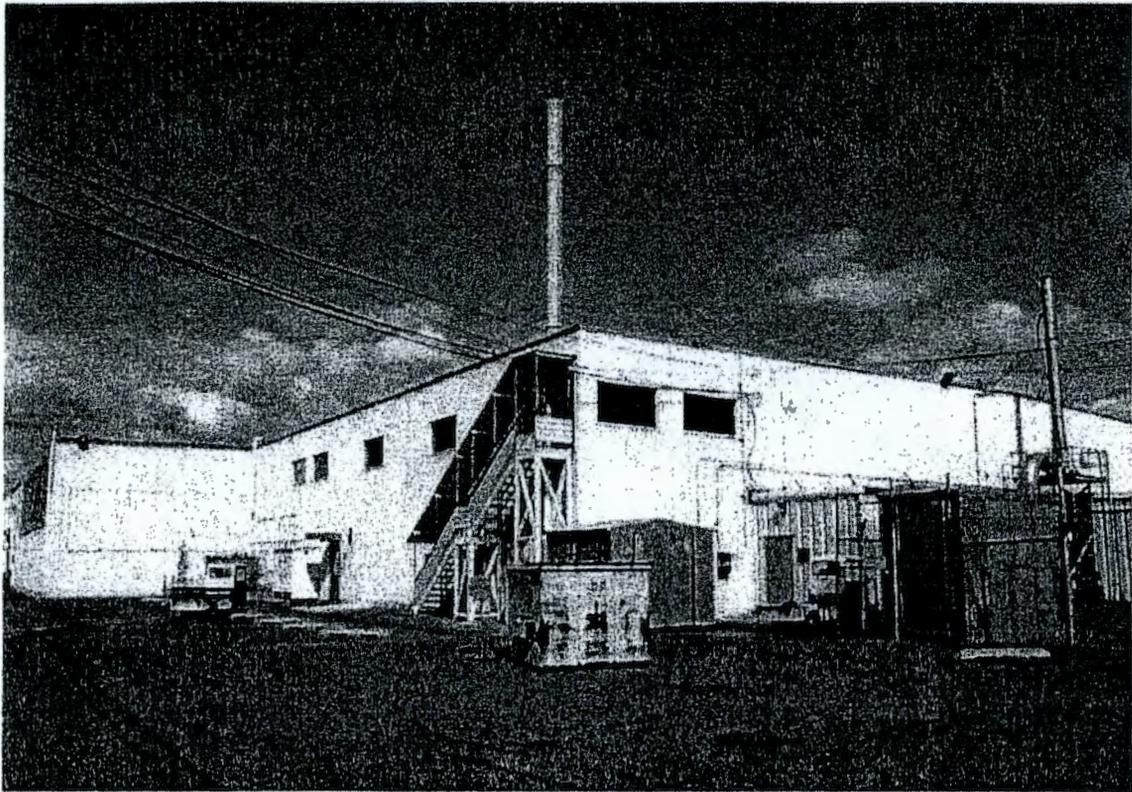
Building 333 - As it appeared in 1987.

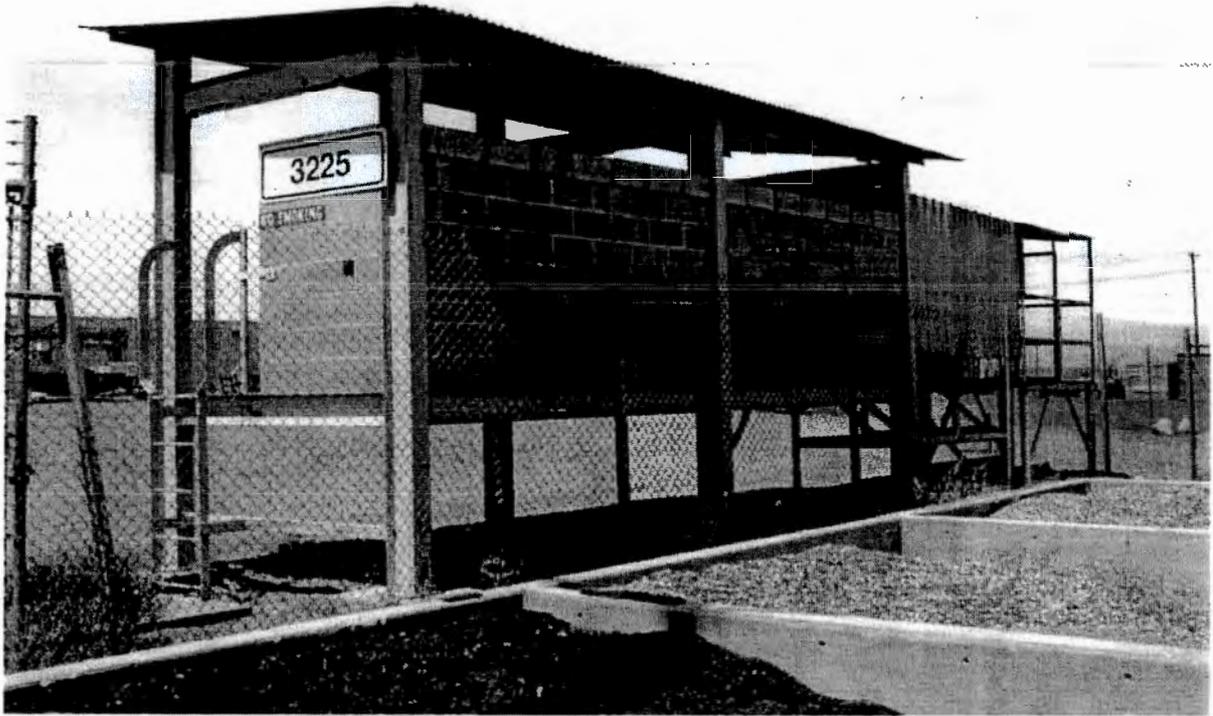
Attachment 2: Project Photographs
3225 Building Complex before Demolition

There were no contaminants of concern for facility demolition. The facility was not radiologically or chemically contaminated.
