DOCUMENT NO. RHO-CD-1076

DATE September 1980

STRUCTURAL EVALUATION OF THE PUREX NO. 1 BURIAL TUNNEL

G. R. Silvan

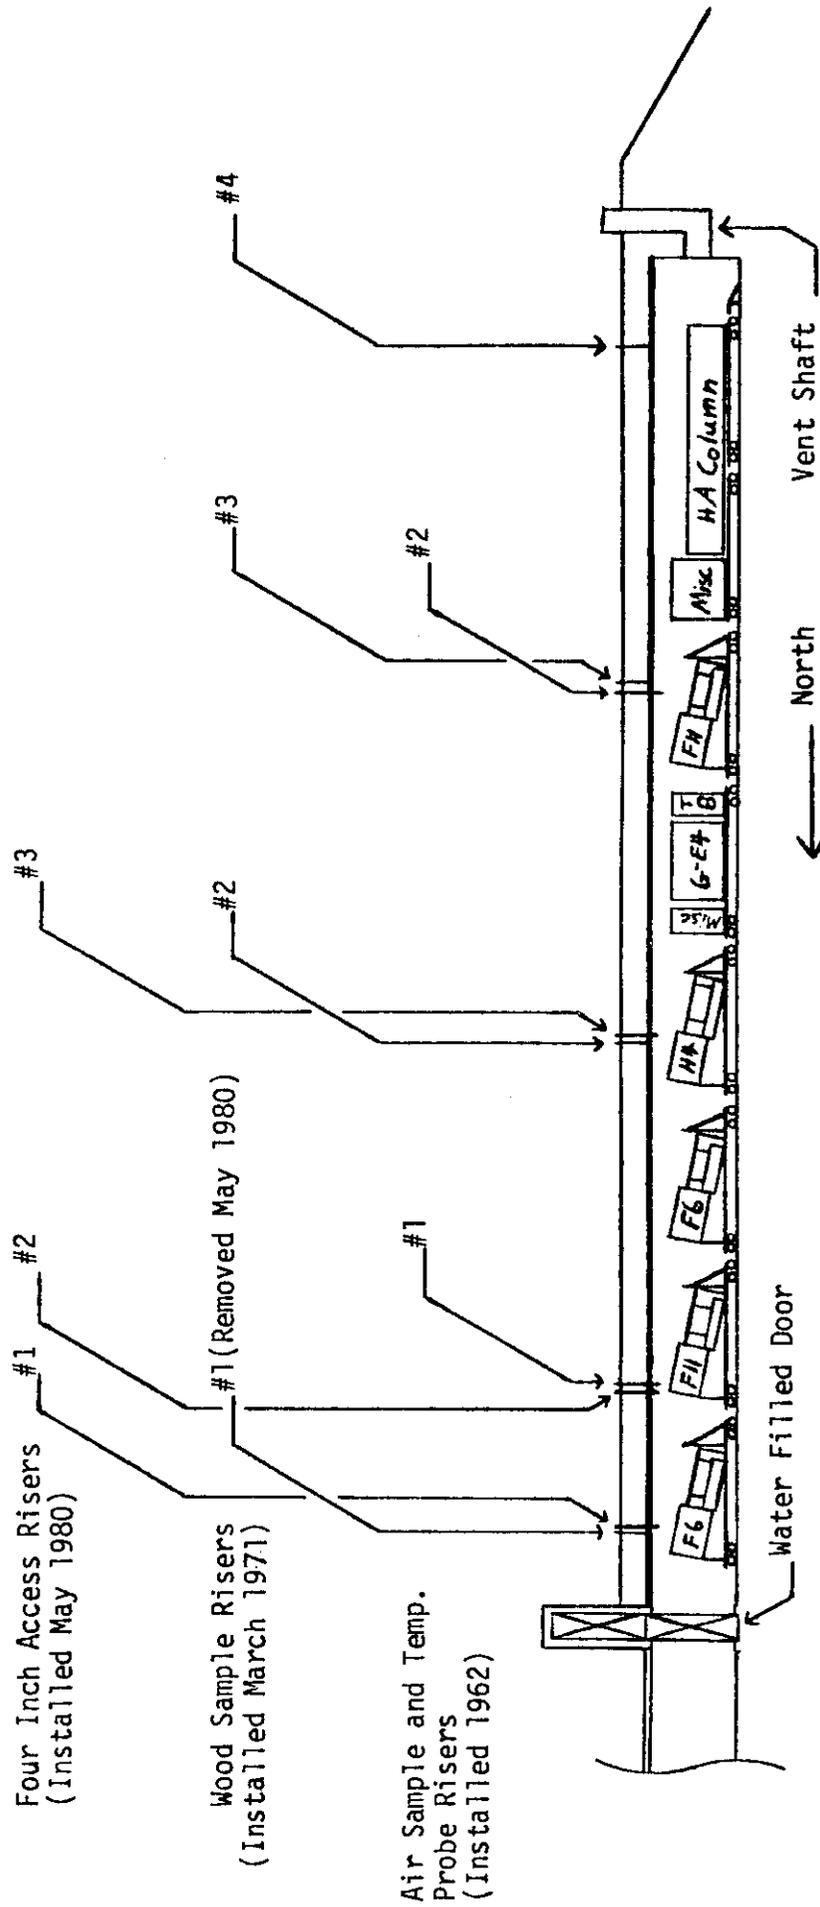
FIGURE 2: PUREX NO. 1 BURIAL TUNNEL

Construction of the burial tunnel was completed in 1956 and the first two burial cars were loaded into it in June, 1960. Between this date and January, 1965, six more cars were loaded into the tunnel. Table 1 contains a list of the burial cars and their contents. During the loading of the number seven car, the burial tunnel was pressurized due to the heat given off by the contents of the car. To alleviate this problem, a blower fan and filter were connected to the vent shaft. Also, two air sample and temperature probe risers were mounted in the roof of the tunnel to allow occasional monitoring of the tunnel environment. These risers were placed at locations 60 and 240 feet south of the water filled door enclosure (see figure 2). After the last car was loaded in 1965, the water filled door was deactivated.

Site Preparation. Excavation of the sample sites began on Monday, May 5, 1980 and was completed with the plywood shoring boxes in place two days later. During the digging of the number one site, the number one wood sample riser (see figure 2) was struck by the clamshell and had to be removed. Exposure rates at the number one and number two locations presented a problem for the workers while they were removing the last bit of dirt and scraping the tar from off the timbers (see table 3). However, by using extension handles and by rotating personnel, radiation exposure was kept well below allowable limits. Once the fiberglass pipe was in place, the amount of exposure to personnel was cut considerably. Also, insertion of the lead donut into the fiberglass pipe just prior to core drilling further reduced the amount of exposure to well below acceptable limits. The largest dose received by any one man during the entire operation was one hundred miliroentgen. Preparation of all three sample sites was completed on Friday, May 9.

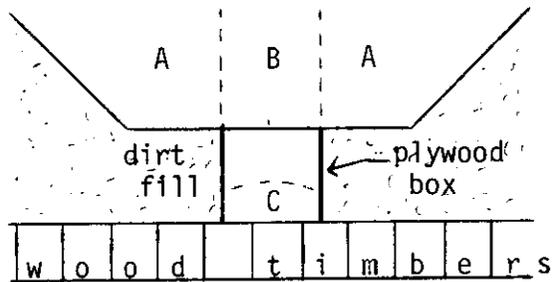
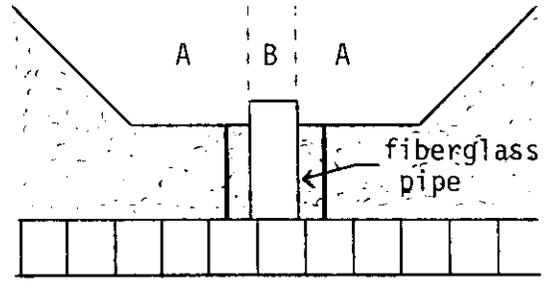
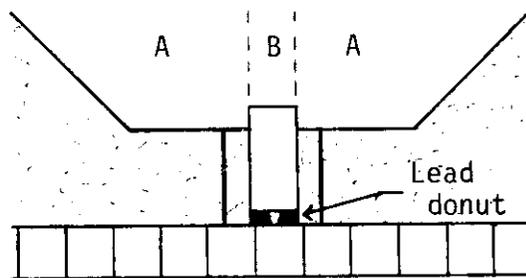
First Stage: Plywood shoring box in place

Second Stage: Fiberglass pipe in place

Third Stage: Lead donut in place
