TRANSMITTAL OF THE 100-F/IU-2/IU-6 AREA – SEGMENT 4 ORPHAN SITES
EVALUATION REPORT, OSR-2011-0001, REVISION 0

100-F/IU-2/IU-6 Area – Segment 4 Orphan Sites Evaluation Report

**Prepared for the U.S. Department of Energy
by Washington Closure Hanford**

November 2011

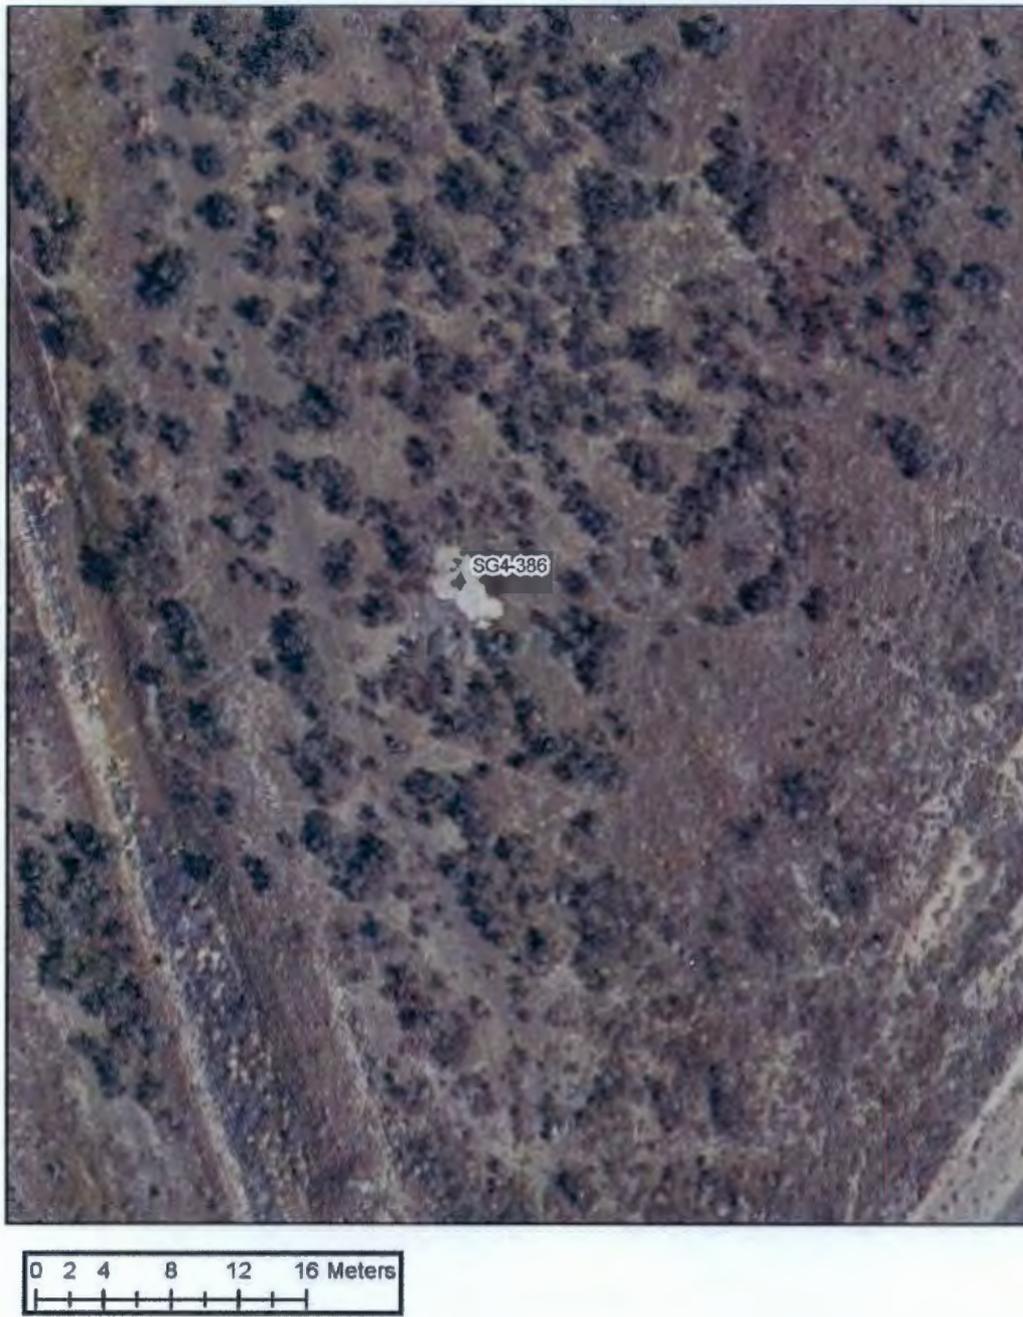
Figure 5-1. Example of Imagery Data (SG4-386).

For the flight survey evaluation, 30- by 30-m (98.43- by 98.43-ft) grid areas were developed for the Segment 4 orphan sites evaluation. Each grid area is evaluated using the aerial photography as shown in Figure 5-1 (feature SG4-386 depicted) and at a more global resolution for potentially larger features. Field verification determined this feature to be concrete cleanout; therefore, it was classified as Stewardship. Man-made materials and features or disturbed areas were identified and recorded into a GIS database.

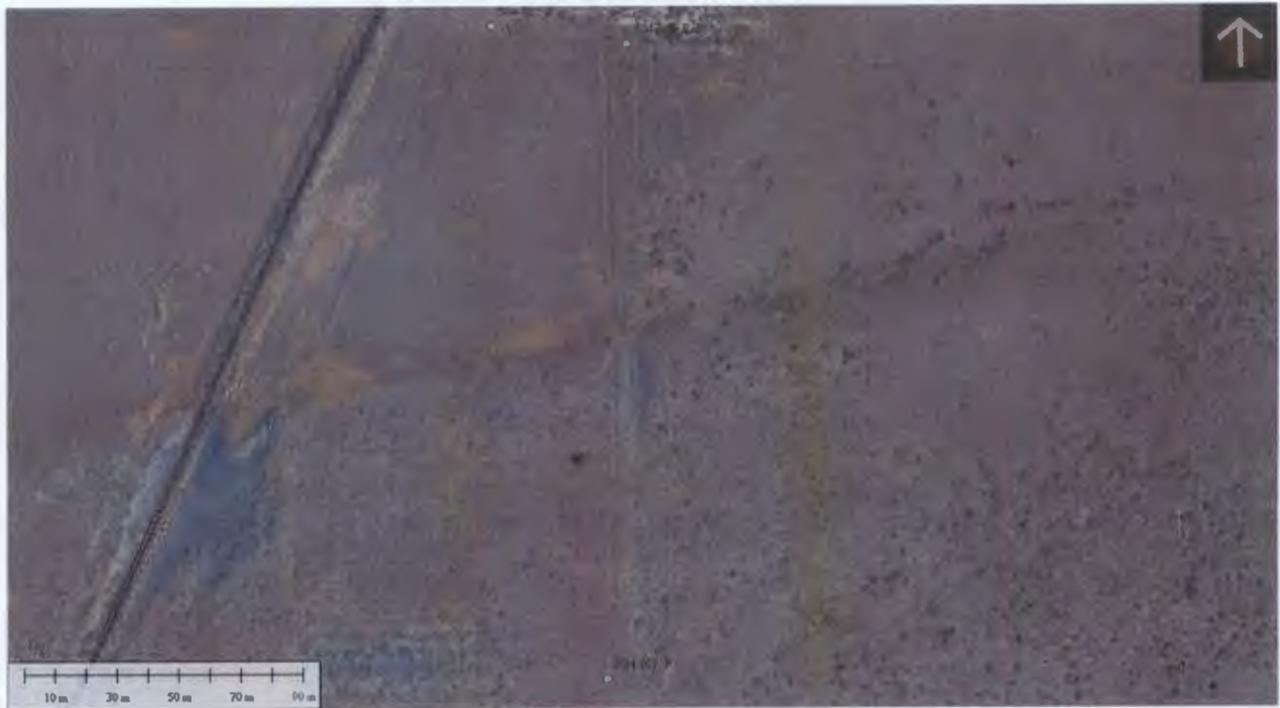
Figure 5-3. Example of Orthography for Stewardship Feature SG4-089.

The features identified in Segment 4 were compared to known GIS historical baseline information (e.g., historical drawings) to potentially identify the origin and/or purpose of the feature. When possible, timeline and origin estimation for each feature were developed using rectified orthophotography, maps, or GIS layers. This information was then recorded in the form of a disposition including all references. Figures 5-3 through 5-5 show examples of a linear feature (SG4-089) located during analysis of orthophotography, utilizing Global Mapper 3D software.
