FIELD SUMMARY REPORT FOR THE CENTRAL PLATEAU FISCAL YEAR 2017 AERIAL THERMAL SURVEY

CH2MHILL
Plateau Remediation Company

Date Published
January 2021

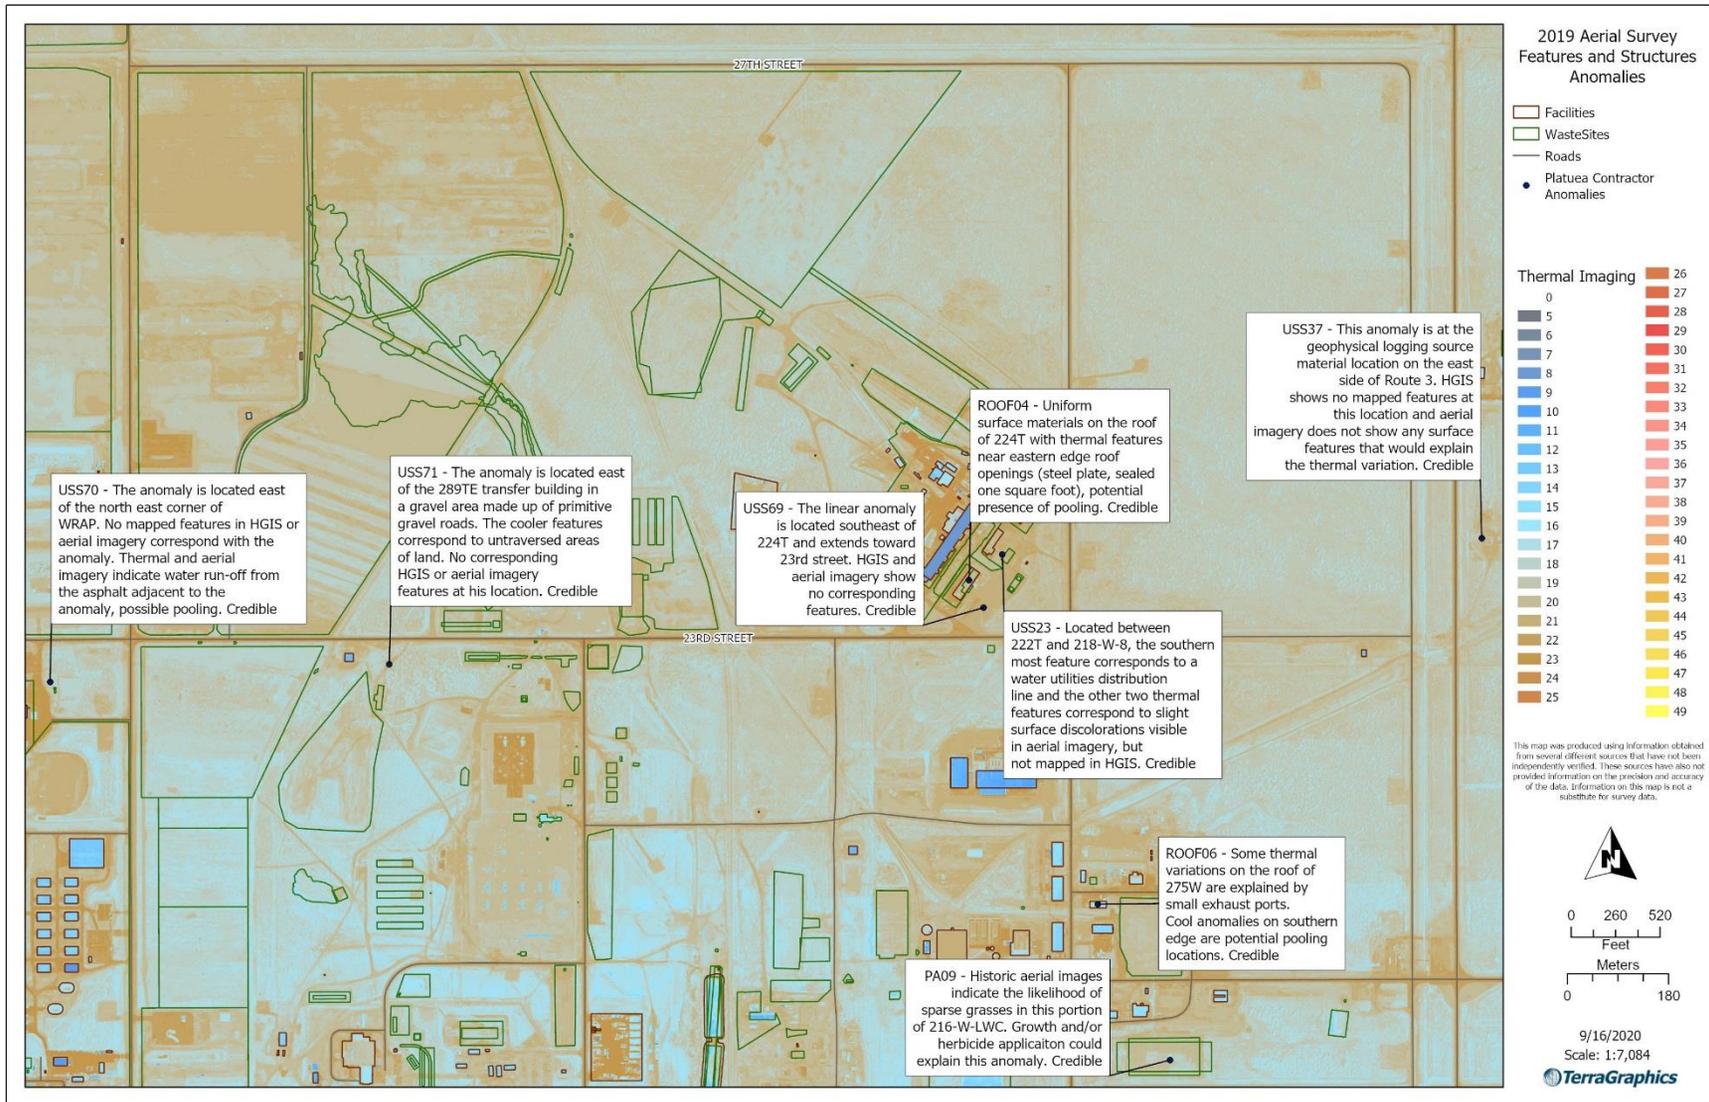
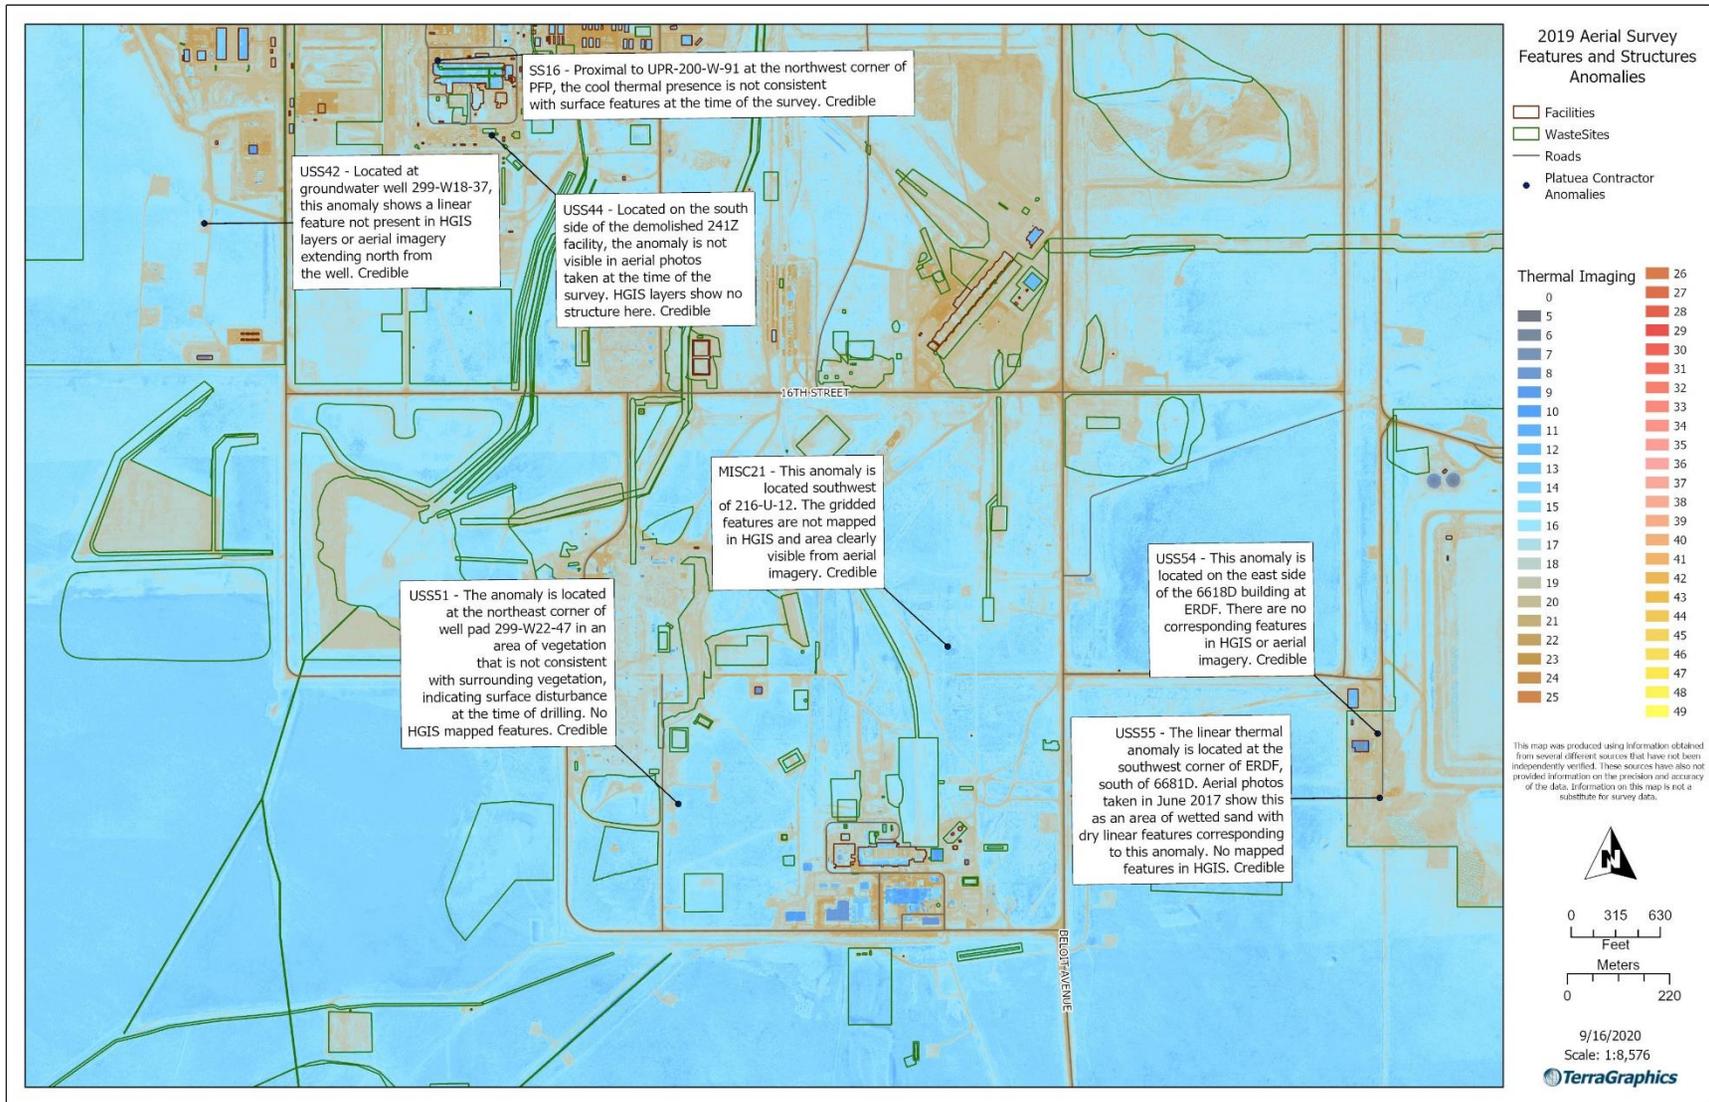
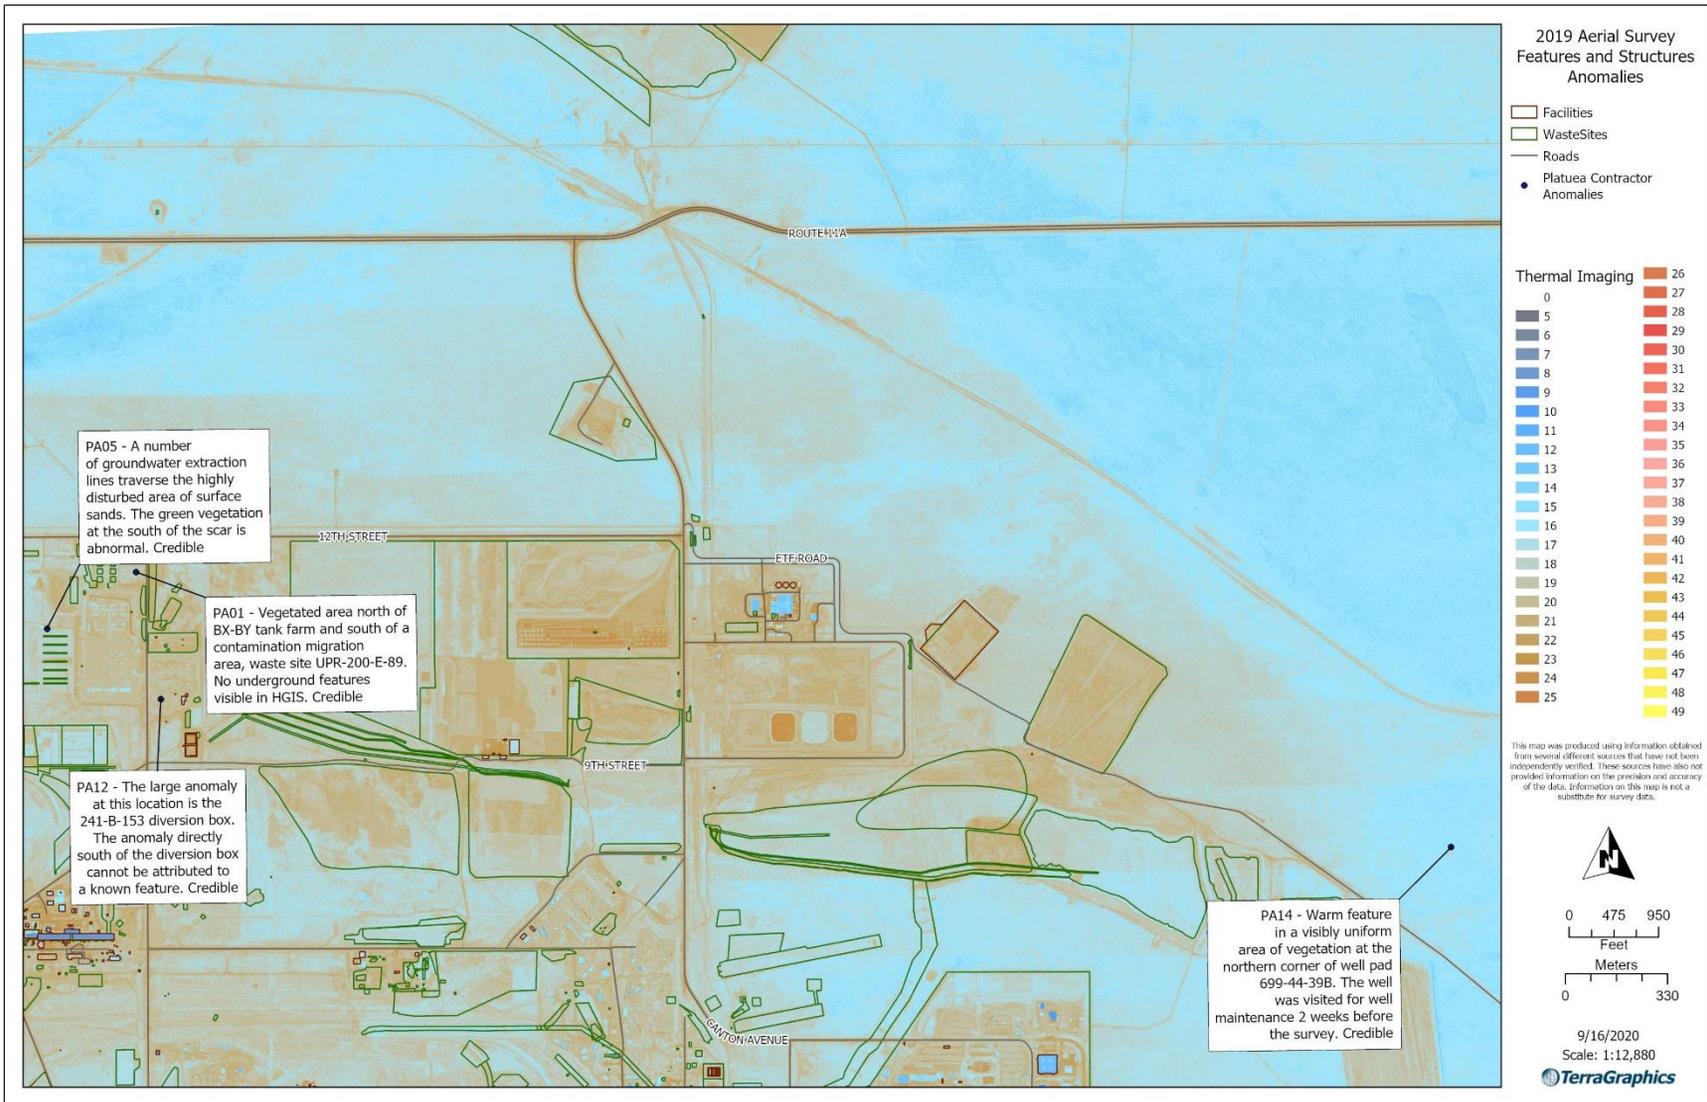
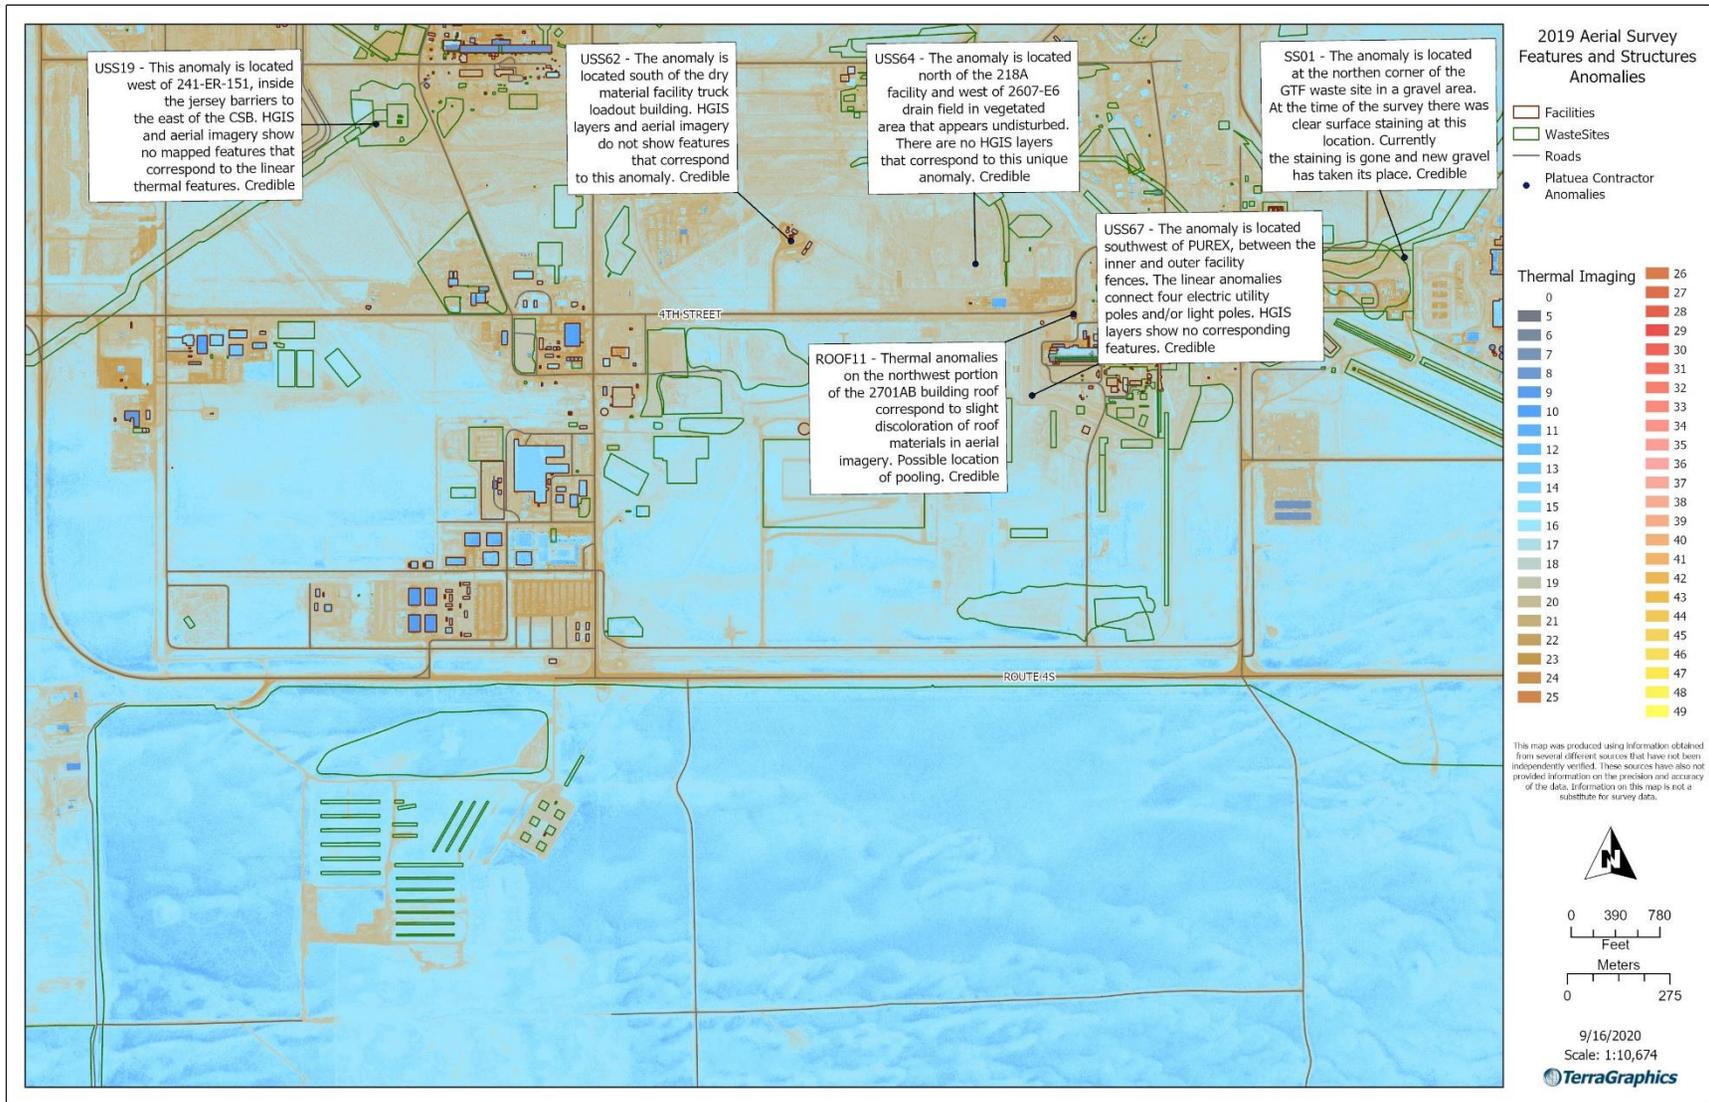
Figure B-8. Credible Anomalies in Locations Managed by the Central Plateau Contractor (CH2M HILL Plateau Remediation Company) (1 of 4)

CHPRC	SS01	Surface staining from spill.	The anomaly is located at the northern corner of the GTF waste site in a gravel area. At the time of the survey, there was clear surface staining at this location. Currently, the staining is gone, and new gravel has taken its place.
CHPRC	PA01	Possible holding area that drains along the east edge.	Vegetated area north of the BX-BY Tank Farm and south of a contamination migration area; UPR-200-E-89 waste site. No underground features visible in HGIS.
CHPRC	MISC21	Grid with thermal background related to surface elevation. Possible site study.	This anomaly is located southwest of 216-U-12. The gridded features are not mapped in HGIS and the area is clearly visible from aerial imagery.
CHPRC	PA05	East-west scar along the road and warm anomaly that shows watered vegetation.	A number of groundwater extraction lines traverse the highly disturbed area of surface sands. The green vegetation at the south of the scar is abnormal.

CHPRC	USS71	Thermally cool drainage patterns that don't correspond to anything visible.	The anomaly is located east of the 289TE transfer building in a gravel area made up of a web of primitive gravel roads. The cooler features correspond to untraversed areas of land. No corresponding HGIS or aerial imagery features at his location.
MSA	USS02	Possible thermal evidence of prior roadwork/repair. Could be associated with pipelines.	The anomaly is located on 4 th Street north of 241AP271. HGIS shows no mapped utilities at this location, and aerial imagery shows no visible surface feature.
MSA	USS43	Possible thermal signature of underground power lines.	West of 234-5Z-BA boiler annex building. There are a number of mapped electrical utilities in this area but match the orientation of the linear thermal feature.
MSA	USS45	Linear thermal feature under the road.	Located at the intersection of 20 th Street and Albany Avenue, there are multiple electrical utilities mapped in HGIS at this location, but none with the exact orientation of the anomaly.

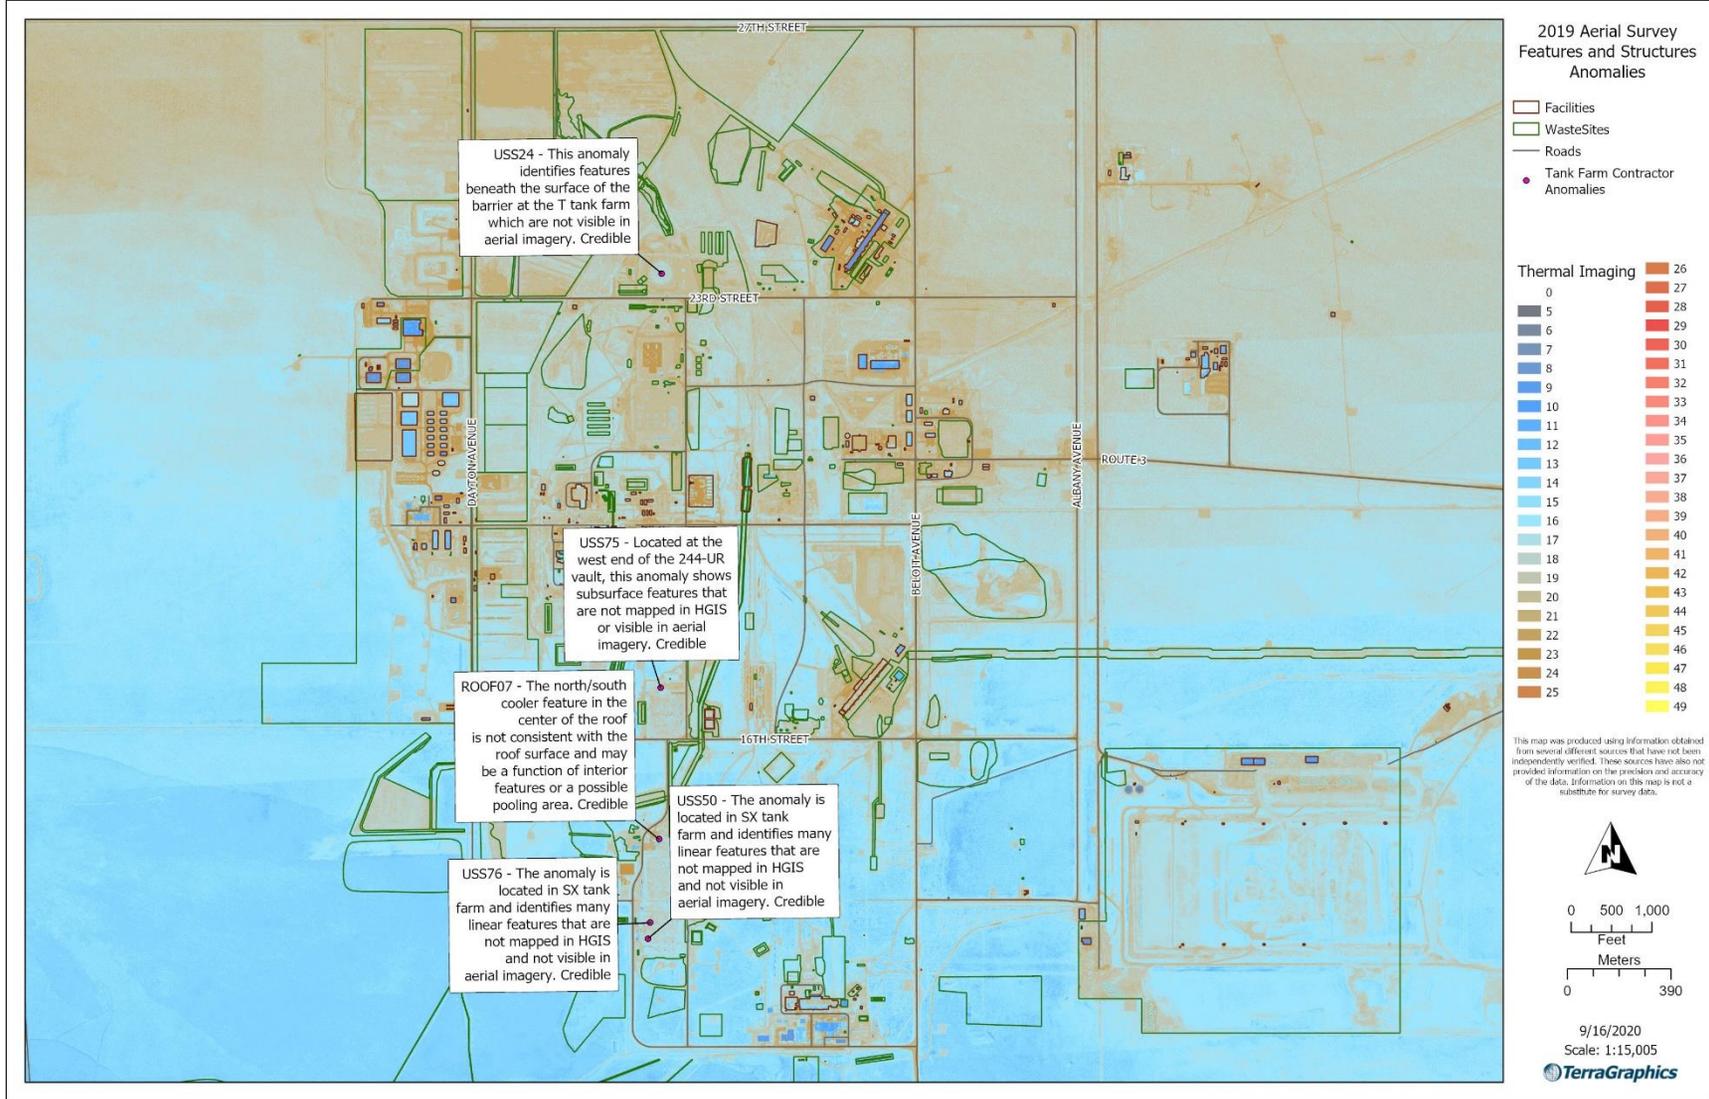
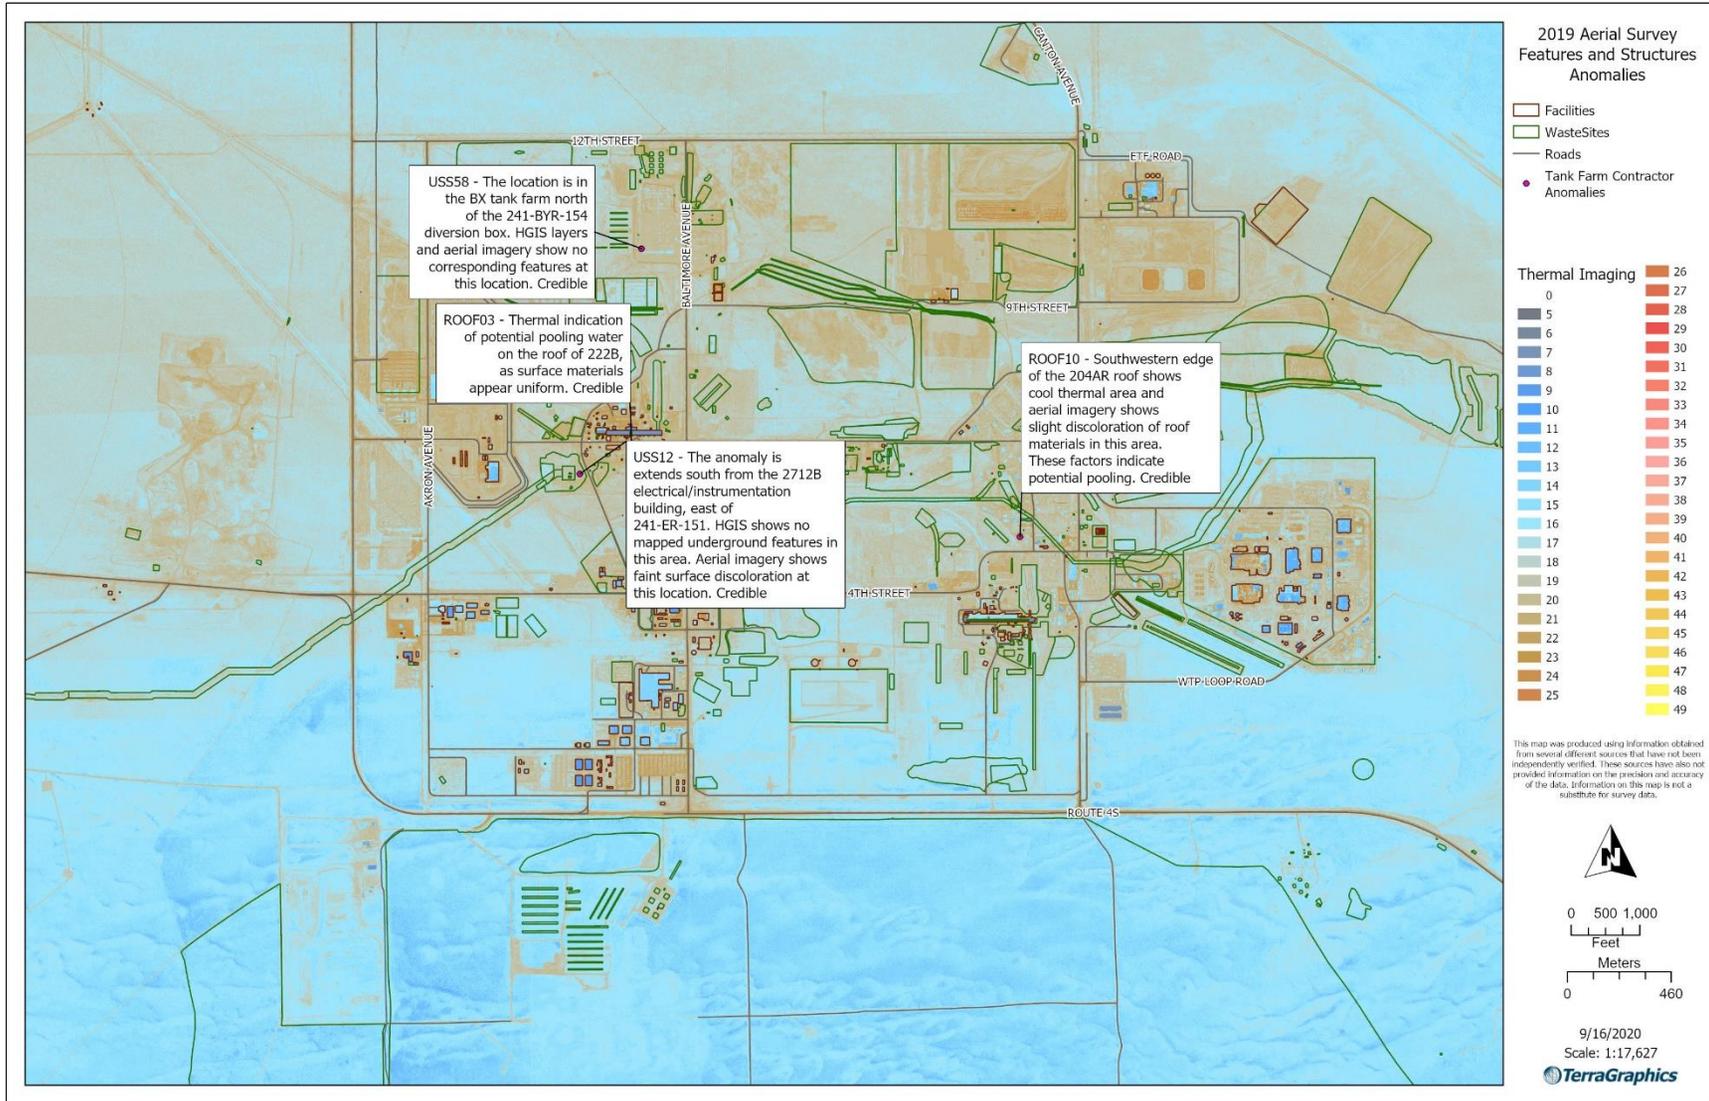
Figure B-10. Credible Anomalies in Locations Managed by the Mission Services Contractor (Washington River Protection Solutions) (1 of 2)

WRPS	USS58	Rectangular thermal feature is probably a buried foundation. Also, a circular thermal feature that is a mound.	The location is in the BX Tank Farm north of the 241-BYR-154 diversion box. HGIS layers and aerial imagery show no corresponding features at this location.
WRPS	ROOF10	Thermal anomaly on the roof that is not seen in visible imagery. Two circular thermal anomalies on the ground east of the building also not in visible data.	Southwestern edge of the 204AR roof shows cool thermal area and aerial imagery shows slight discoloration of roof materials in this area. These factors indicate potential pooling.
