Hanford Single-Shell Tank Leak Causes and Locations - 241-B Farm

Washington River Protection Solutions

Abstract: This document identifies 241-B Tank Farm (B Farm) leak cause and locations for the 100 series leaking tank (241-B-107) identified in RPP-RPT-49089, Hanford B-Farm Leak Inventory Assessments Report. This document satisfies the B Farm portion of the target (T04) in the Hanford Federal Facility Agreement and Consent Order milestone M-045-91F.

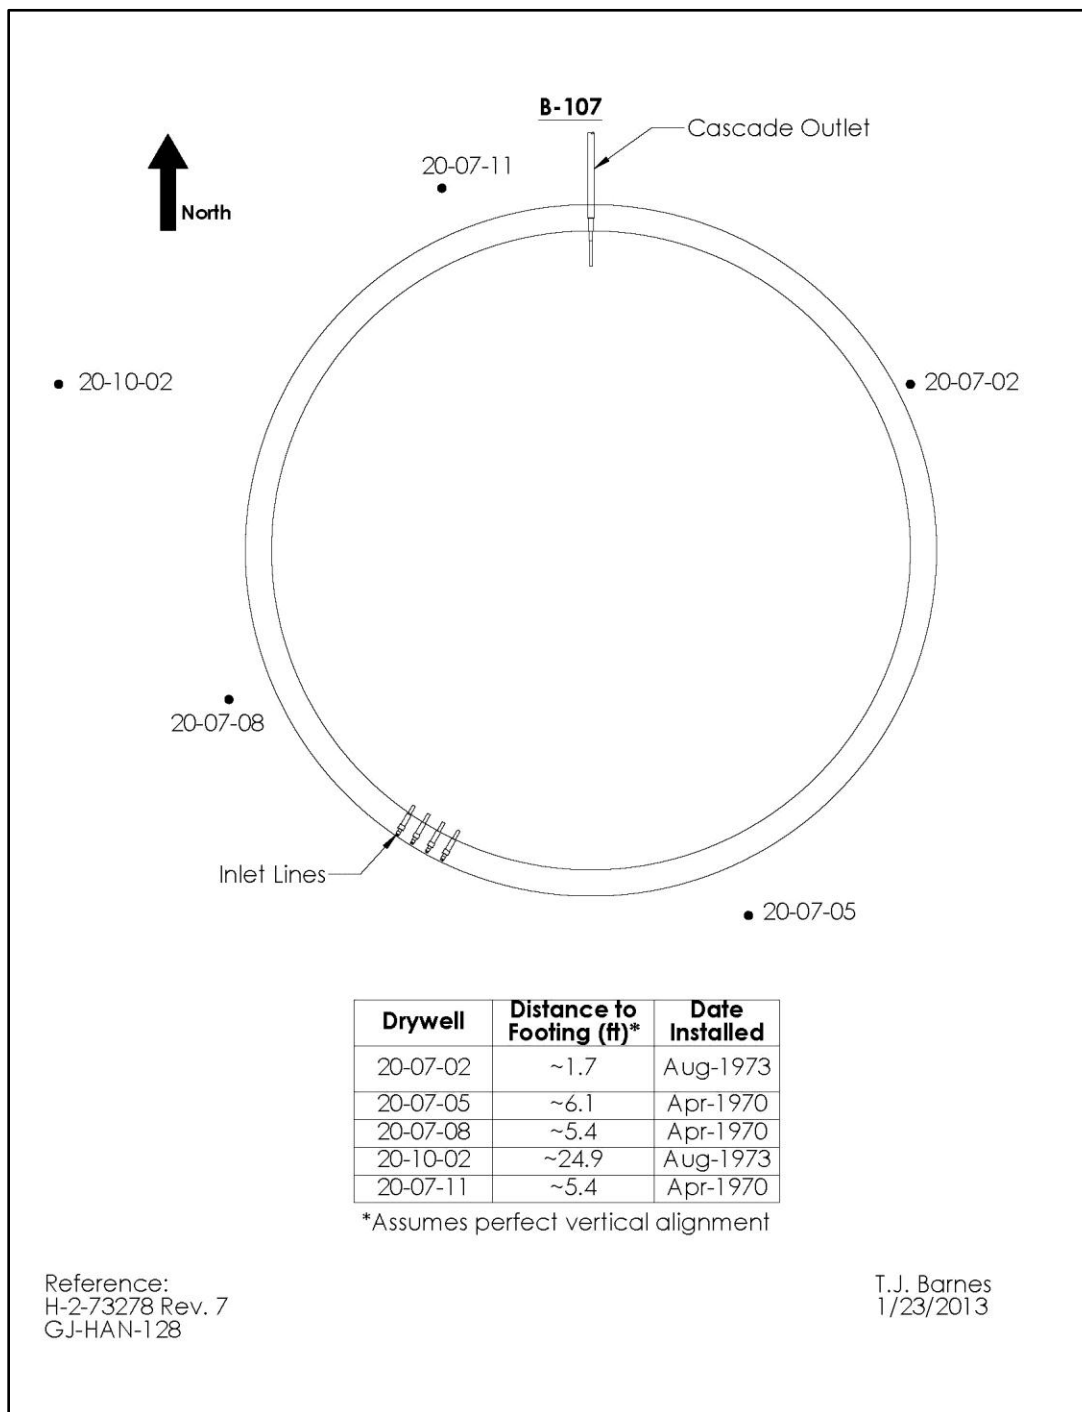
Figure 2-1 shows a simplified schematic of the B Farm tank B-107 with location of the drywells, cascade line, and spare inlet nozzles.

Figure 2-1. B Farm Tank B-107 and Associated Drywells
 Tank inner ring is steel liner, outer ring is outer edge of tank footing

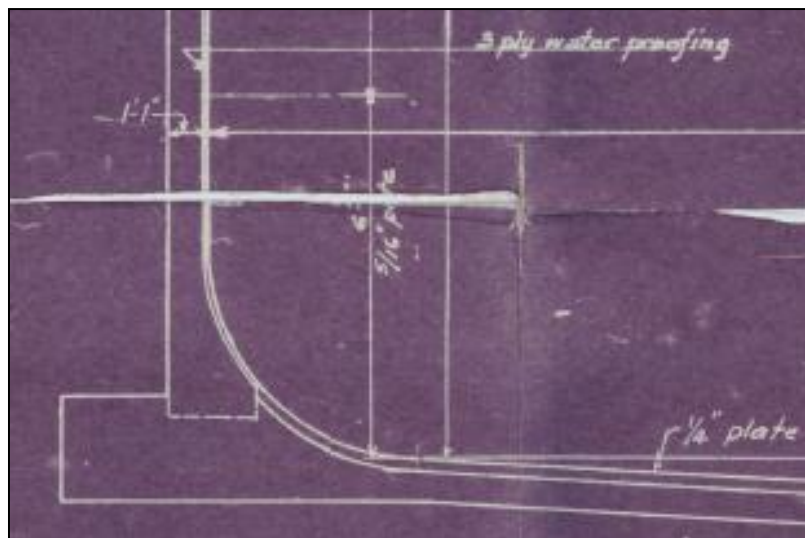
Figure 3-1 shows the detail of the knuckle liner to the grout and three-ply asphaltic waterproof membranes between the bottom, sidewall intersection, and sidewalls (BPF-73550, Sheet B5).

Figure 3-1. B C T U Tank Farm Knuckle Configuration with Three-Ply Waterproofing (BPF-73550, Sheet B5)

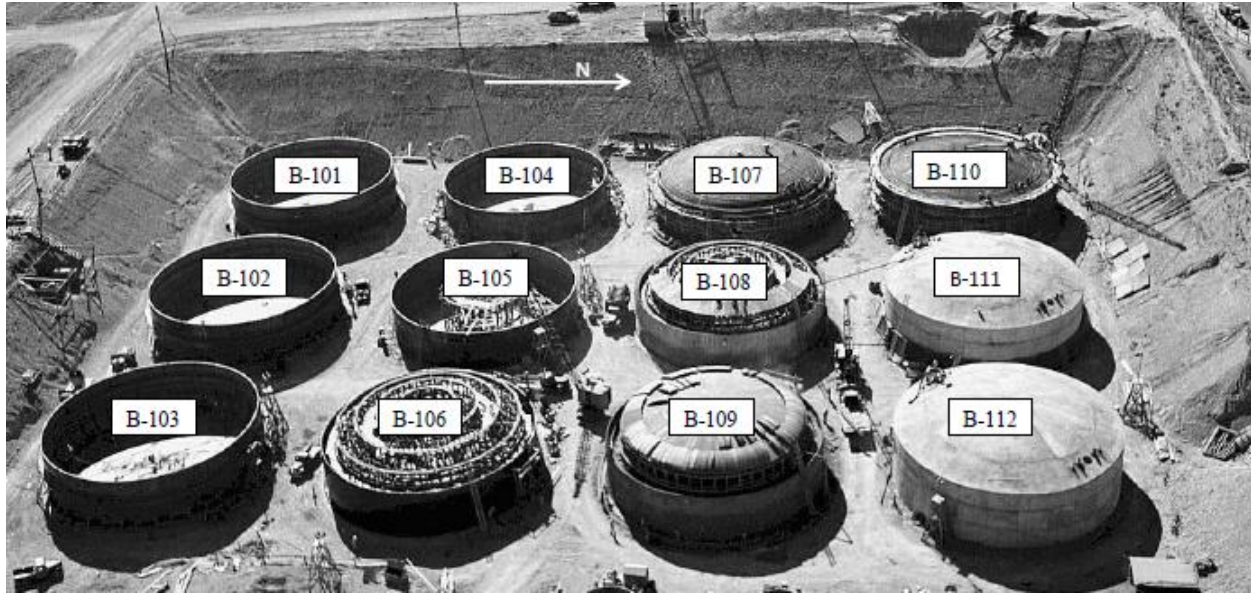
The B Farm construction temperatures were examined to determine if the tank liner fabrication occurred at or below the ductile-to-brittle temperature transition (see Section 4.3.2). The photograph in Figure 3-2 shows the B Farm under construction on September 25, 1944.

Figure 3-2. B Farm Construction Photograph, September 25, 1944 (P6145 N1600681)

2. Pg. 3-2, Fig. 3-2. The photo caption should state that the photo is looking south, as there isn't a map showing all tanks in B Farm. Please add.

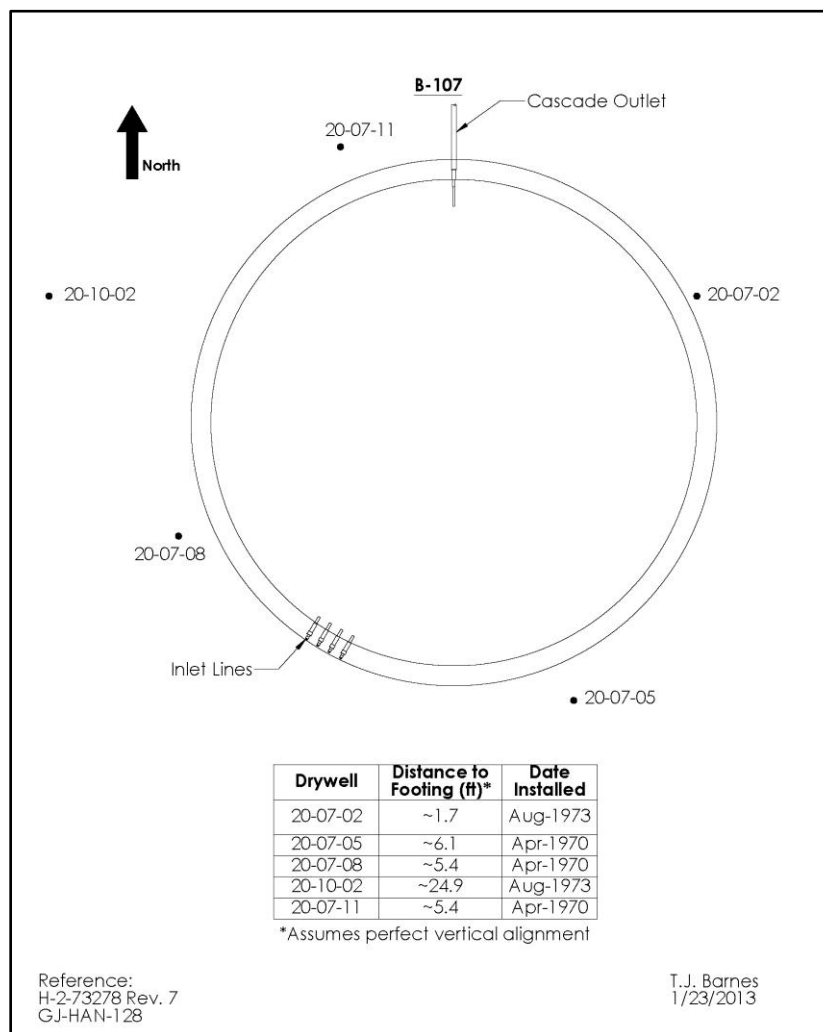
This section provides information on the historical waste loss event associated with single-shell tank (SST) 241-B-107 (B-107). There are five drywells located around tank B-107 with specified distances from the drywell to the tank footing shown in Figure 4-1: 20-07-05, 20-07-08, and 20-07-11 installed in April 1970 and 20-07-02 and 20-10-02 installed in August 1973.

Figure 4-1. Tank B-107 Associated Drywells
Tank inner ring is steel liner; outer ring is outer edge of tank footing

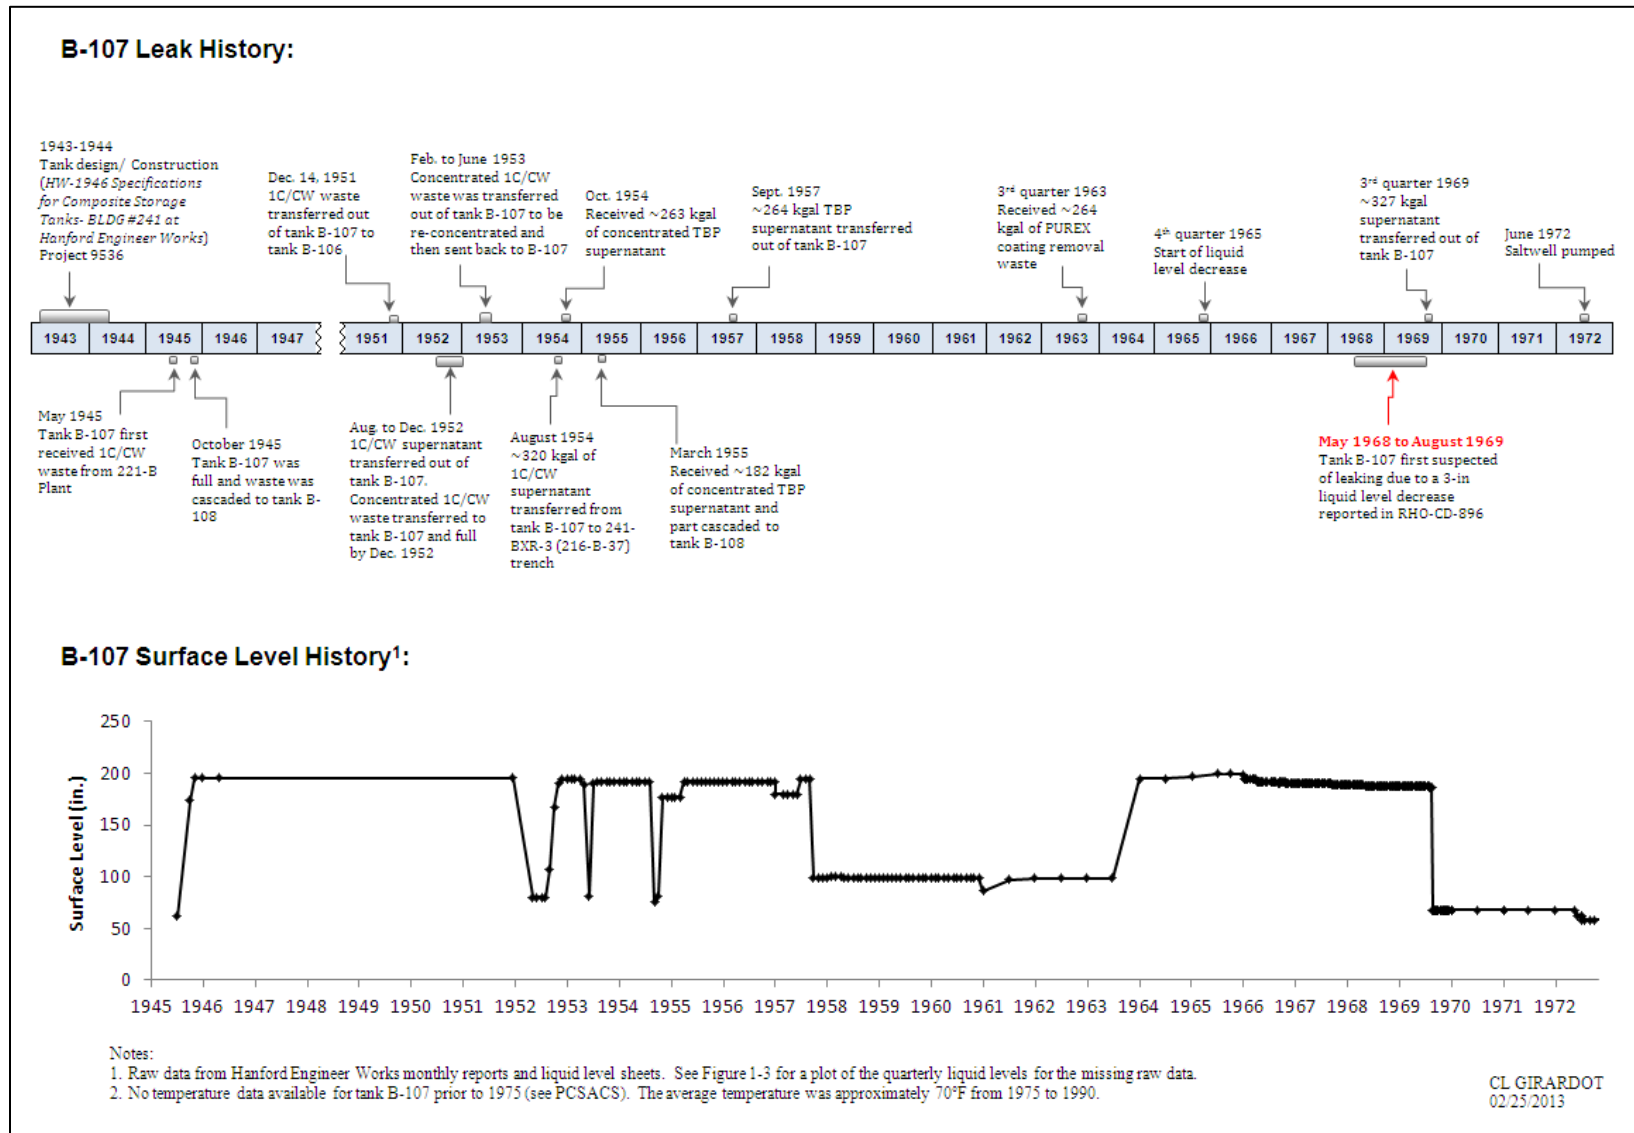
The operational history of tank B-107 leak related details including liquid level is charted in Figure 4-2.

Figure 4-2. Operational Leak History of Tank B-107

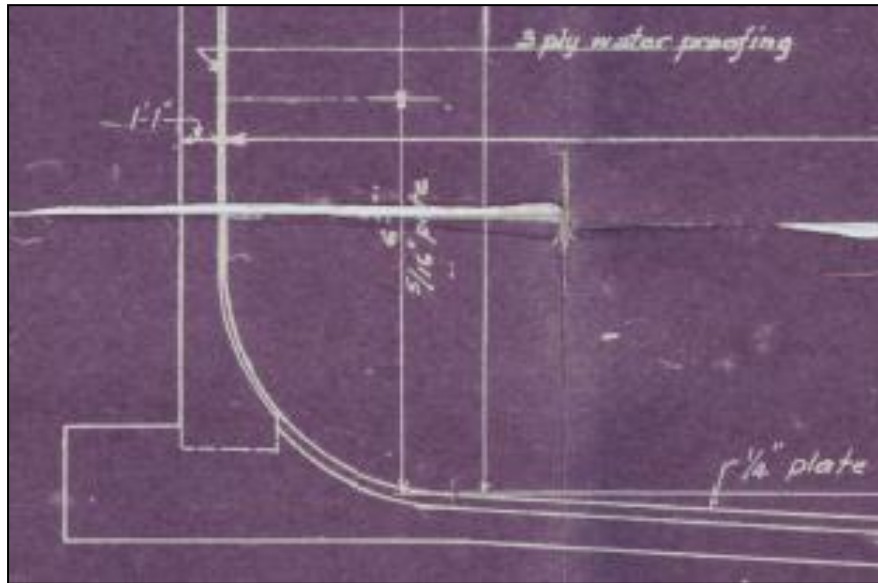
The steel bottoms of the B Farm tanks intersect the sidewall on a 4-ft radius knuckle transition (BPF-73550, Drawings D-2 and D-3). Figure 4-3 shows the detail of the rounded knuckle transition, the three ply asphaltic membrane waterproofing between the liner and the concrete, a notched footing construction joint, and the concrete shell. These features are common to all B Farm tanks (see Section 3.1.1).

**Figure 4-3. B C T U Tank Farm Knuckle Configuration with Three-Ply Waterproofing
BPF-73550, Sheet B5**
