Subject: Contract No. DE-AC06-93RL12367
**ELIMINATION OF ADMINISTRATIVE TECHNICAL SAFETY
REQUIREMENTS ON EF-8 FAN AND HIGH EFFICIENCY PARTICULATE
AIR FILTERS IN THE REDUCTION OXIDATION BUILDING**

Reference: 1. BHI-01142, Rev. 1, *REDOX Facility Safety Analysis Report*
2. BHI-01299, Rev. 0, *Alternative Evaluation for the REDOX (202-S) Plutonium Loadout Hood.*

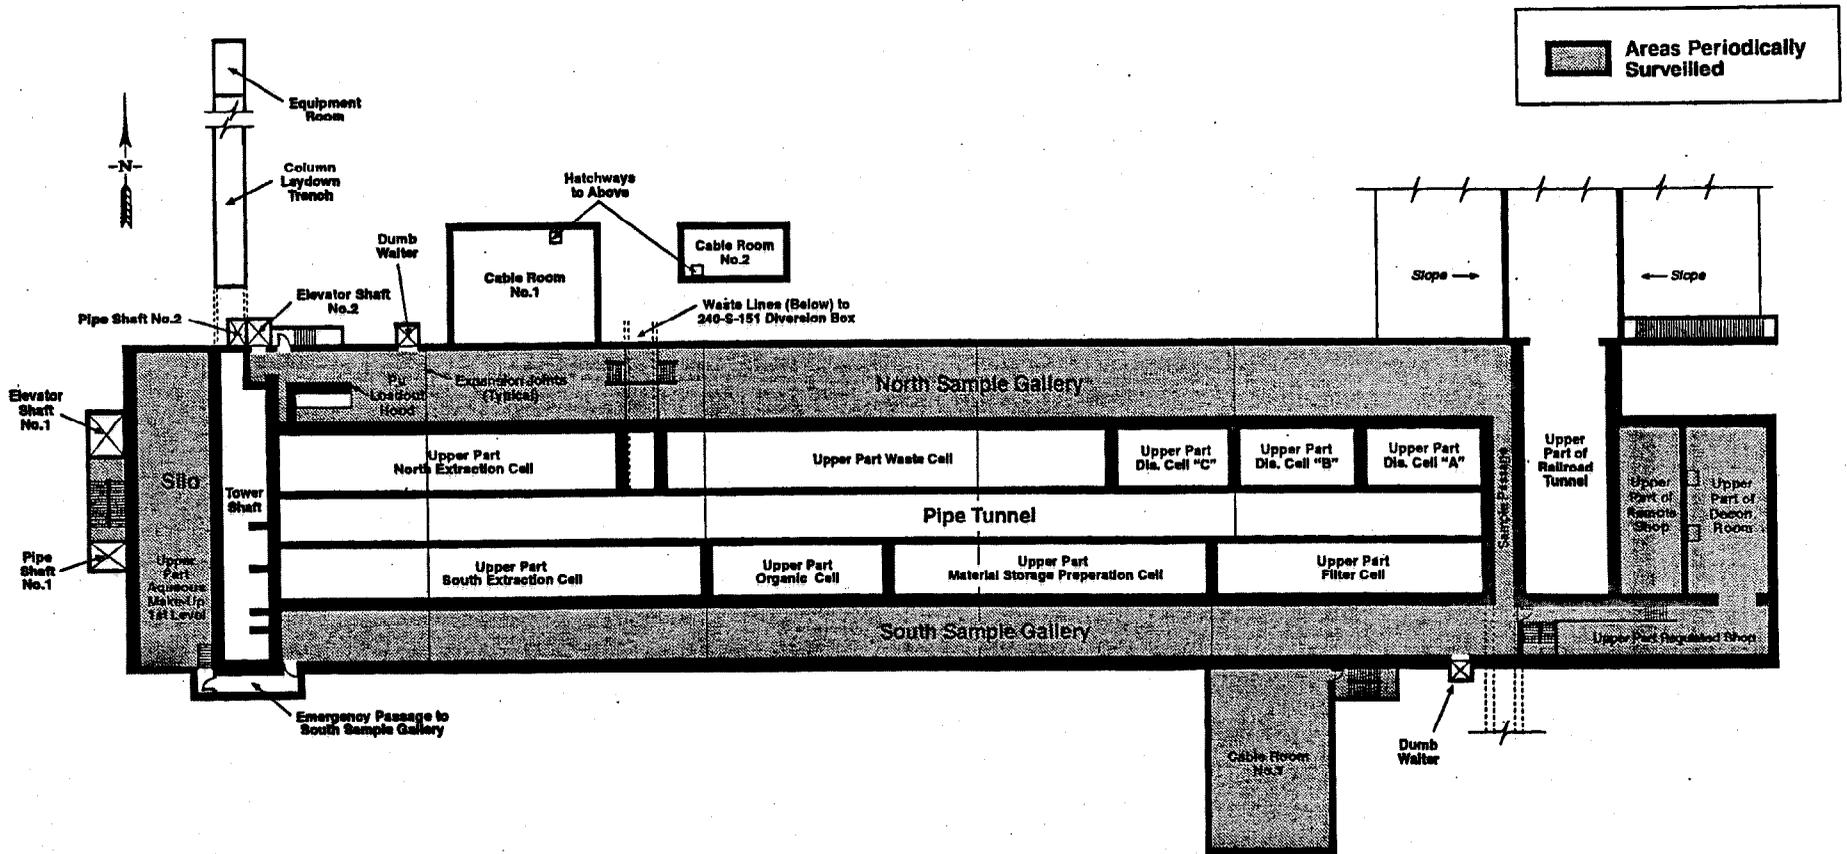
Figure 2-3. Plan View Sample Gallery Level.

PLAN VIEW OF THE SAMPLE GALLERY

Ref. HW-18700 / Figure XI-5a / From DWG. H-2-7402

The Pu Loadout Hood (a.k.a., PR Cage) is located at the west end of the North Sample Gallery of the REDOX canyon building, 202-S. The North Sample Gallery structure is partially below grade and is the lower of three stories that are on the North side of the building. Figures 2-3 and 2-12 of BHI-01142 (Exhibits 1 and 2) provide information relative to the location of the Pu Loadout Hood within the 202-S building.

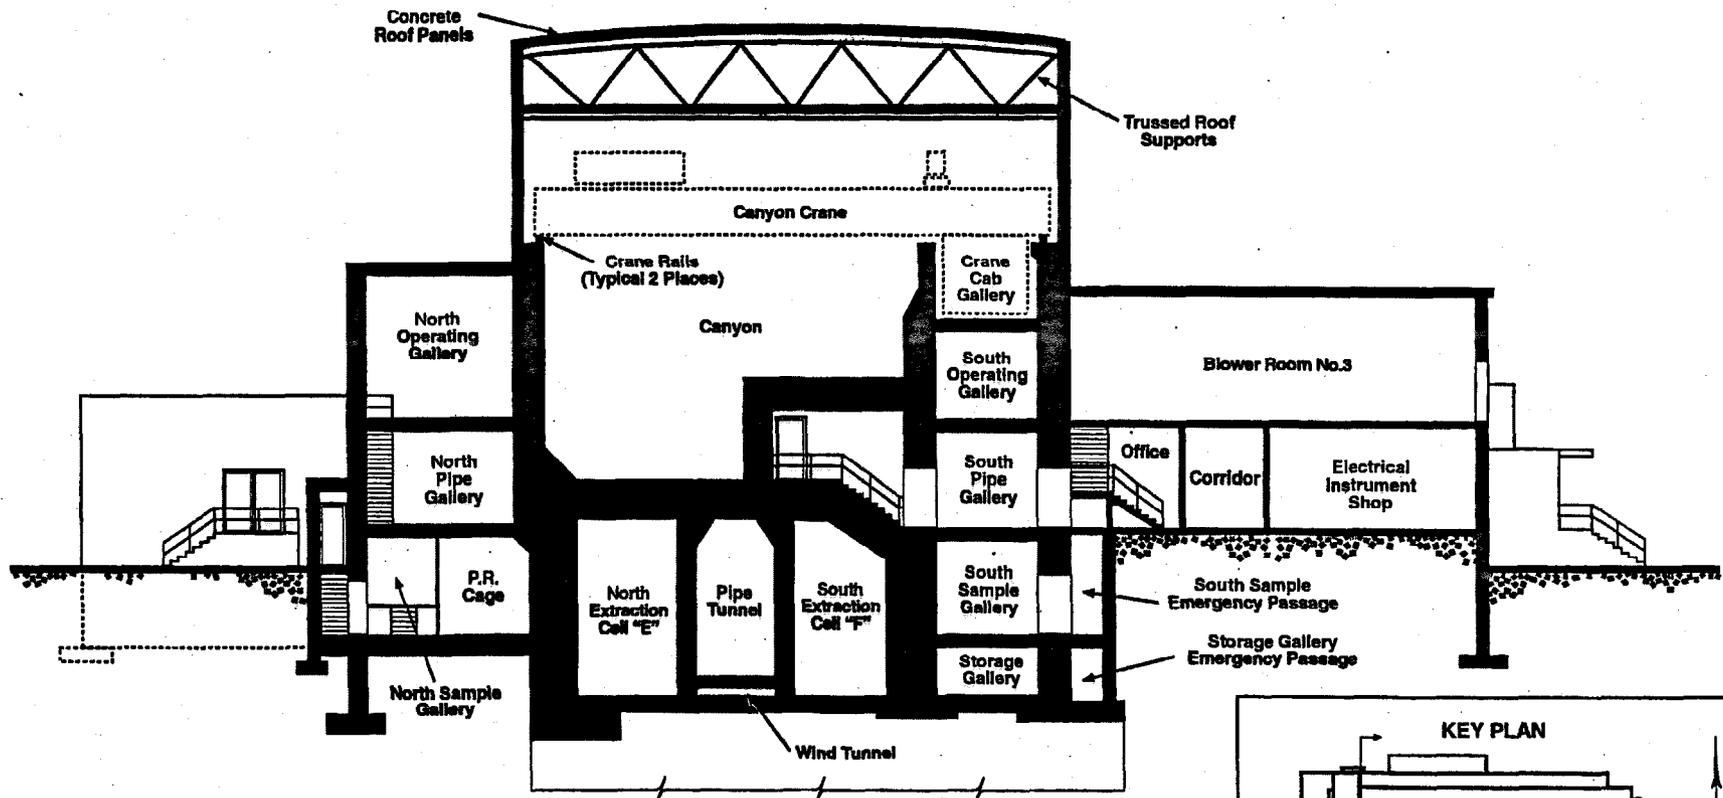
Figure 2-12. Canyon Emergency Exit

CANYON EMERGENCY EXIT

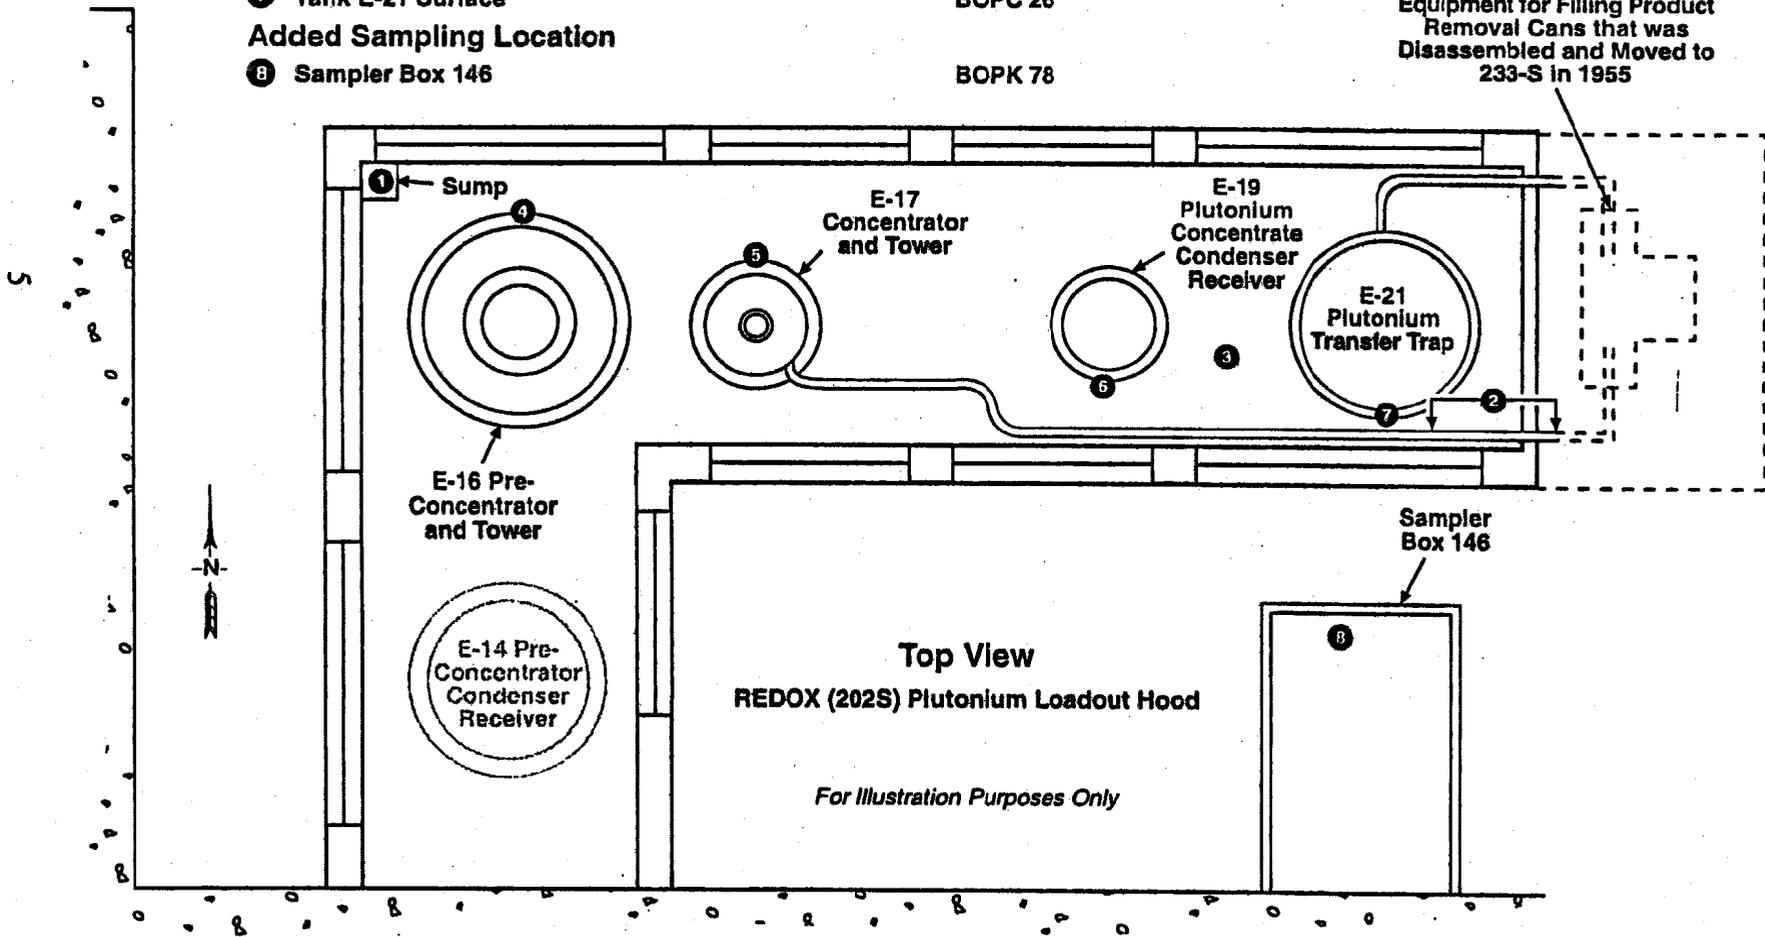
Figure 3. Top View of the 202-S Plutonium Loadout Hood.

FIGURE 3 OF BHI-01299

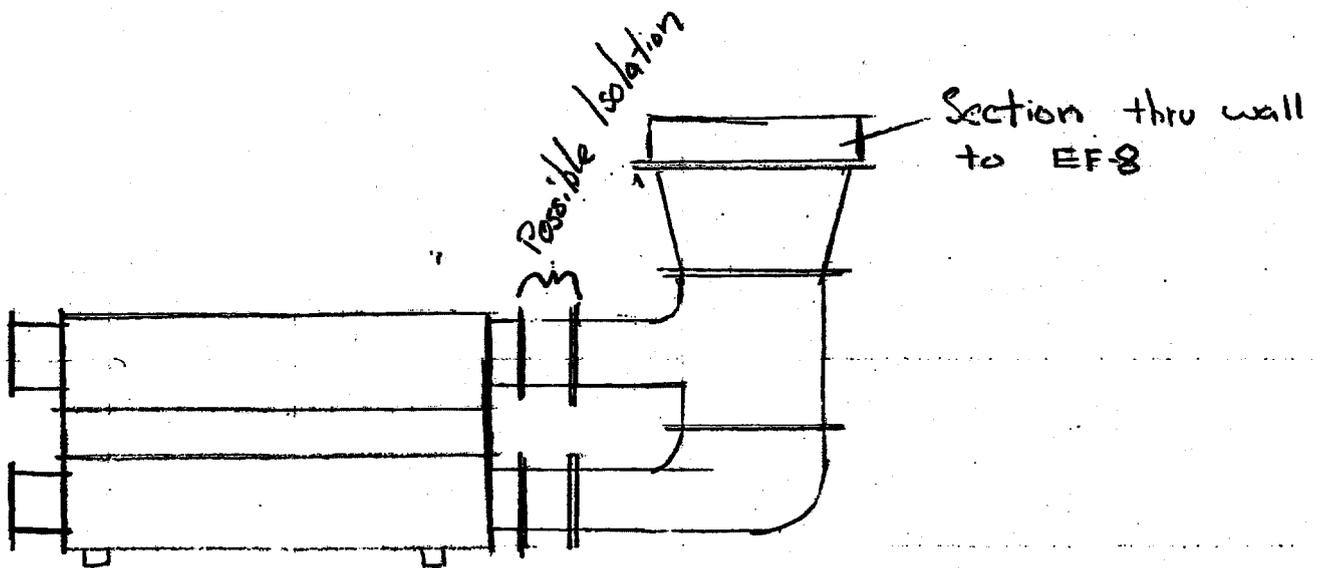
EF-8 HEPA BANK
 NORTH Sample Gallery

Assume: 1) Cap over 296-S-2
 2) Isolate EF-8 duct on outside transition

- The HEPA filter bank and ducting to the EF-8 fan and 296-S-2 stack was found to have a configuration that should support the eventual isolation inside the North Sample Gallery. Consideration should be given to install blanks immediately downstream of the upper and lower filter banks. Current air balance records (3/20/99) indicated flow through the lower bank at 650 cfm and flow through the upper bank at 635 cfm. (See Attached Sketch)
