EFL-1295

4-27-94 300 Area Solvent Evaporator RCRA Closure Project

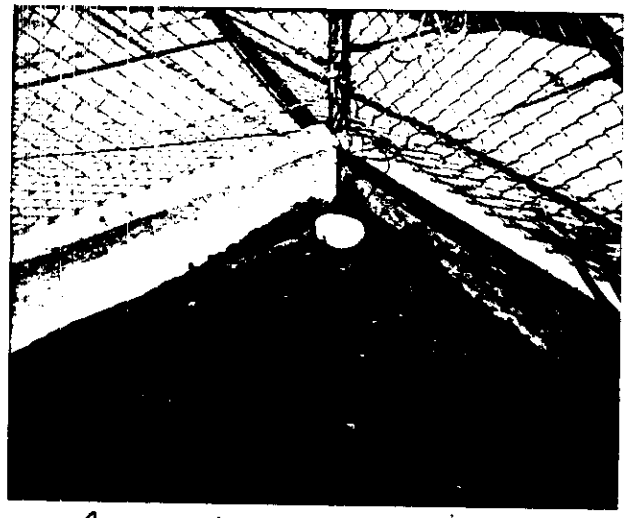
Core #1 Site 4-27-94 0921

0930 - Core #1 cut and removed from 4" slab. 3 more colocated cores will be cut from core site #1. Rad - < det α,β,γ

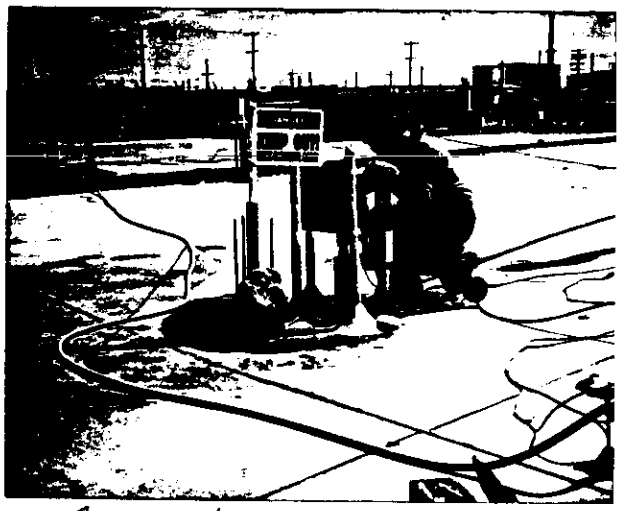
Core Site #2 4-27-94 1334

1335 - Stopped drilling at core site #2. Collected 4 colocated concrete cores from 4" slab. Rad - - det α,β,γ JGL 4-27-94

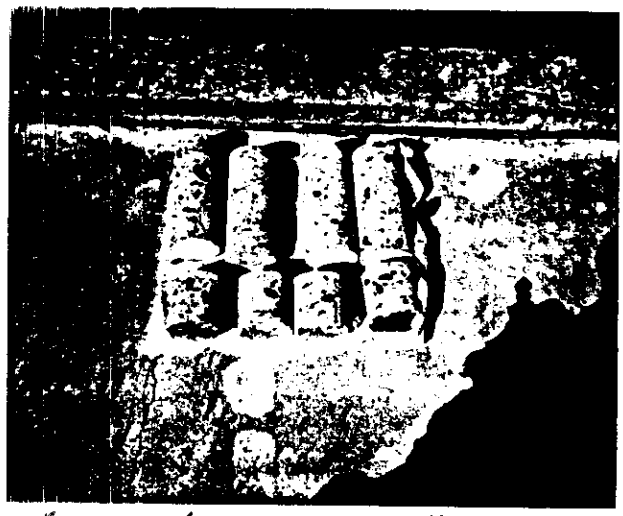
Core site #3 4-28-94
[illegible] cores (colocated) 1031

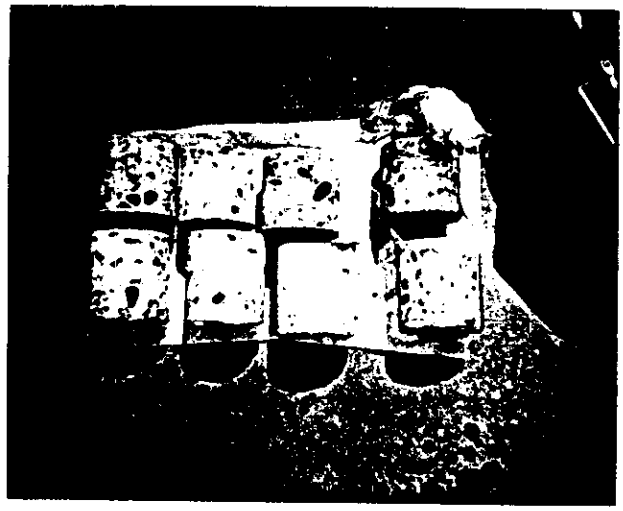
Core site #5 4-28-94
(4 colocated cores) 1125
