11-AMCP-0212

WASTE SITE RECLASSIFICATION FORM (CONTROL NUMBER 2011-048), AND RESPONSE ACTION REPORT FOR THE 200-MG-1 OPERABLE UNIT WASTE SITE 600-40, DOE/RL-2011-66, REVISION 0

Response Action Report for the 200-MG-1 Operable Unit Waste Site 600-40

Date Published
July 2011

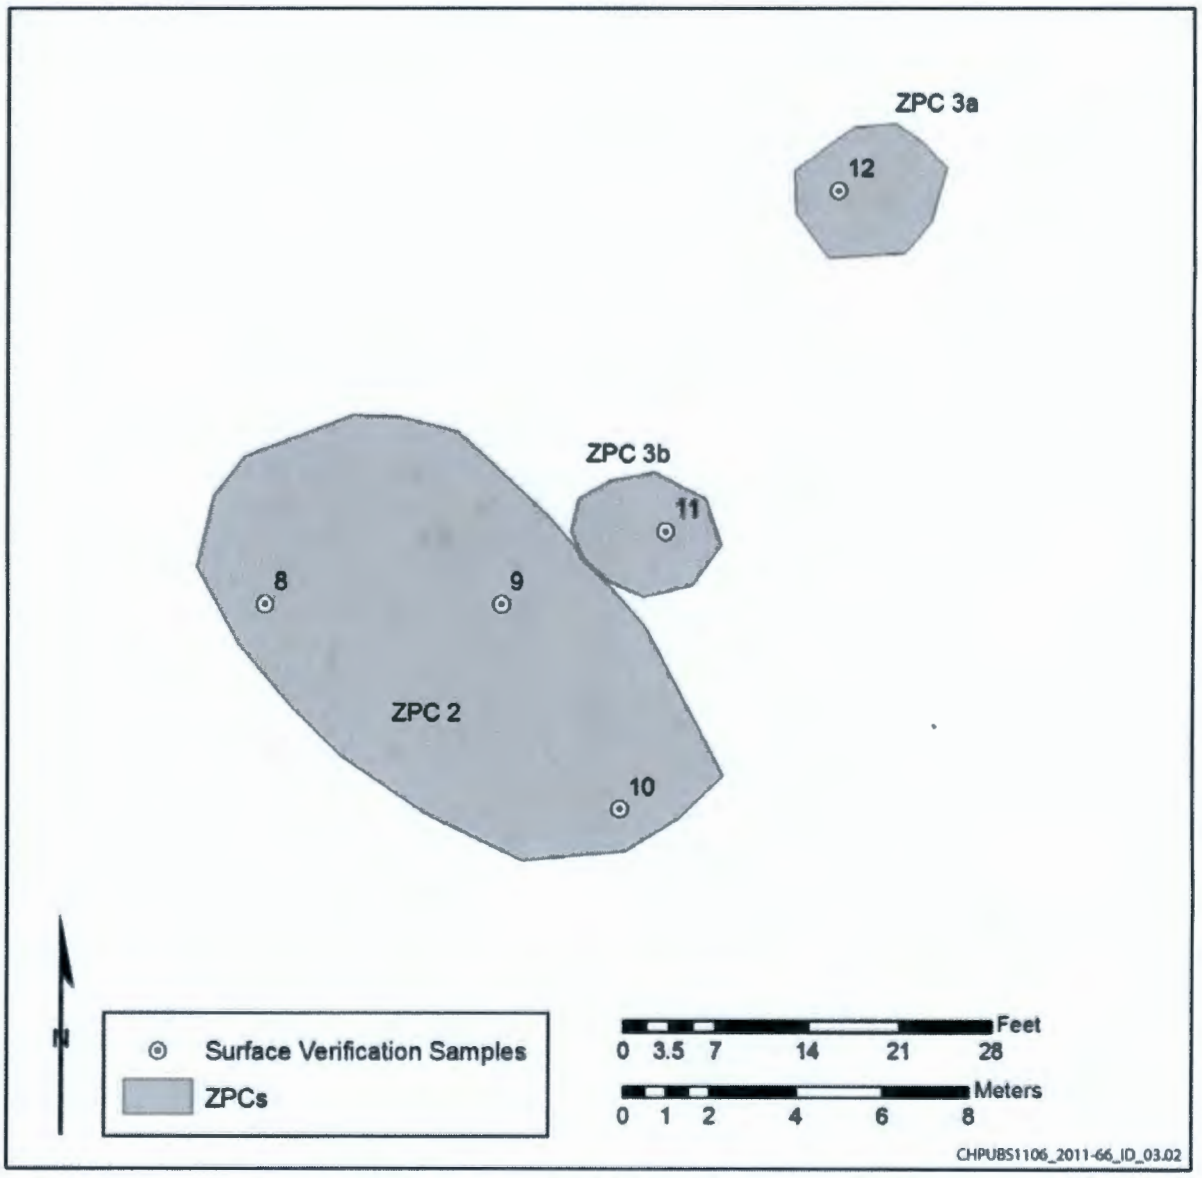
Figure 3-2. ZPCs 2, 3a, and 3b Verification Sample Locations

The area of excavation at ZPC 2 was approximately 98 m^2 (1,055 ft^2); therefore, three soil samples from the base of the excavated area were collected from locations selected randomly utilizing VSP software (Figure 3-2), and analyzed for the full suite of COPCs in accordance with Rev. 0 of the SAP.
