11-AMCP-0213

WASTE SITE RECLASSIFICATION FORM (CONTROL NUMBER 2011-049), AND RESPONSE ACTION REPORT FOR THE 200-MG-1 OPERABLE UNIT WASTE SITE 600-218, DOE/RL-2011-64, REVISION 0

Response Action Report for the 200-MG-1 Operable Unit Waste Site 600-218

Date Published
July 2011

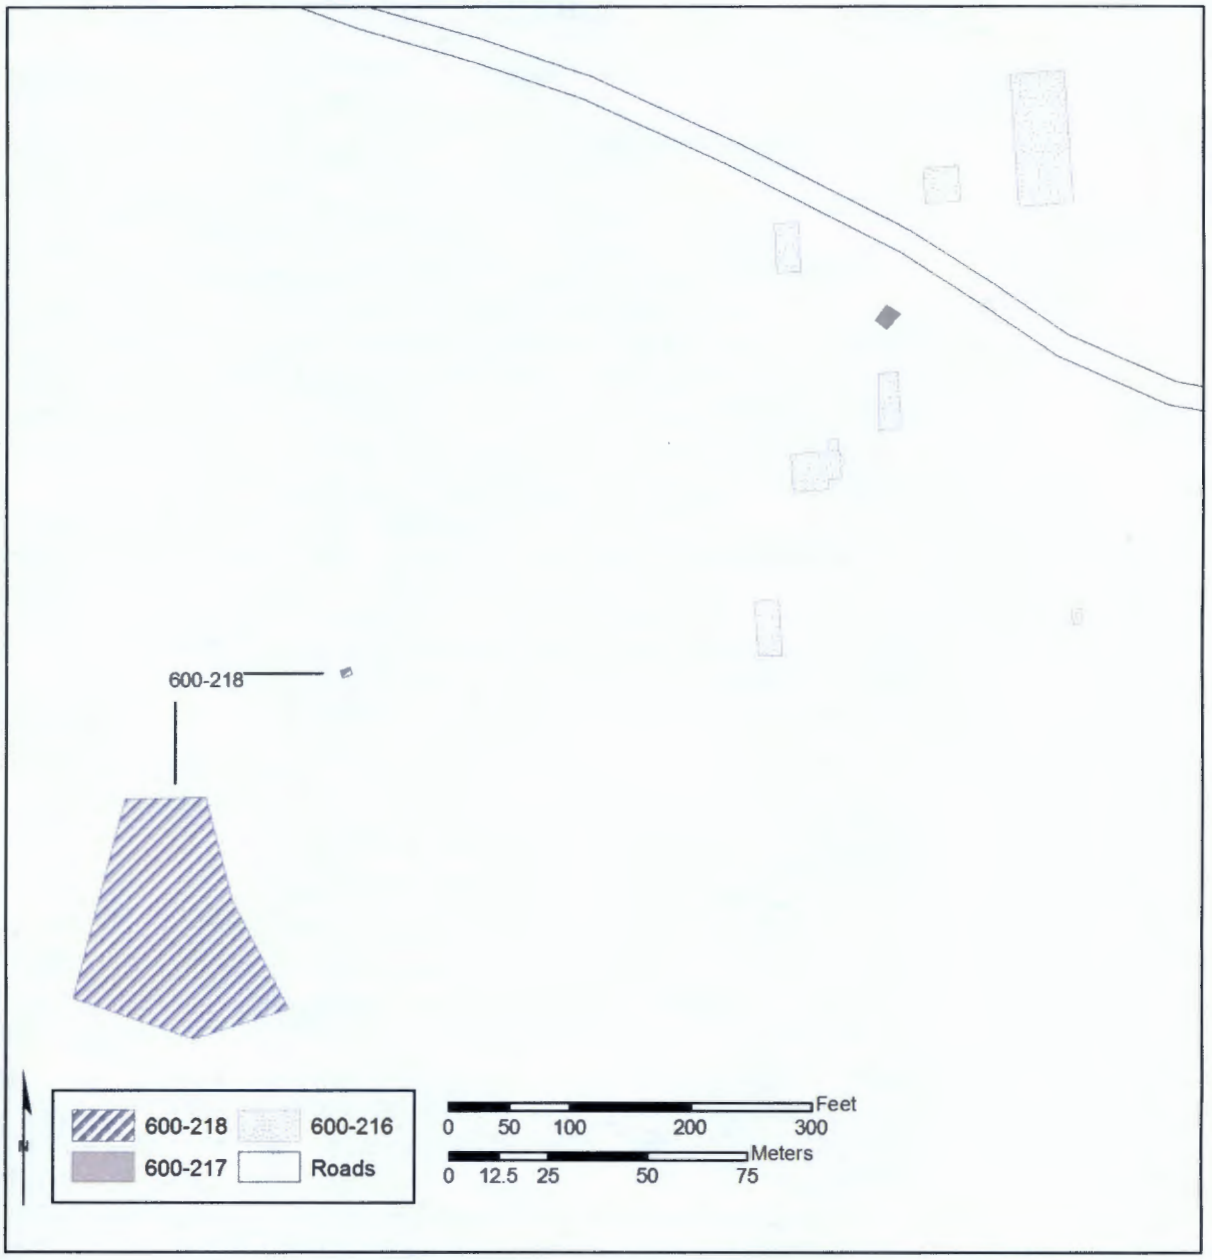
Figure 2-1. 600-218 Waste Site

The 600-218 waste site is located northwest of the 200 West Area. The site is described in the Waste Information Data System (WIDS) as a dumping area for inert debris generated from the construction of a nearby anti-aircraft site. The 600-218 waste site is irregularly shaped and is comprised of two areas separated by land not designated as a waste site (Figure 2-1). According to WIDS, the larger portion of the waste site is approximately 74 m (243 ft) at the longest point by 20.4 m (67 ft) at the widest point with an area of approximately 1,513 m^2 (16,280 ft^2). The smaller portion of the site lies approximately 48 m (157 ft) northeast of the larger portion, and is recorded as being generally rectangular in shape, approximately 1.5 m (5 ft) by 1.8 m (6 ft), with an area of approximately 2.8 m^2 (30 ft^2). No documentary evidence was found suggesting that stabilizing material has ever been added to this site, and no structures exist at this site.

In March 1997, a site investigation team mapped and photographed the waste site. The WIDS listing describes debris in the waste site area including empty metal cans (oil, paint, and food), wood, concrete rubble, pipe, sheet metal, barbed wire, and metal fence posts. No evidence exists identifying a potential for radioactive material at this site. WIDS lists the waste site category as "nondangerous/nonradioactive."

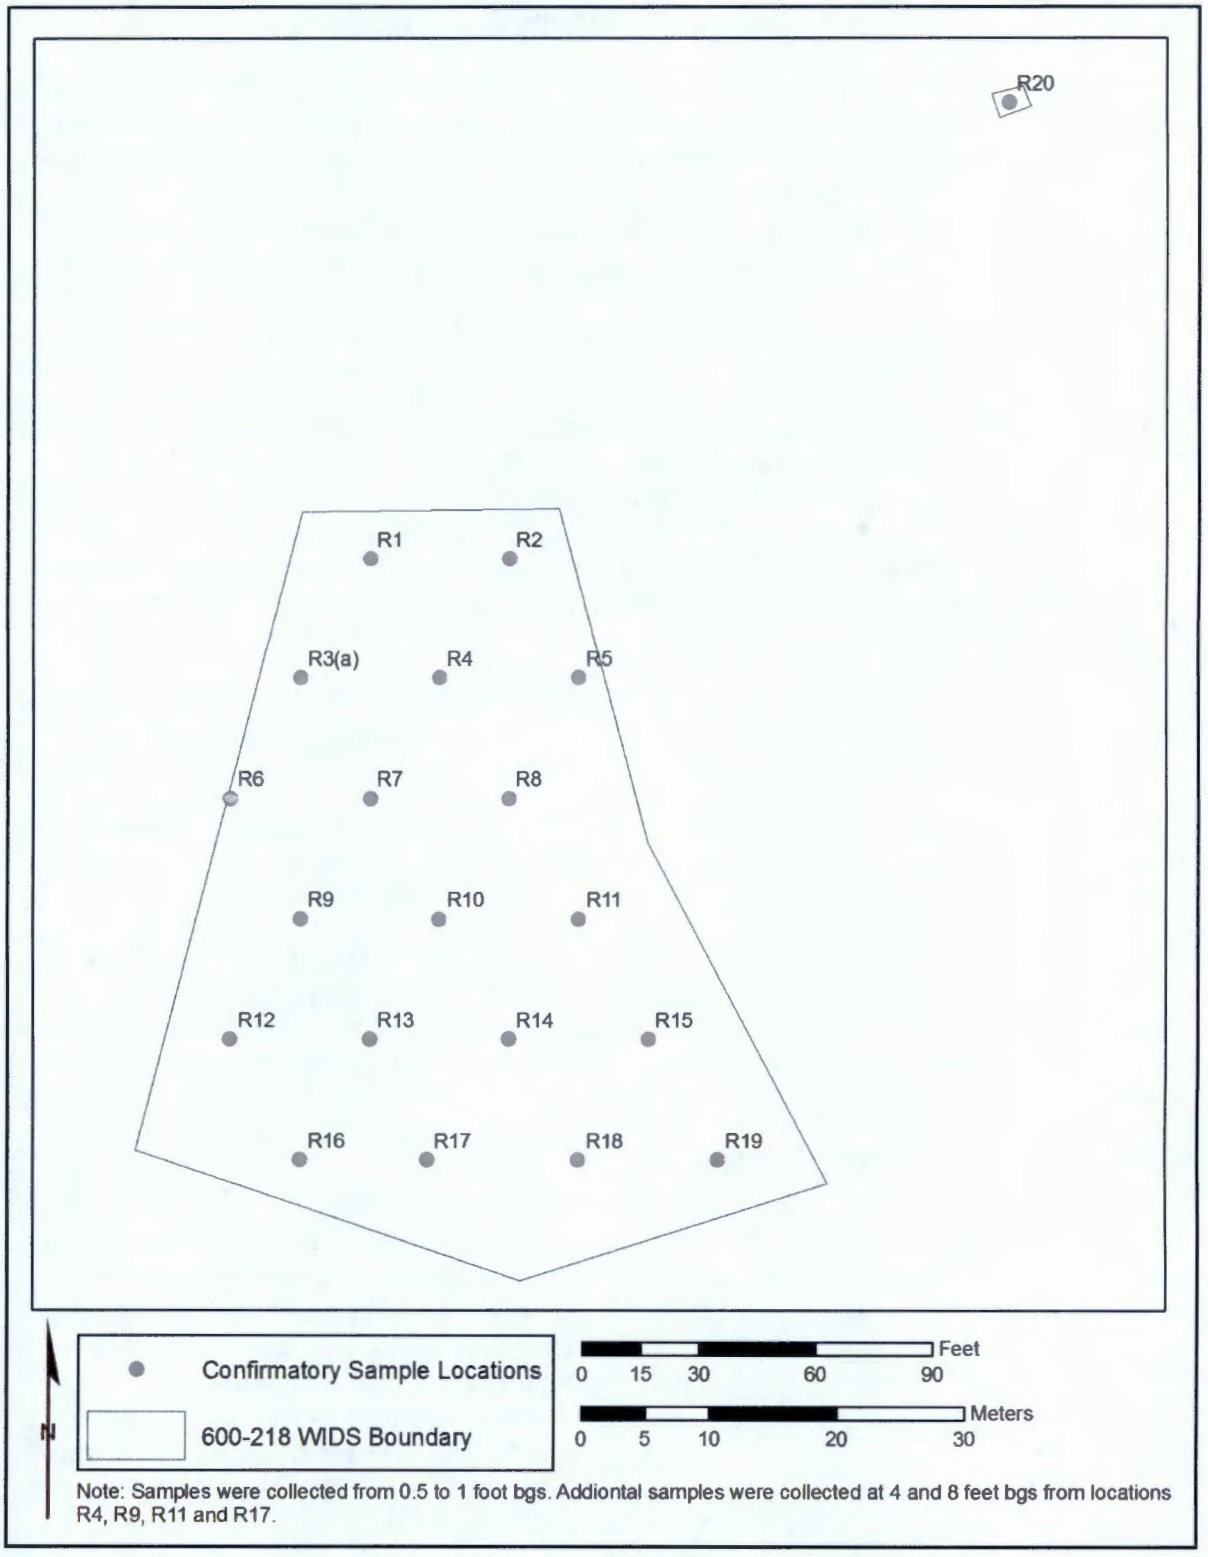
Figure 3-1. Initial Sample Locations at the 600-218 Waste Site

Observations made at the smaller, northern portion of the waste site (Figure 3-1) during site evaluation included fencing materials and empty containers; however, there were no visual indicators of potential contamination such as soil staining or devegetation.

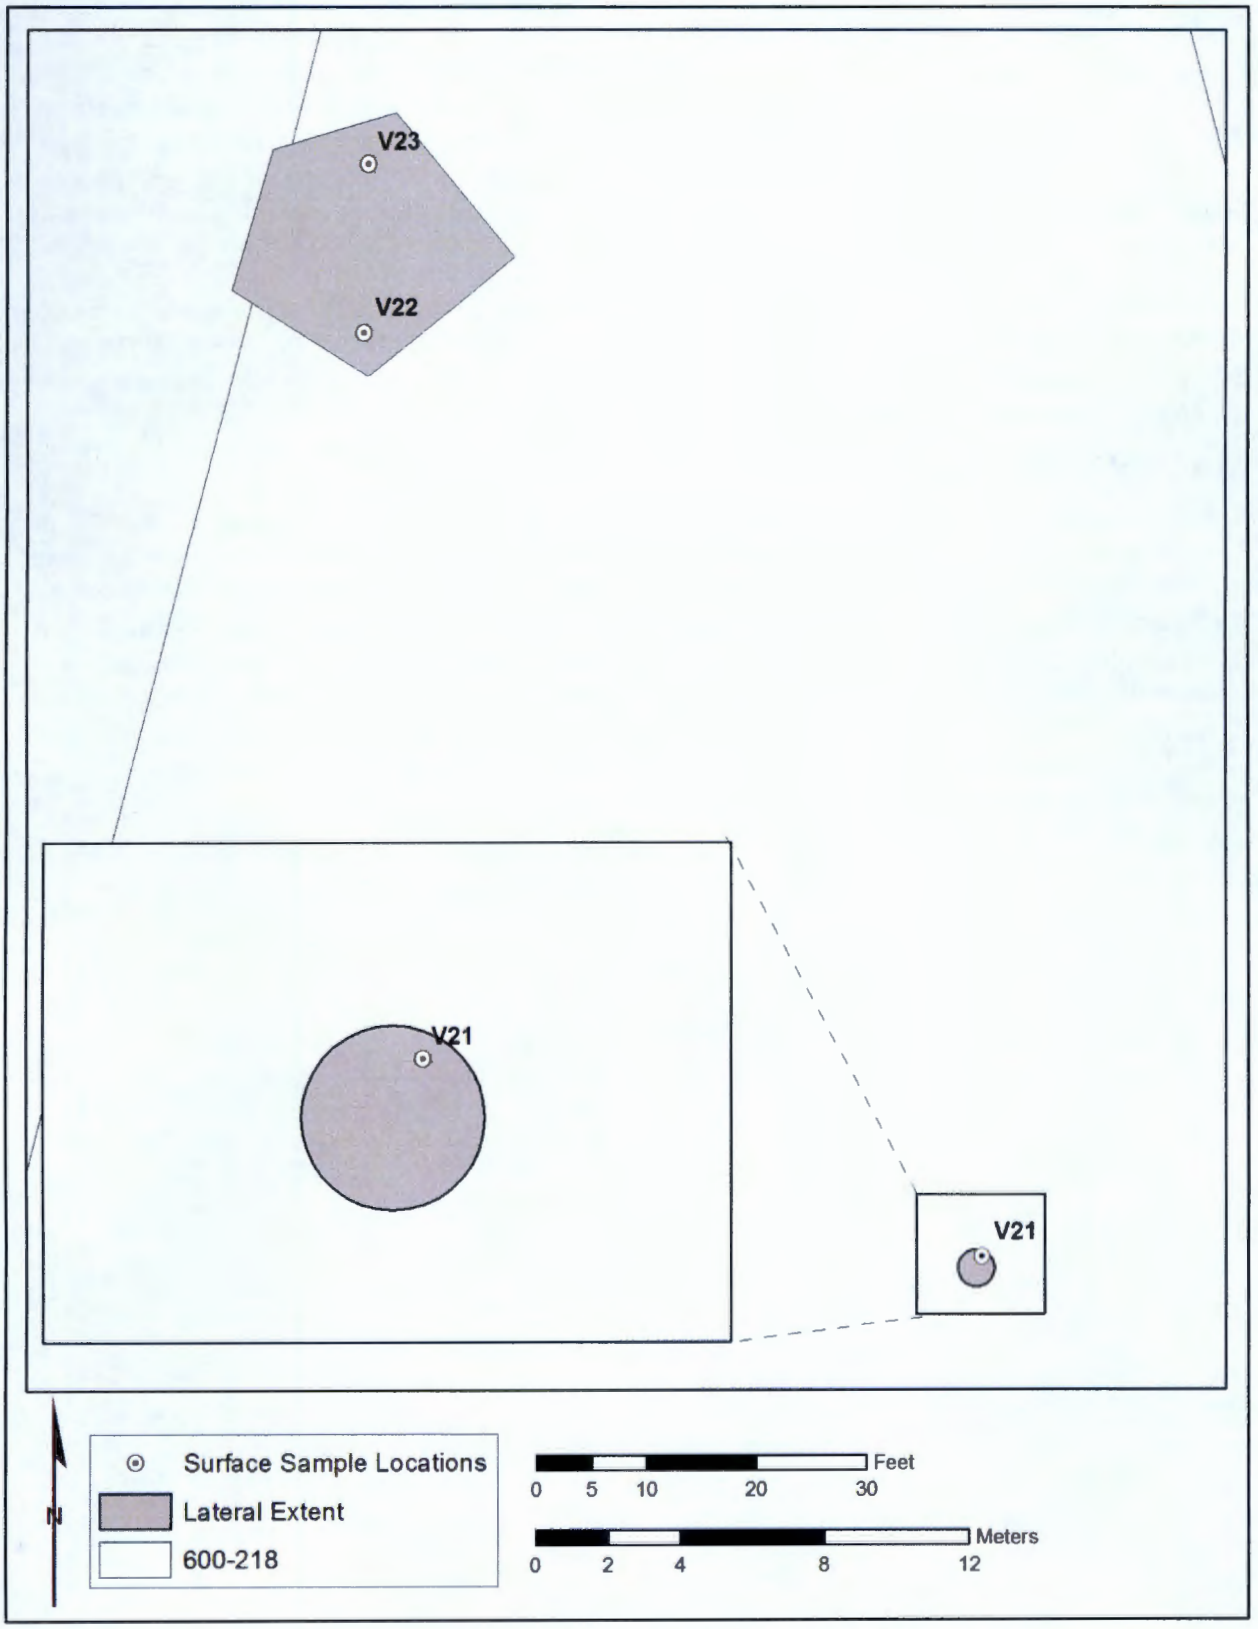
Figure 3-2. Verification Sample Locations at the 600-218 Waste Site

The area of impact at sample location R14 was approximately 0.8 m^2 (8.5 ft^2) as determined by analytical results of in process samples indicating COPC concentrations less than established RALs; therefore, one random sample was collected from the base of the impacted area surrounding sample location R14 (Figure 3-2). Implementation of Revision 1 of the SAP allowed for the refinement of the list of COPCs targeted during verification sampling to include metals analysis only. Manganese, mercury, and hexavalent chromium were excluded from analysis because they are not considered COPCs for the 600-218 waste site, and because analytical results from confirmatory and in process sampling confirmed concentrations were less than the respective RALs for those analytes.
