Re: ERDF Cells 3 and 4 at the Department of Energy Hanford Site Construction Quality Assurance Audit

**Final EPA ERDF Phase II CQC/CQA Audit
Geomembrane Seam Destructives**

July 23, 1999

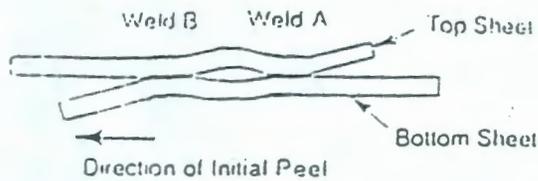
**Schematic of
Untested Specimen**

Types of Break	Locus-of-Break Code	Break Description	Classification ^a
	AD	Adhesion failure.	Non-FTB
	BRK	Break in sheeting. Break can be in either top or bottom sheet.	FTB
	SE1	Break at outer edge of seam. Break can be in either top or bottom sheet.	FTB
	SE2	Break at inner edge of seam through both sheets.	FTB
	AD-BRK	Break in first seam after some adhesion failure. Break can be in either the top or bottom sheet.	FTB

^a FTB = Film - Tear Bond
