116-B-5

DOE/RL-96-017

Clean Up Verification Package for the 116-B-5 Crib

December 1996

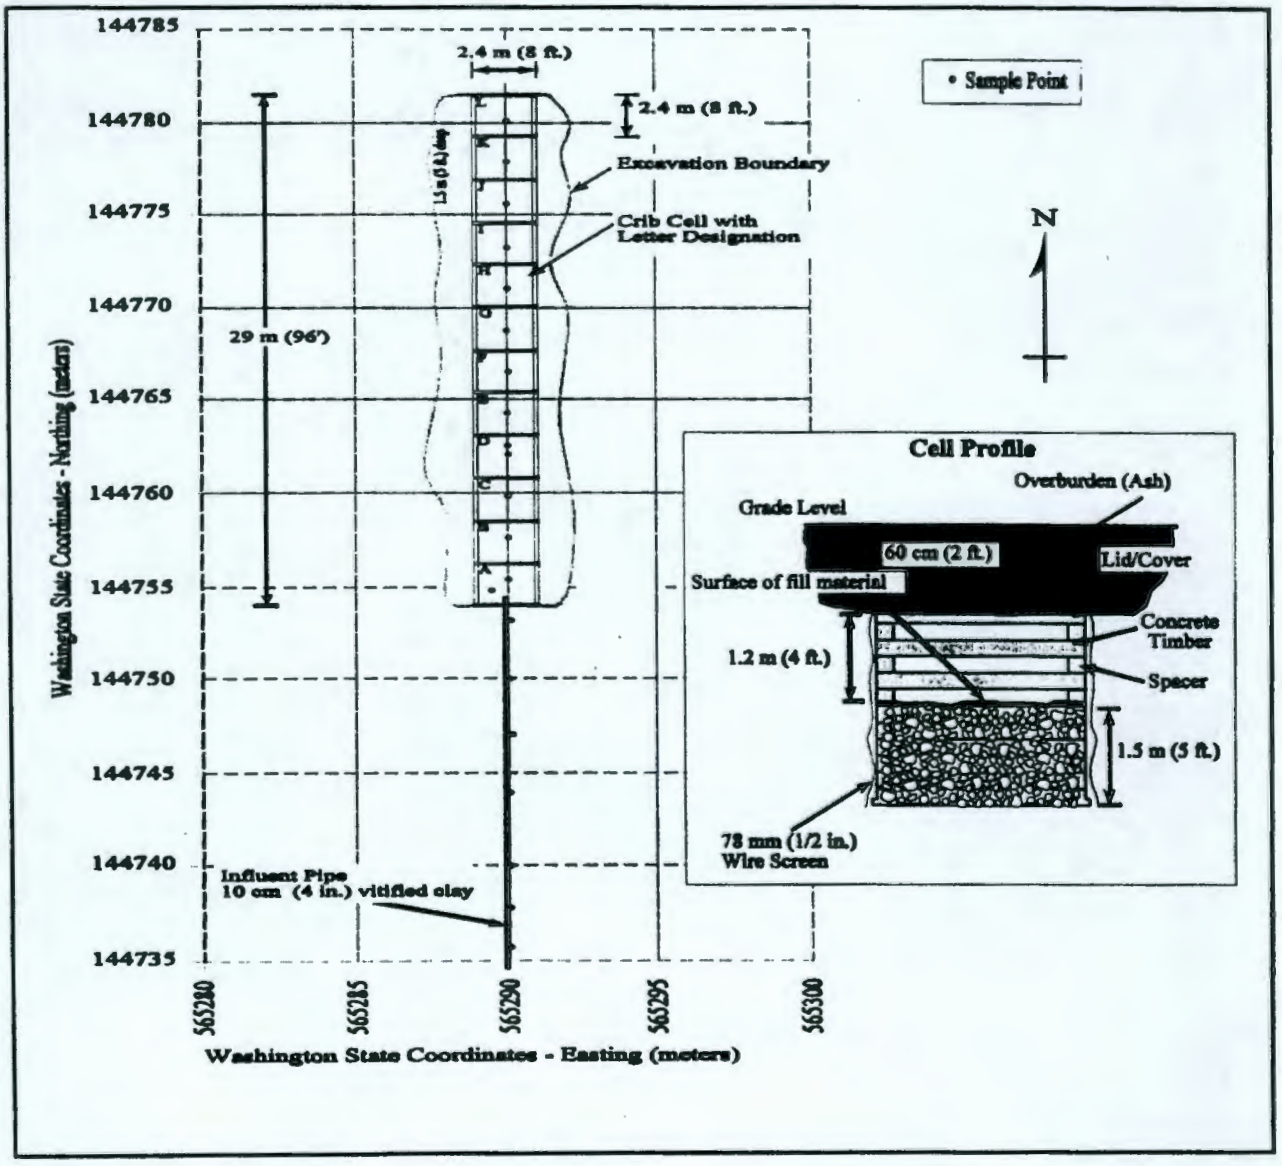
Figure 1. 116-B-5 Crib Profile and Plan View.

The 116-B-5 Crib received wastes generated from the 108-B Building P-10 Project. This project performed tritium (H-3) separations to derive product for the U.S. Nuclear Weapons Program. The crib was located at Washington State Plane coordinates E565288, N144768. The crib consisted of 12 rectangular cells approximately 2.4 m x 2.4 m and 2.7 m deep. The crib was constructed of concrete members supporting a concrete roof. The crib had no structural bottom and was filled with sandy gravel and ash approximately 1.5 m thick. A single clay inlet pipe was encountered. Figure 1 shows the construction of the crib.

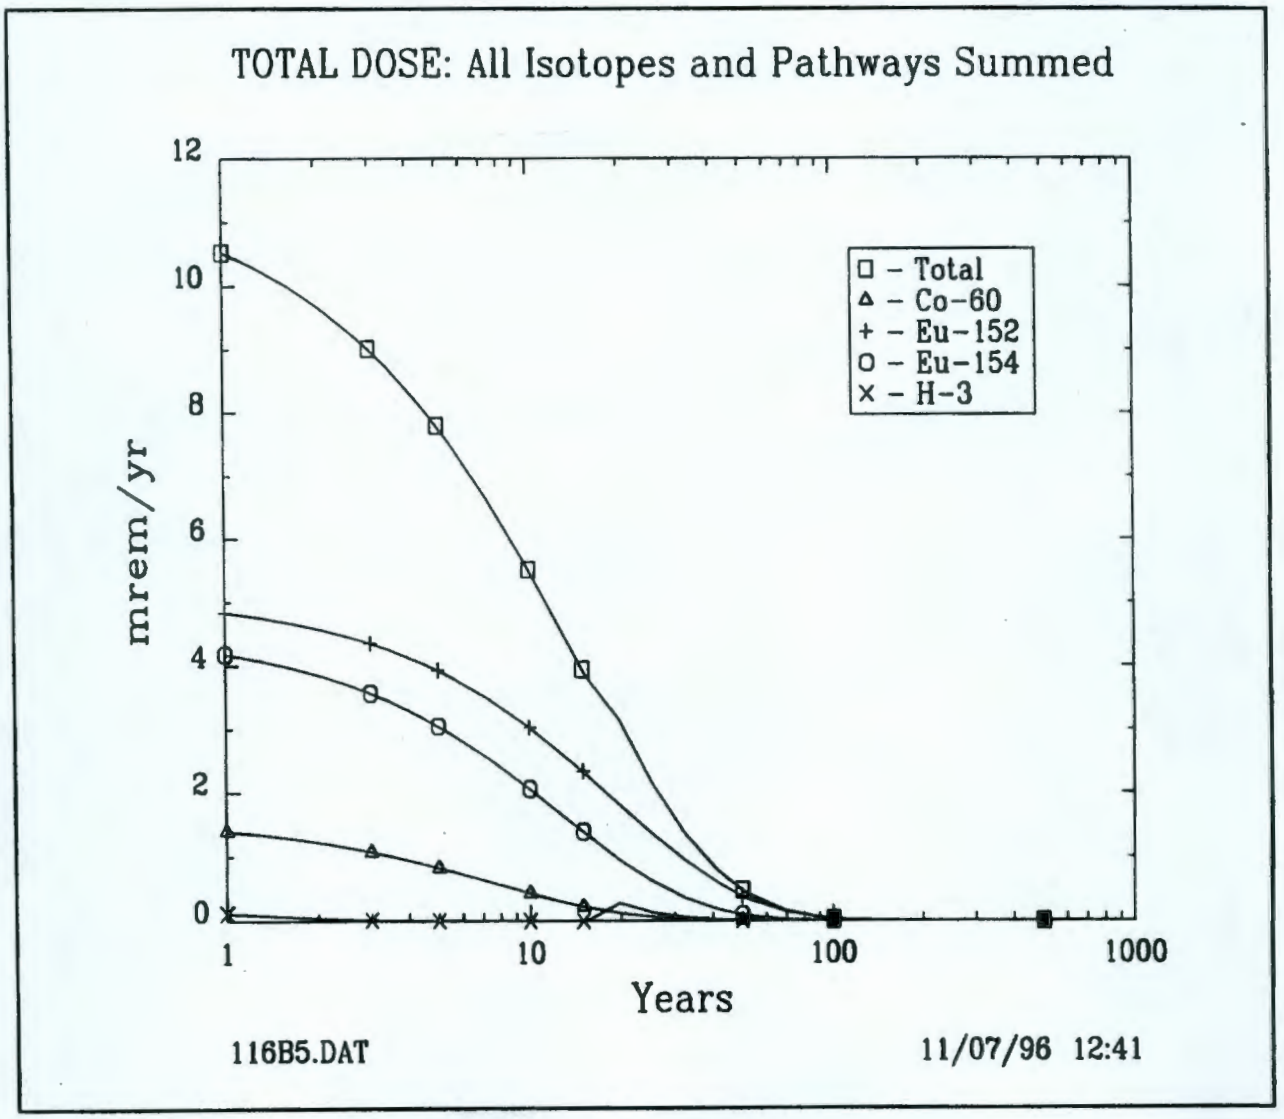
Figure 2. RESRAD Results

Figure 2 illustrates the RESRAD results for the rural residential exposure scenario; as shown, the total estimated dose associated with radionuclide concentrations peaks at about 10.5 mrem/yr above background, and therefore meets the RAG for radionuclide soil cleanup standard.

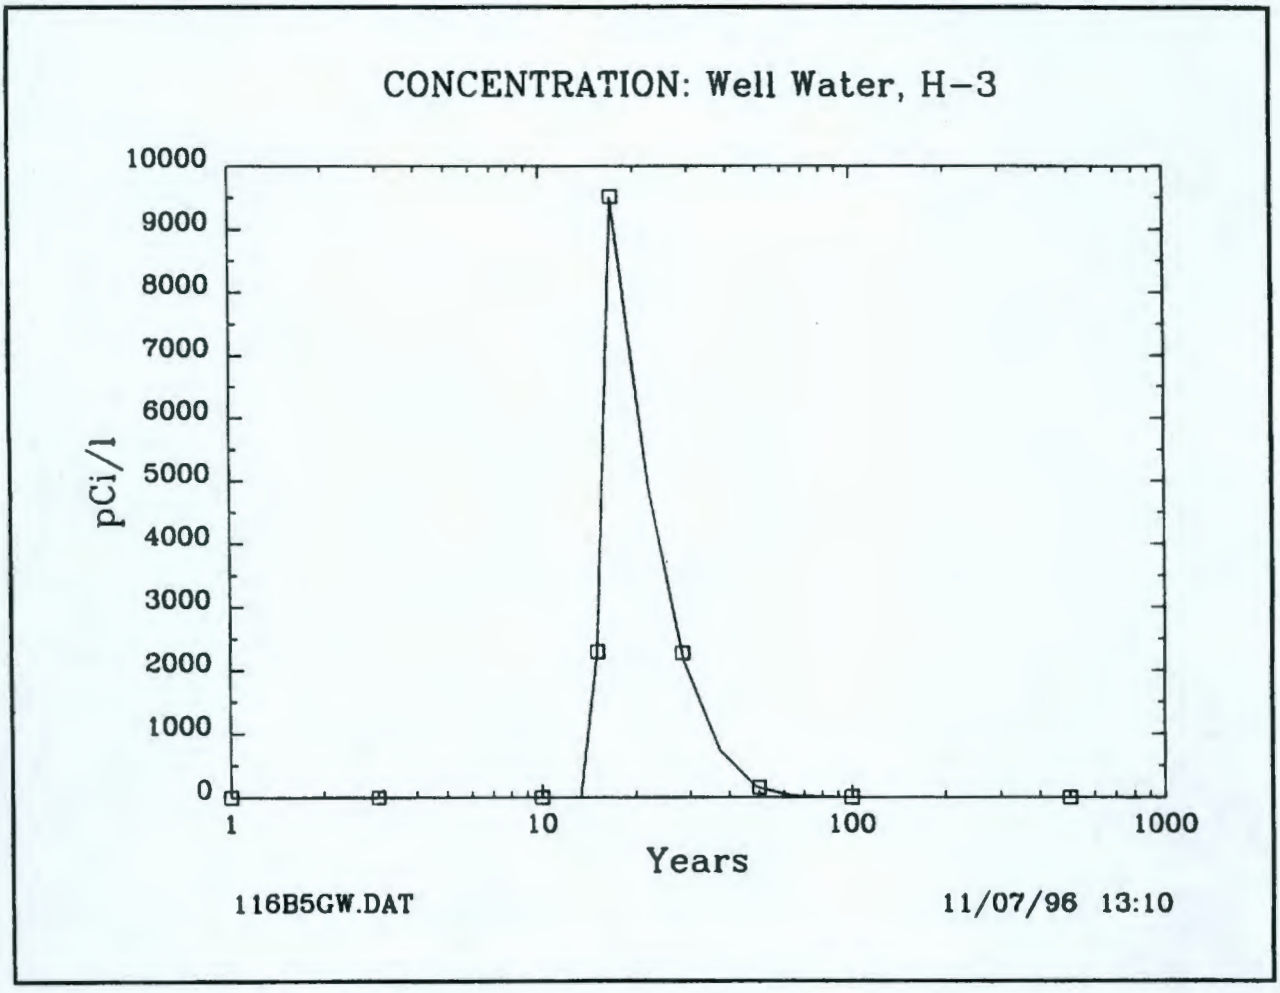
Figure 3. Tritium Concentrations in Groundwater

The RESRAD model predicts that only tritium may be transported to groundwater. It should be noted that tritium is currently present in the groundwater. Wells 199-B4-1, 199-B4-2, and 199-B4-3 surround the 116-B-5 Crib and have been monitoring the presence of tritium at approximately 3,500 pCi/L. The model predicts (Figure 3) the potential for a sharp spike in concentration in groundwater between years 15 and 30 following backfilling and the introduction of irrigation included in the rural residential scenario. The maximum concentrations of 9,500 pCi/L is predicted at year 18 and is much less than the RAG of 20,000 pCi/L. Therefore, the RAG for tritium has been met. The model shows no other radionuclides will reach groundwater within a 1,000-year period.
