RL-SA-15

G. E. Backman
Chemical Processing Department
General Electric Company
Richland, Washington

June 3, 1965

RADIATION CONTROL OF ACCIDENTALLY CONTAMINATED SEEPAGE PONDS

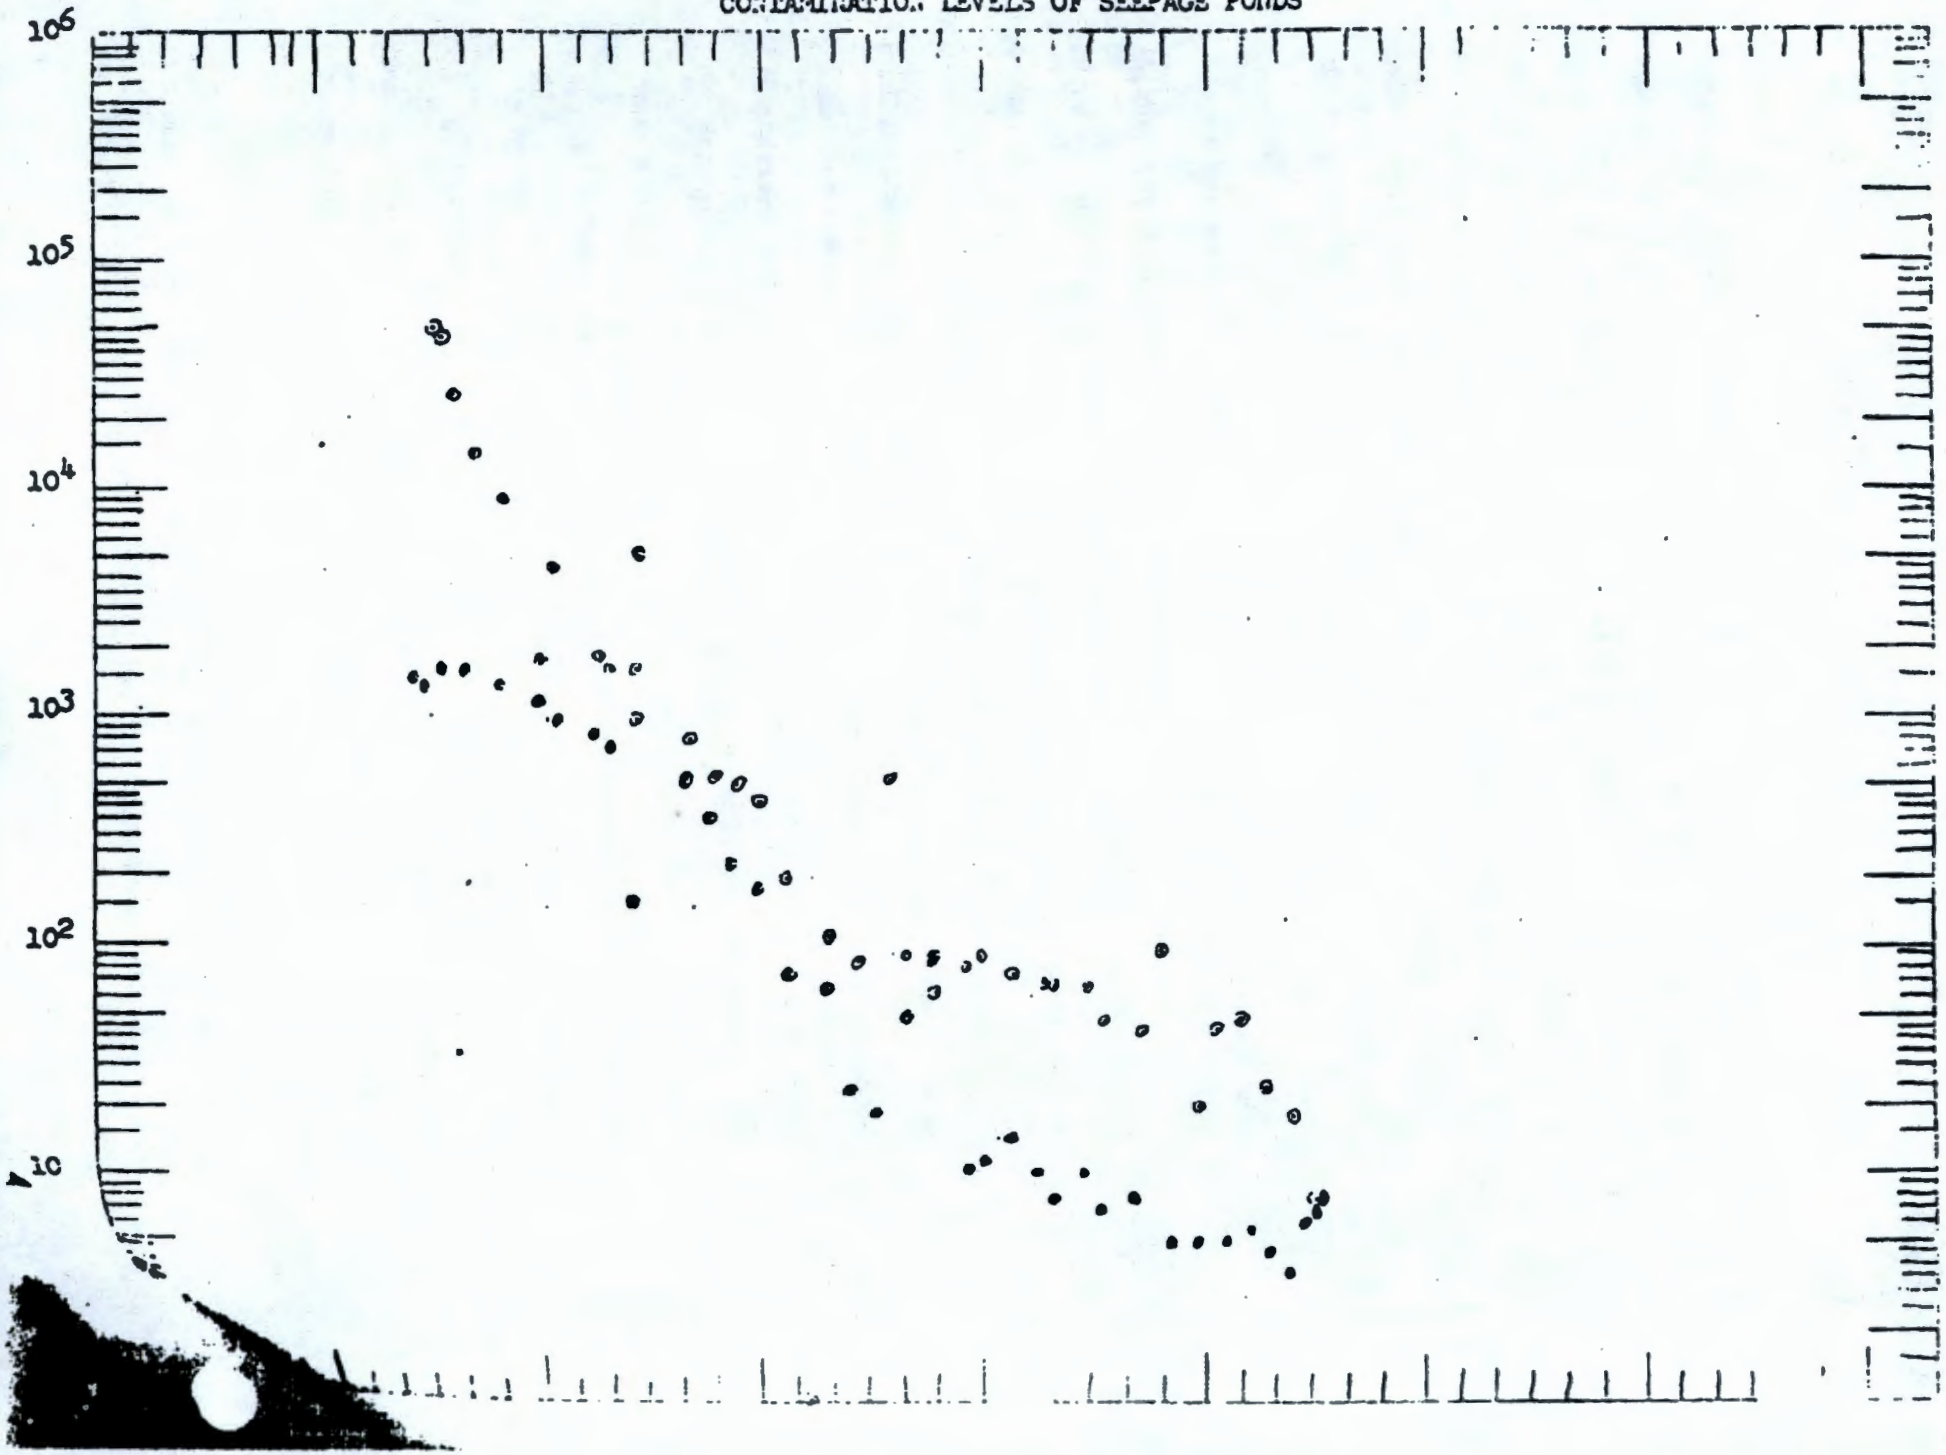
CONTAMINATION LEVELS OF SEEPAGE PONDS

As mentioned previously, the Task Force determined that it would be desirable to maintain the pond liquid levels to that that existed at the time of the incident, until the contamination level of the water dropped to less than 10^{-4} μCi/cc. Table V and Figure 1 show the rate of contamination reduction.

Most of the contamination that reached the open ponds was actually removed by adsorption on the bottom sediments of the ponds. Some reduction also occurred through radioactive decay. After the level fell below 10^{-4} μCi/cc, it was the intent to raise the liquid level several inches anticipating that the contamination, which was practically all adsorbed on the mud, would then be inaccessible to the water fowl. In addition, the radiation levels around the ponds would be significantly reduced because of the additional water shielding. Tests were conducted using diatomaceous earth to determine how much of this material would have to be added to reduce the percolation rate of the water through the soil to the point that the liquid level would raise on the order of one foot. These studies indicated that approximately forty tons, evenly dispersed over the pond area, should effectively plug the bottom of the pond and cause the water to rise. Application of the diatomaceous earth in a satisfactory manner turned out to be a most difficult problem and after adding some six and a half tons nonuniformly through various methods, with no significant rise in the liquid level, other methods were sought. The use of airplanes to dust the diatomaceous earth on the ponds was investigated and actually would have been employed. However, bulldozers were already employed in filling the edges around the large pond and this operation proved to be more successful than was anticipated. By the time dirt was pushed into the pond an average of twenty feet all around the perimeter, the liquid level rose rapidly and before long was well above that originally planned. Apparently most of the liquid actually percolated through the soil to the ground water at the edges of the ponds.

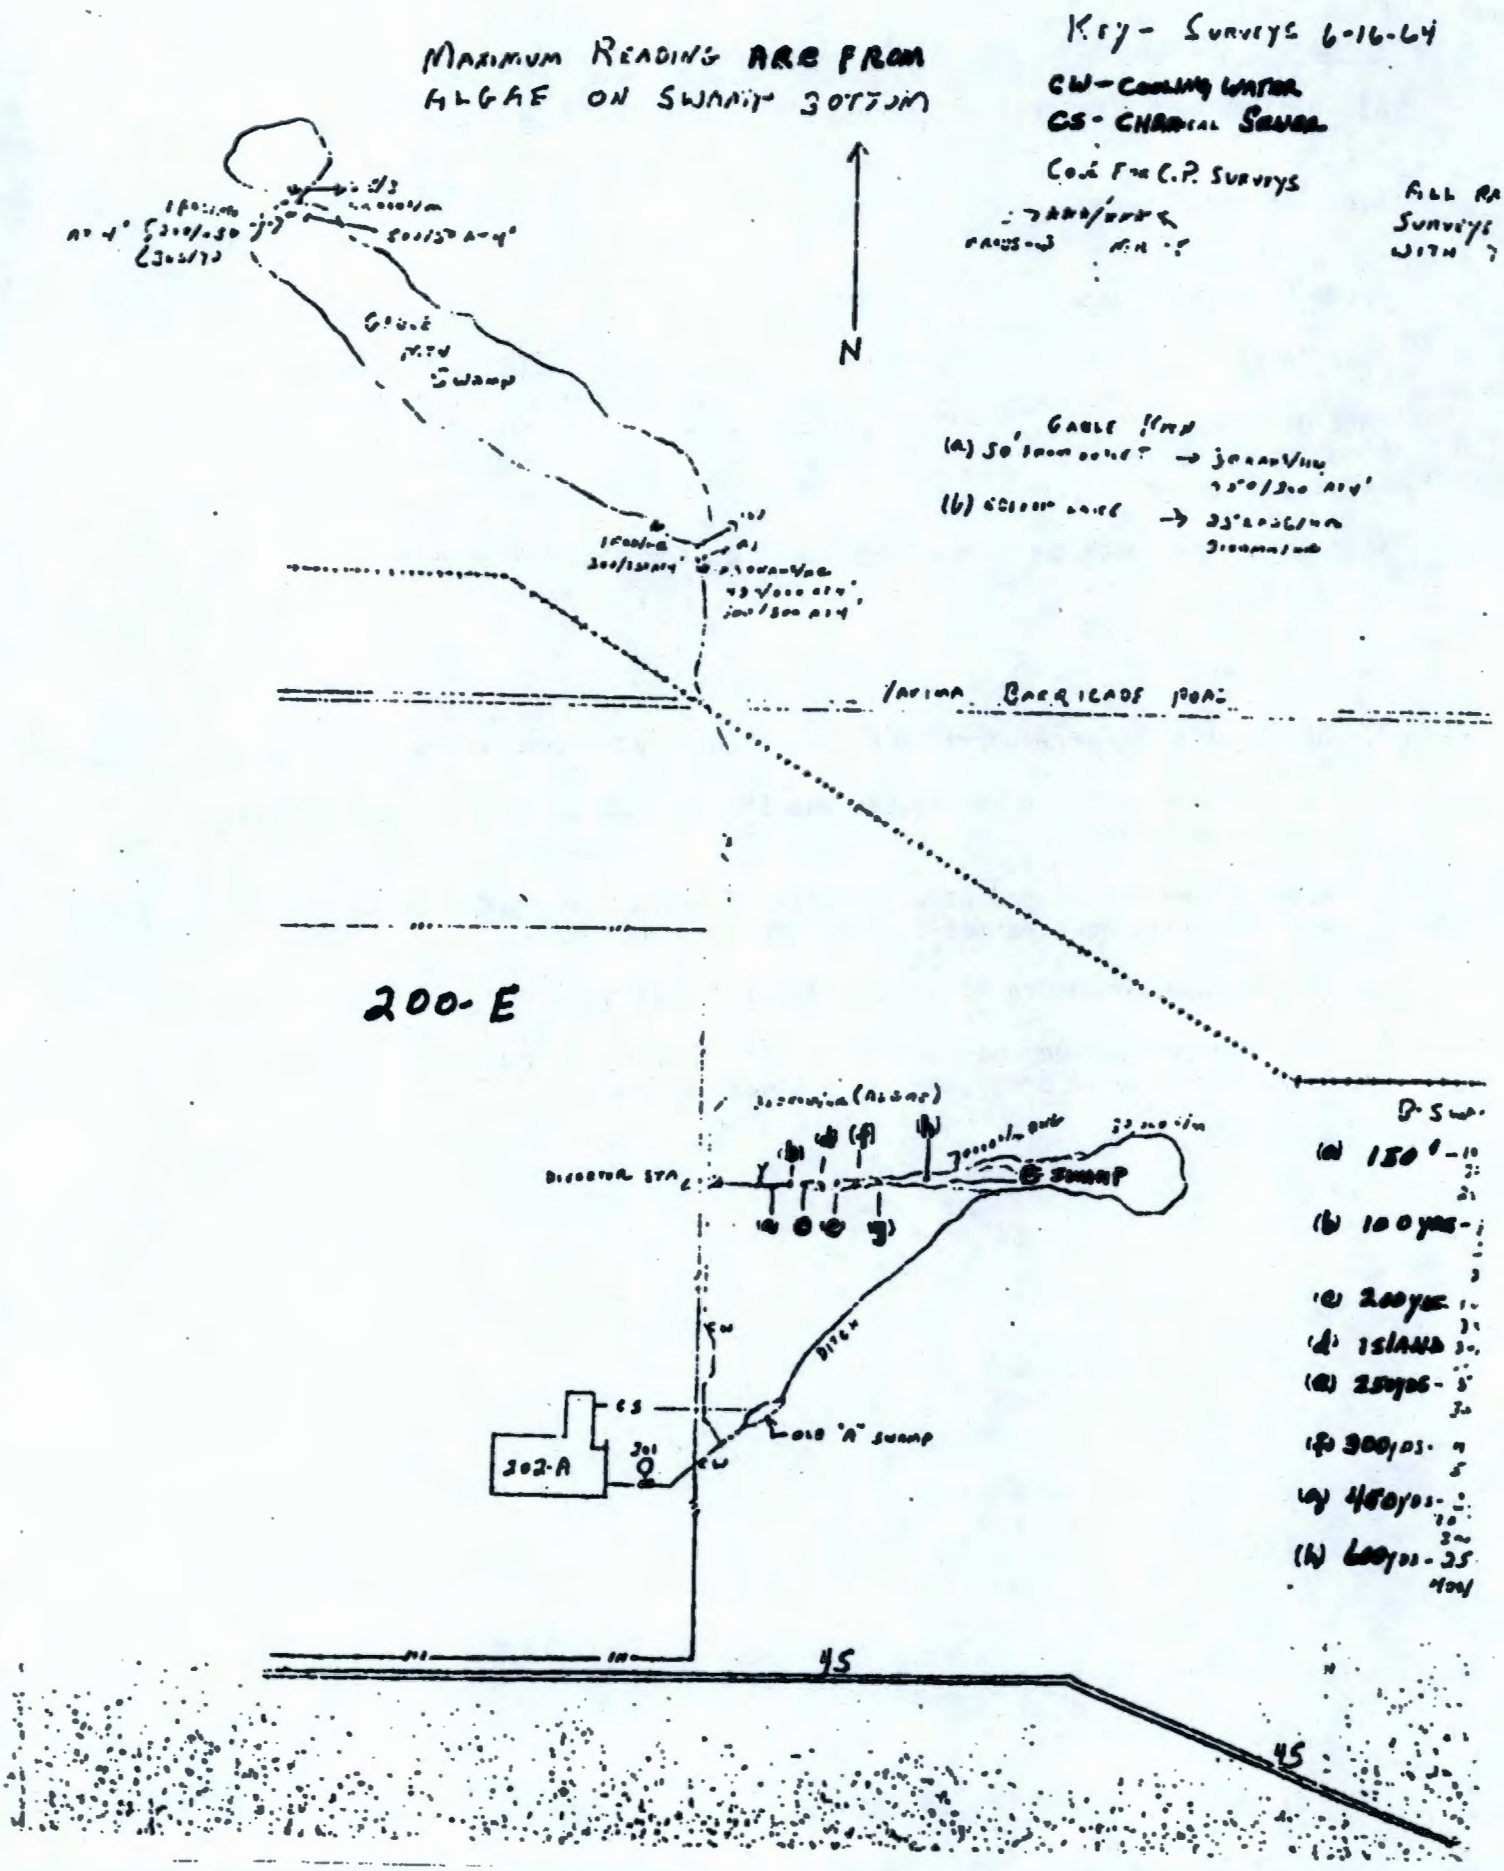
Station surveys made on 6-16-64 are shown on the attached drawing.

MAXIMUM READING ARE FROM ALGAE ON SWAMP BOTTOM
KEY - SURVEYS 6-16-64
CW - COOLING WATER
CS - CHEMICAL SEWER
N
GABLE MTN SWAMP
YAKIMA BARRICADE ROAD
200-E
DIRECTOR STA
SWAMP
DITCH
OLD "A" SWAMP
202-A
CS
CW
45
45
