2. Title	3. Number	4. Rev No.
Expedited Response Action Proposal for Sodium Dichromate Barrel Landfill	WHC-SD-EN-AP-112	0

The document contains the Expedited Response Action Proposal for the Sodium Dichromate Landfill. The Proposal describes the site characterization activities, sample results, screens alternatives, and recommends a preferred alternative to close out the ERA action.

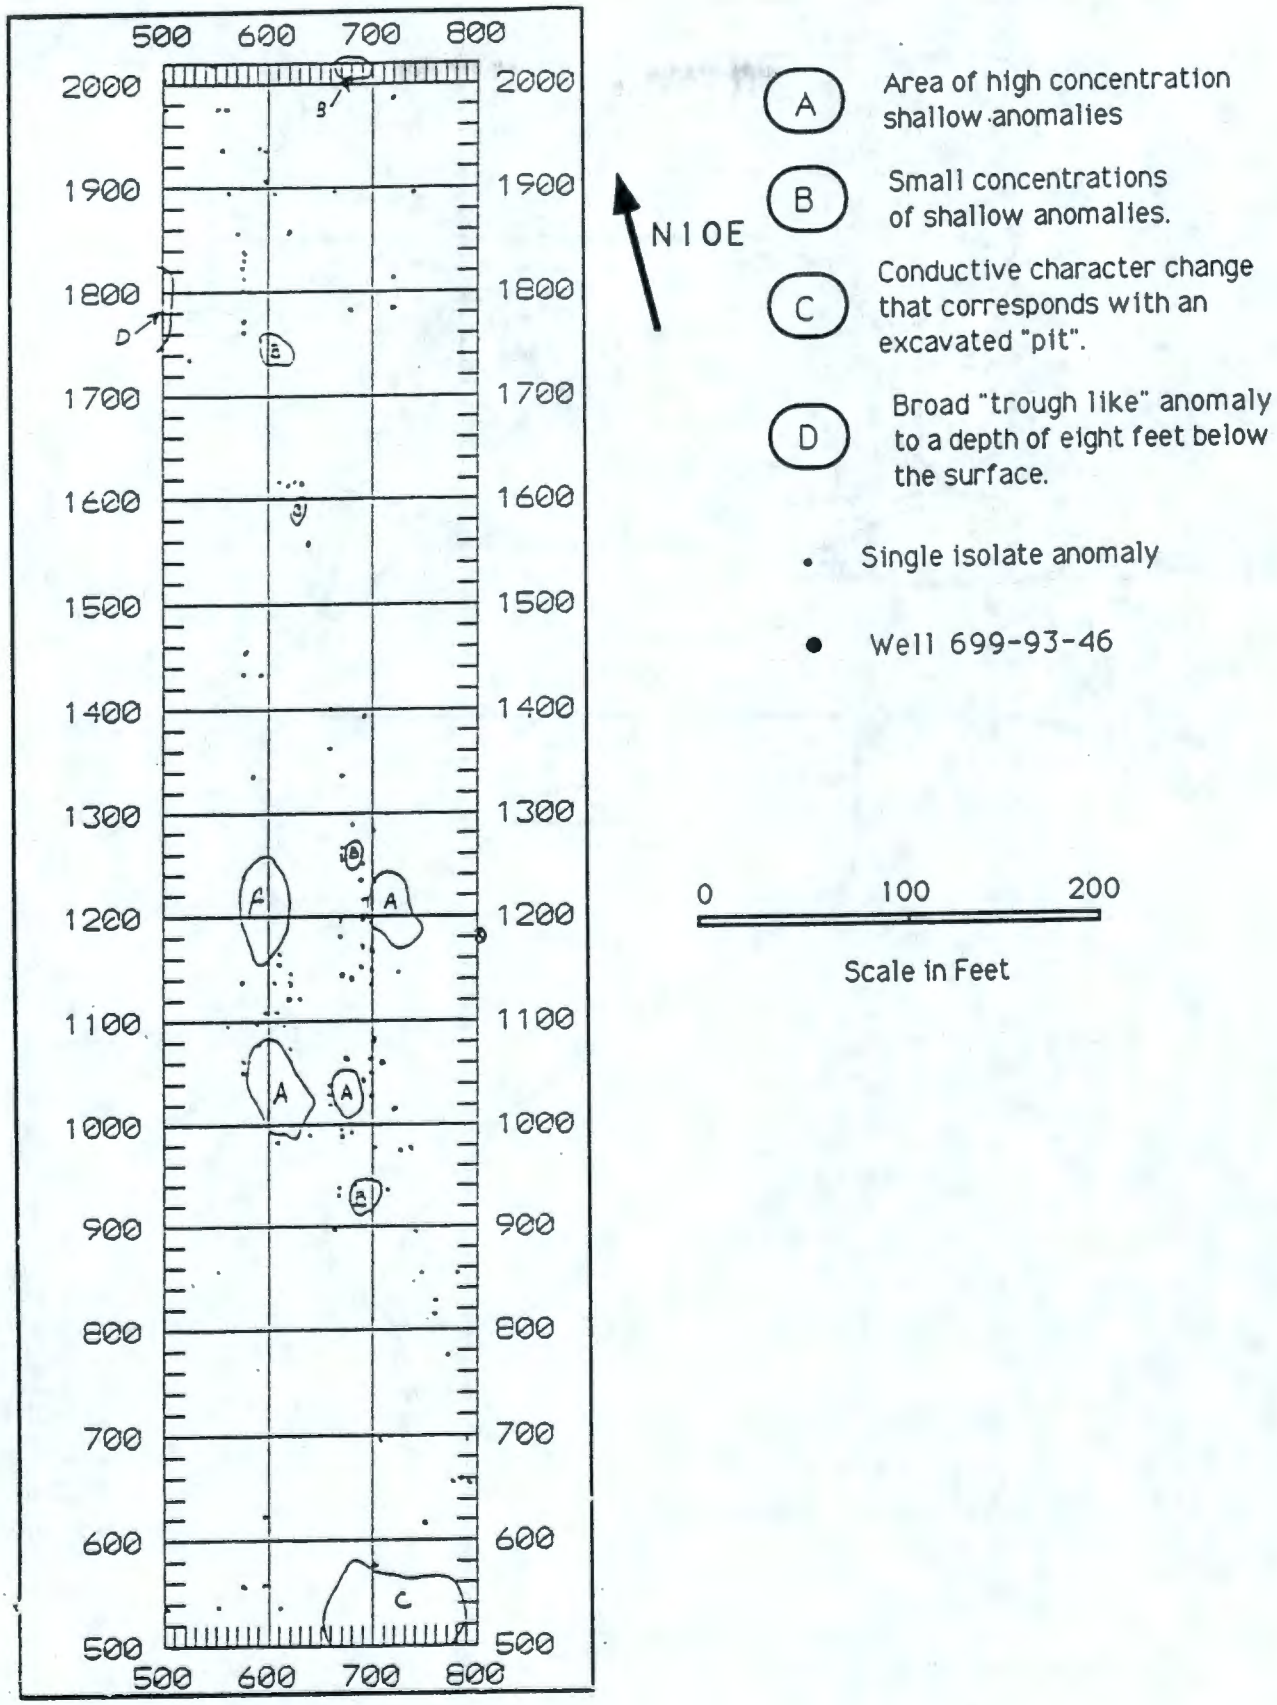
Figure 5. Phase I Ground-Penetrating Radar Interpretation.

The original geophysical survey (Figures 5 and 6) identified many subsurface anomalous zones. The survey identified the need to remove the surface debris (about 41 barrels and homestead objects) which interfered with the survey (Figure 7 and 8) and resurvey. Field screening and offsite laboratory analysis sample collection occurred during surface debris cleanup.
