DOE/RL-93-25
Revision 0

Sodium Dichromate Barrel Landfill Expedited Response Action Proposal

Date Published
September 1993

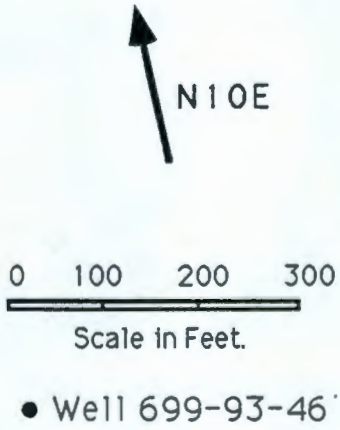
Figure 6. Phase I Electromagnetic Contour Map.

Four additional areas were identified in the site's northern portion (Figure 6). Three appear to be from shallow metallic debris and the other is a buried "trough-like" feature. These four areas are probably from past farming activities.

The EMI component displayed on this contour map is the subsurface electrical conductivity expressed in millimhos. The regional conductivity of the area is in the range of 5–10 millimhos per meter. These values are a function of the natural environment; primarily the sediment type and moisture type. Several anomalous zones outside the 5–10 millimho conductivity range are found between N980 and N1260. In many cases, these zones do not coincide with surface metal debris.

The anomalous zones are complicated and do not reveal a simple geometry. The tight contour lines signal an abrupt change in sub-surface conductivity. The depth of these conductivity anomalies is unknown. The anomalies may be due to buried metallic debris.

Some non-regional anomalies coincide with surface metal debris, but there are four large anomalies with no marked surface debris.
