PFP Security Buildings Demolition Report

As Left Characterization

Document Type: RPT Program/Project: PFP Closure

R. Bloom CH2M HILL Plateau Remediation Company

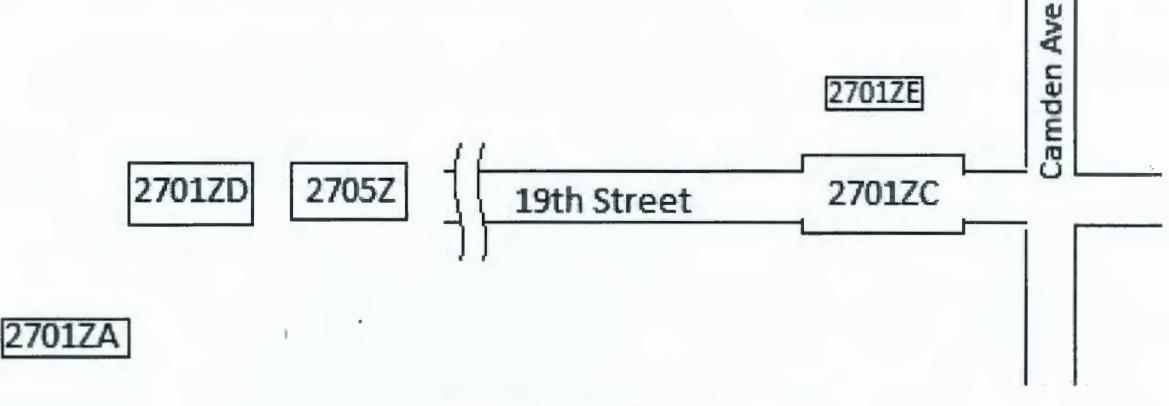
Figure 1. PFP Access Control

The buildings were located east of the PFP outer fence and provided access control to the PFP protected areas (Figure 1). Buildings 2701ZA, 2701ZD, and 2705Z were all constructed onsite using concrete cinderblocks. Building 2701ZE was a small prefabricated structure, and 2701ZC was built onsite with metal framework and enclosed using a weatherproof tarp. Demolition of the buildings was initiated in August 2010 and completed in September 2010.

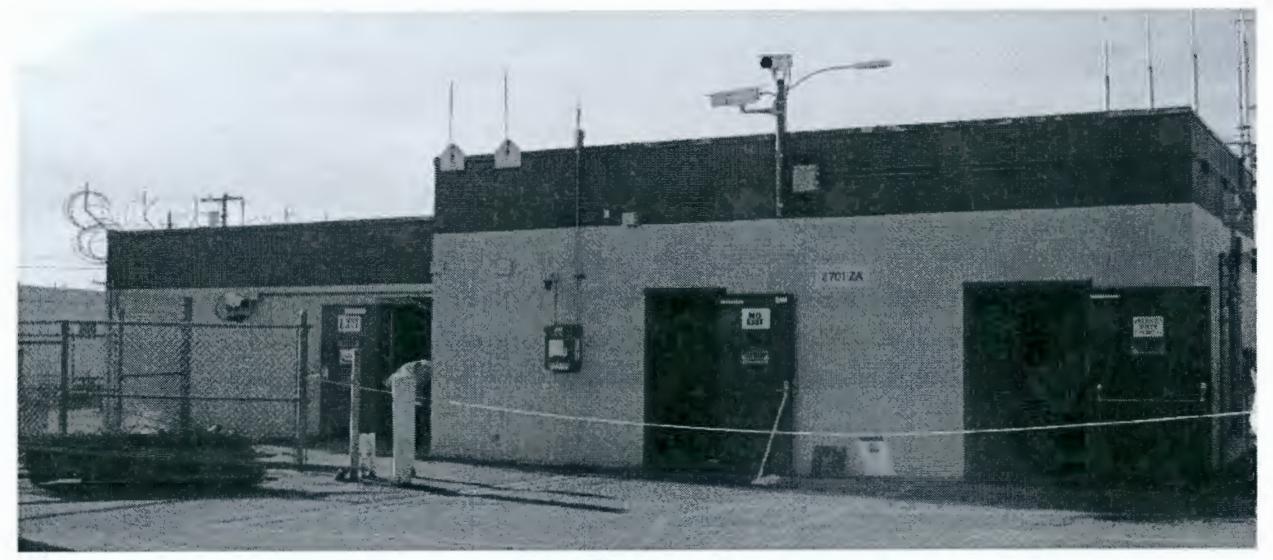
Figure 2. 2701ZA Building Before Demolition

The 2701ZA Building (Figure 2), constructed in 1977, was approximately 1,300 ft². The building was located outside the PFP fenced area at longitude/latitude 119.63123/46.55144. The building was

constructed using concrete blocks for the walls, steel for the door and frames, and vinyl for the flooring. The 2107ZA Building was used by the security force as a central alarm monitoring station.

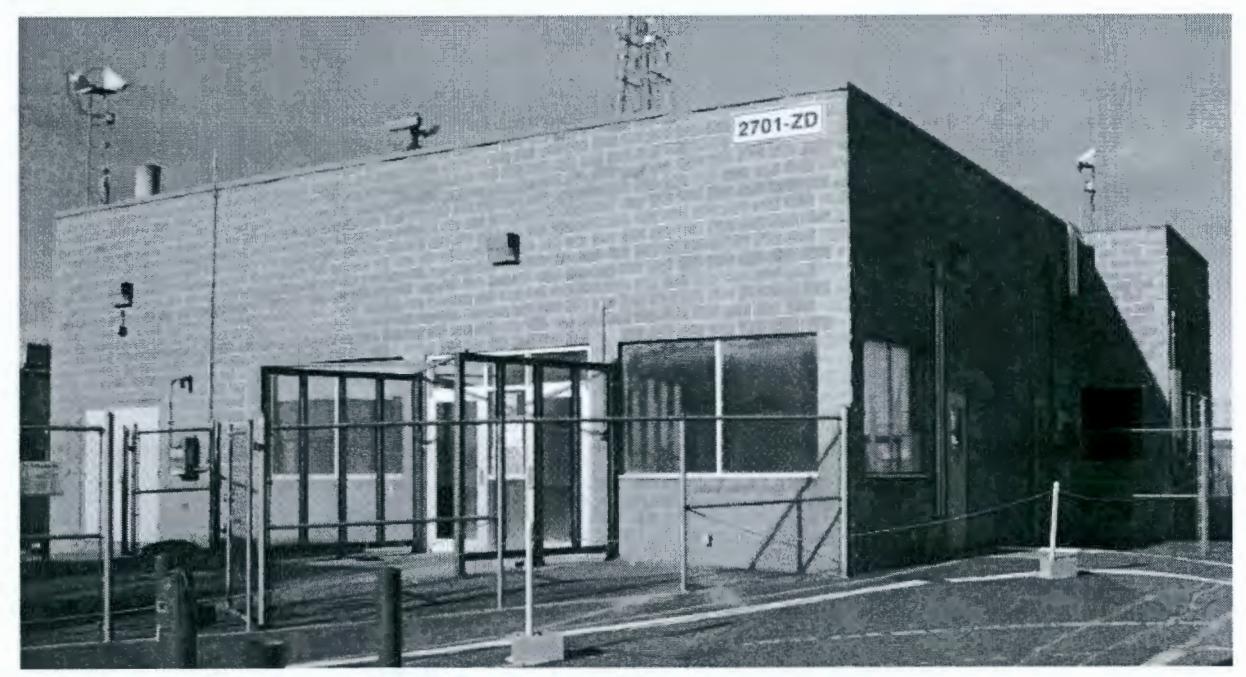
Figure 3. 2701ZD Building Before Demolition

Building 2701ZD (Figure 3), approximately 2,480 ft², was comprised of concrete walls with reinforced steel. The building, constructed in 1991, served as the PFP badge house. The building was located outside the PFP fenced area at longitude/latitude 119.63088/46.55156.

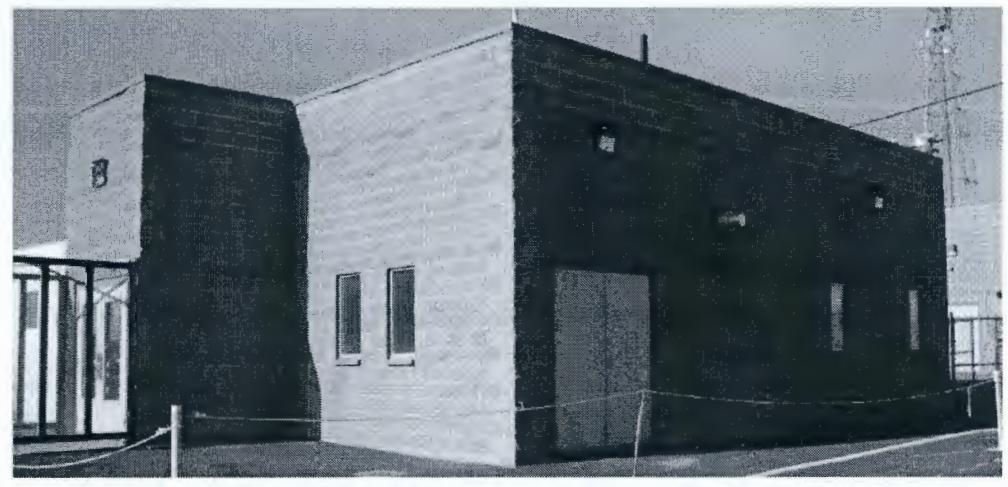
Figure 4. 2705Z Building Before Demolition

Building 2705Z (Figure 4) was approximately 1,100 ft² and constructed of steel with interior walls constructed of drywall on steel studs. The building, constructed in 1991, served as the PFP Operations Control Facility, which provided the first screening of personnel entering the PFP Complex. It also includes personnel monitors for logging in/out PFP personnel for accountability purposes required during emergencies. The building was located outside the PFP fenced area at longitude/latitude 119.63054/46.55152.

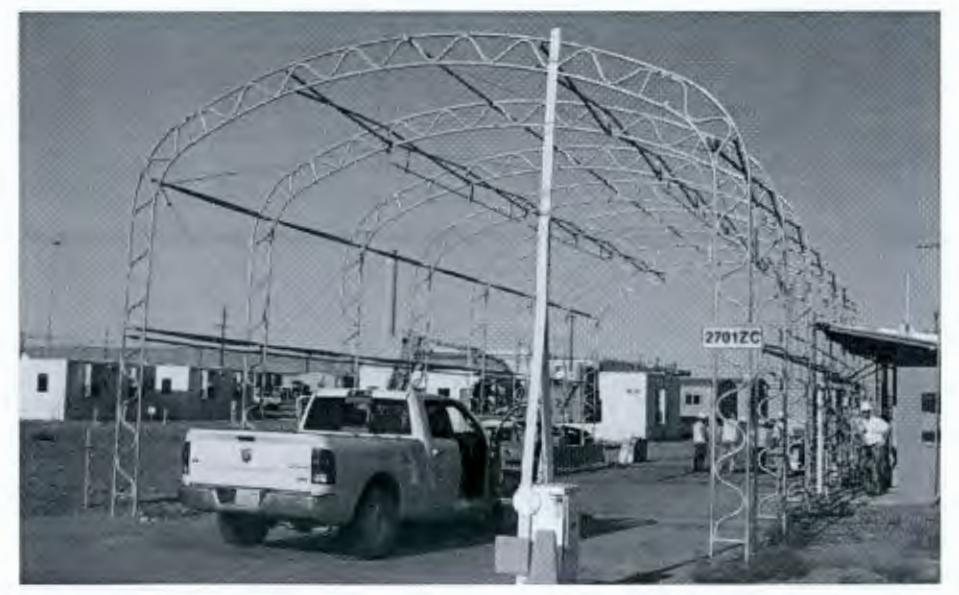
Figure 5. 2701ZC Building Before Demolition

Building 2701ZC (Figure 5) was a large weather cover located next to Building 2701ZE and was used at the vehicle inspection portal to PFP. The building was located outside the PFP fenced area at longitude/latitude 119.62811/46.55156. The cover provided shelter for vehicles being inspected prior to PFP entry. Building 2701ZC was constructed of steel tubing formed to hold a canvas weather cover material. The structure, built in 2007, was anchored to the ground to stabilize it in the wind.

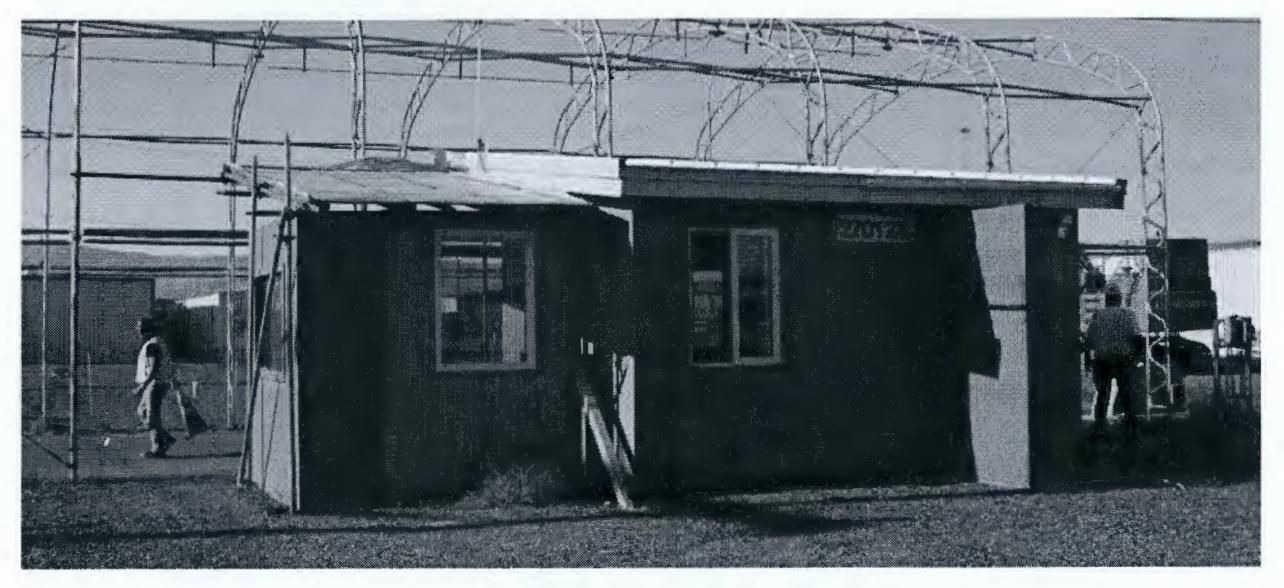
Figure 6. 2701ZE Building Before Demolition

Building 2701ZE (Figure 6) was a small wooden structure with an asphalt roof. The building was located outside the PFP fenced area at longitude/latitude 119.62815/46.55163. It was used by patrol personnel as a station for the vehicle preinspection building and was the control facility for the vehicle barrier located adjacent to the building. Building 2701ZE, constructed in 2007, was less than 100 ft².

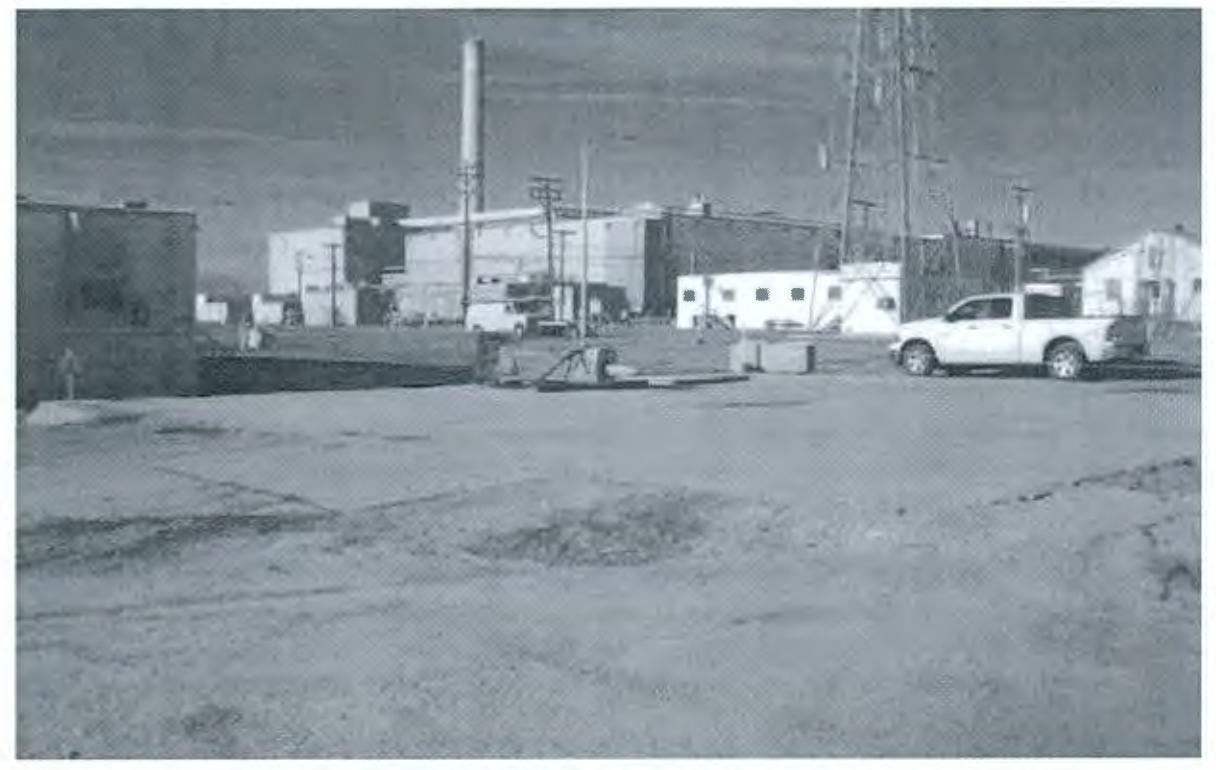
Figure 7. 2701ZA Building After Demolition

The building was left in a clean slab-on-grade condition with all penetrations sealed (Figure 7).

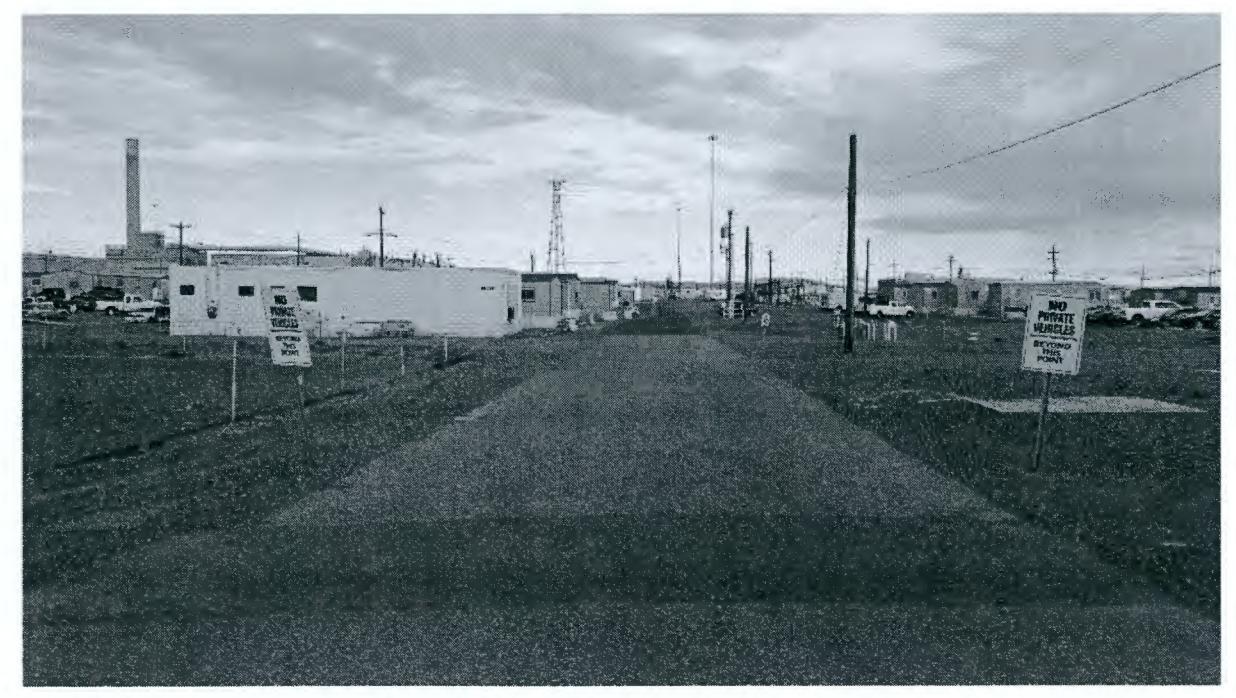
Figure 8. 2701ZC Building After Demolition

The vehicle shelter frame over the roadway on 19th Avenue was removed (Figure 8).

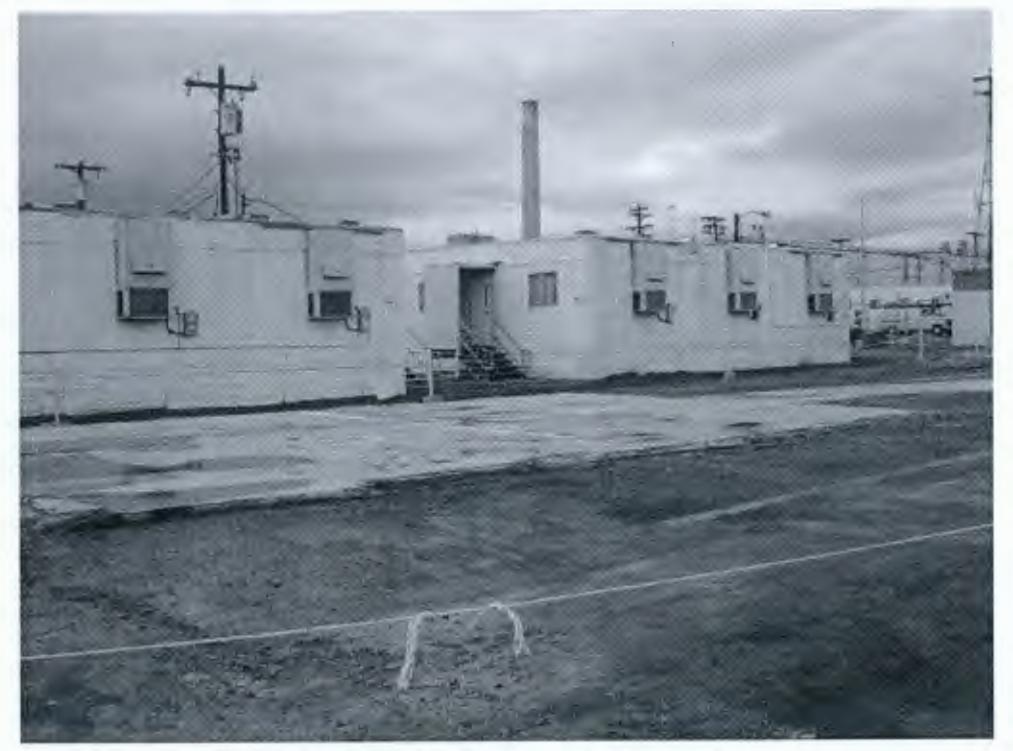
Figure 9. 2701ZD Building After Demolition

The building was left in a clean slab-on-grade condition with all penetrations sealed (Figure 9).

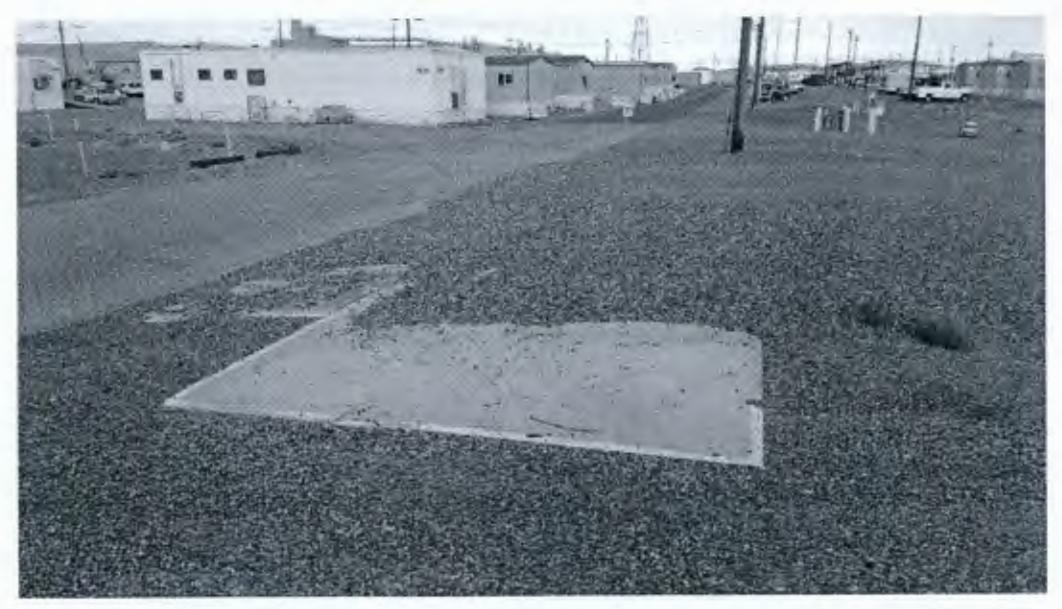
Figure 10. 2701ZE Building After Demolition

The building was left in a clean slab-on-grade condition with all penetrations sealed (Figure 10).

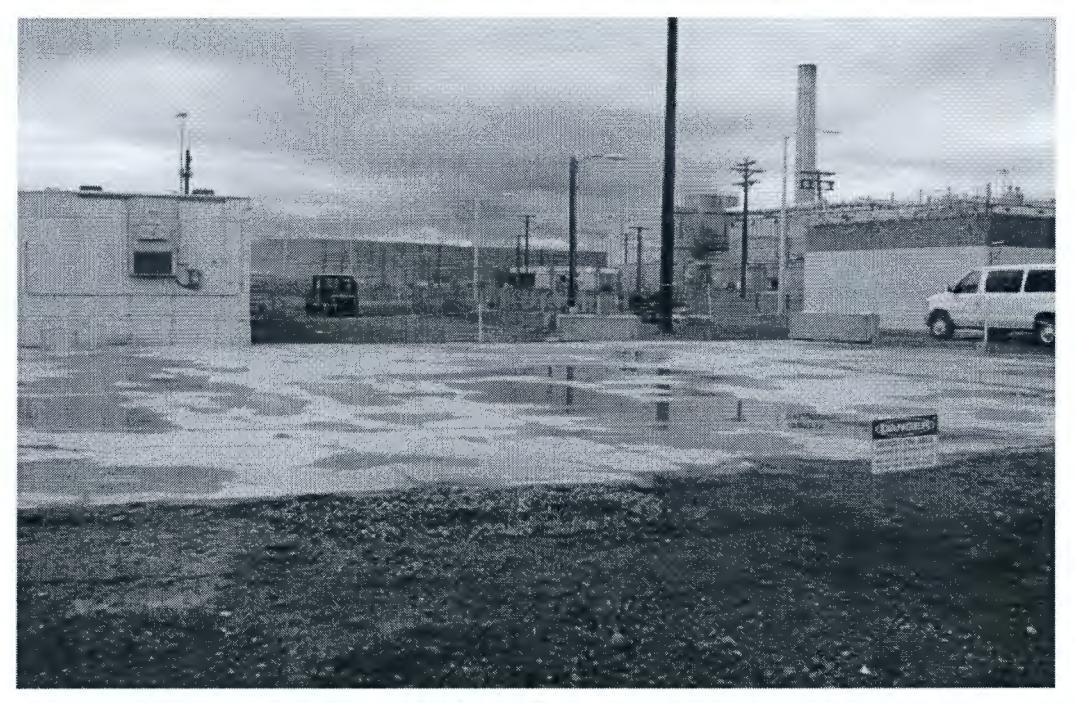
Figure 11. 2705Z Building After Demolition

The building was in a clean slab-on-grade condition with all penetrations sealed (Figure 11).

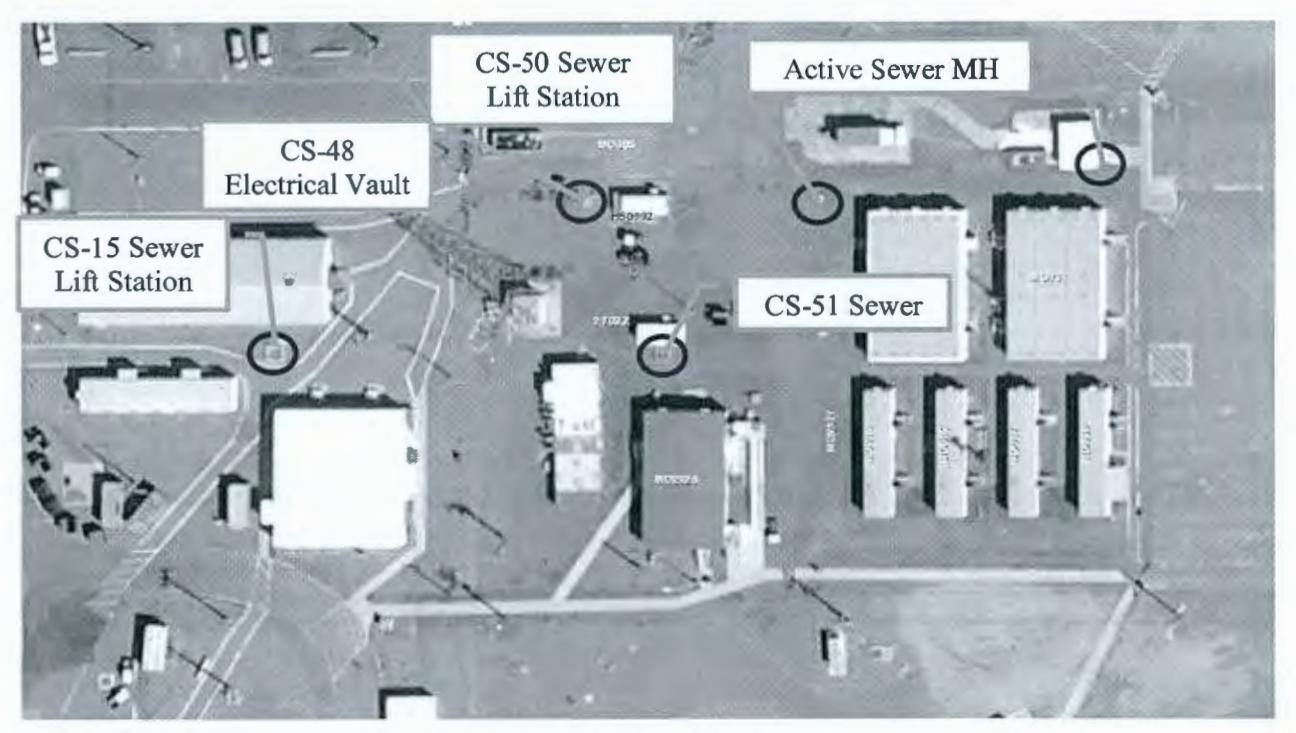
Figure 12. Sewer Manholes

No industrial hazards have been identified. No confined spaces were assigned to the building, but five confined spaces are associated with the electrical and sewer line for the facilities: one active manhole adjacent to the 2905Z slab, and four inactive confined spaces (CS-15, CS-48, CS-50 and C-51) (Figure 12).

Admin-5	Document compliance with confined space program.	This endpoint compiles the individual endpoints into one report reflecting the remaining confined spaces.	Four sewer manholes and an electrical vault need to be addressed (see Section 4.4)
Admin-6	Document compliance with the asbestos program.	The post-demolition condition of the PFP Complex will be assessed for compliance with the site asbestos program.	See Section 4.3
Admin-7	Document amount and location of remaining hazardous substances and/or dangerous wastes.	This endpoint compiles the individual endpoints into one report reflecting the remaining hazardous substances/dangerous wastes.	See Section 4.3
Admin-8	Complete and provide current FHA.	An FHA will be completed reflecting the endpoint condition of the PFP Complex.	Not applicable ^b
Admin-9	Transfer facility physical property records.	The property records for the PFP Complex will be updated as the transition and dismantlement effort removes excess and or disposes of property.	The demolition status of the structures were documented via a Facility Status Change Form
