**TRANSMITTAL OF APPROVED WASTE SITE RECLASSIFICATION FORM AND
SUPPORTING DOCUMENTATION FOR THE 100-K-93, DRUM REMNANT WASTE SITE,
REVISION 0**

100-K-93, DRUM REMNANT WASTE SITE

Attachment to Waste Site Reclassification Form 2013-063

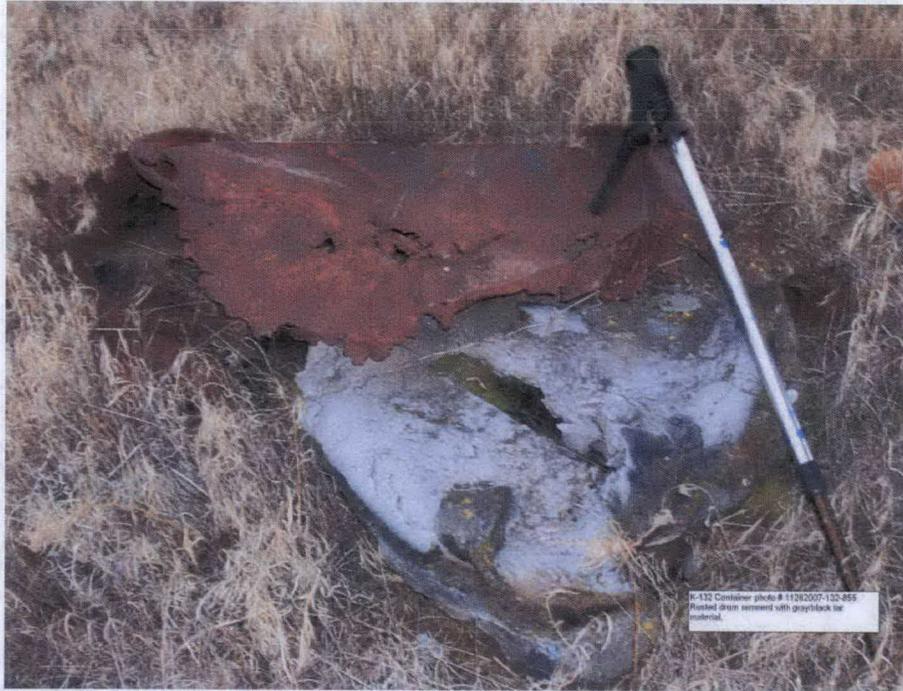
Figure 2. 100-K-93 Waste Site Before Remediation.

The 100-K-93, Drum Remnant waste site, part of the 100-KR-1 Operable Unit, consisted of a 208-L (55-gal) drum remnant with approximately 0.03 m³ (1 ft³) of solidified gray/black tar-like substance and the underlying soil. No historical processes were identified for this site. The site is located approximately 90 m (300 ft) from the Columbia River in the 100-K Area. The 100-K-93 waste site is encompassed within the 100-K-111, Effluent Seepage Area, from the 116-K-2 waste site and is being consolidated and dispositioned with the 100-K-111 waste site. The 116-K-2 trench received contaminated effluent from the 100-K Area retention basin system consisting of reactor cooling water effluent, fuel storage basin overflows, and discharges from the 105-KE and 105-KW Reactor floor drains. Seepage and overflow from the 116-K-2 waste site and other liquid effluent disposal sites are addressed by the 100-K-111 waste site.

All waste materials associated with the 100-K-93 waste site, including the crushed drum, solid tar-like substance, and the underlying soil was removed (by hand digging) on November 6, 2012, and disposed at the Environmental Restoration Disposal Facility (ERDF). This resulted in a total of approximately 0.5 bank cubic meters (0.7 bank cubic yards) of material being removed and disposed at ERDF. Cleanup verification sampling was performed on February 5, 2013, to determine if the waste site met remedial action objectives and remedial action goals (RAGs) established by the *Interim Action Record of Decision for the 100-BC-1, 100-BC-2, 100-DR-1, 100-DR-2, 100-FR-1, 100-FR-2, 100-HR-1, 100-HR-2, 100-KR-1, 100-KR-2, 100-IU-2, 100-IU-6, and 200-CW-3 Operable Units, Hanford Site, Benton County, Washington*, U.S. Environmental Protection Agency, Region 10, Seattle, Washington (Remaining Sites ROD) (EPA 1999) and the *Remedial Design Report/Remedial Action Work Plan for the 100 Area, DOE/RL-97-17, Rev. 6, U.S. Department of Energy, Richland, Washington (DOE-RL 2009)*.

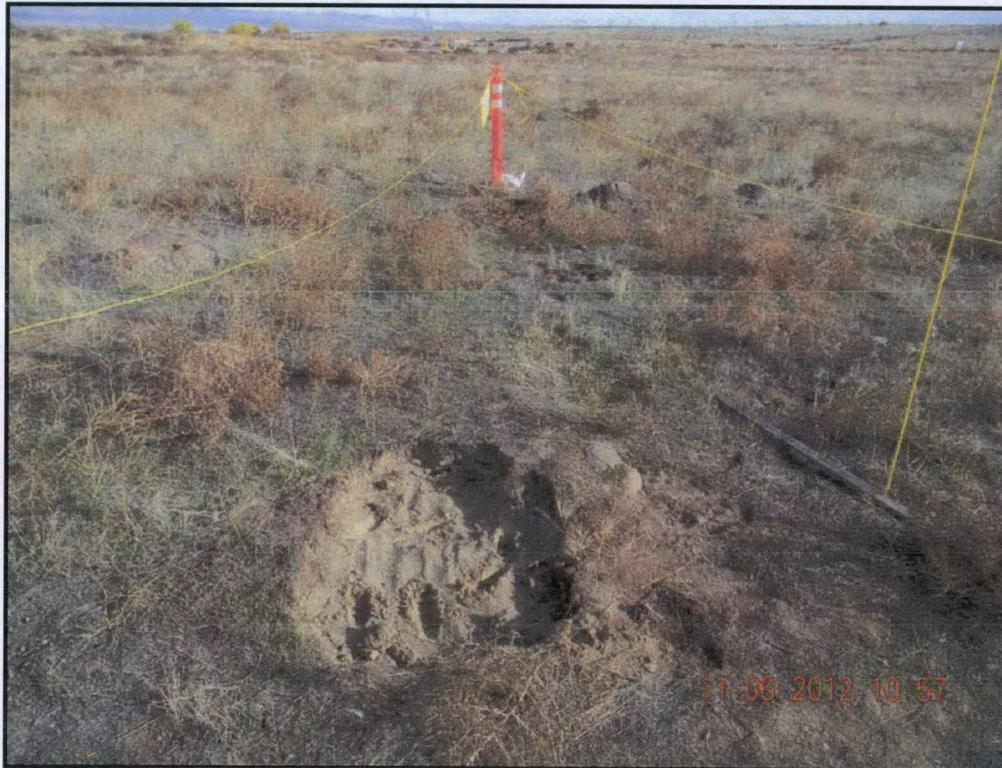
Figure 3. 100-K-93 Waste Site Following Remediation.

The 100-K-93 verification sampling results indicated that the concentration of total chromium in the remaining soil was above the groundwater and river protection RAGs. For informational purposes, hexavalent chromium analyses were performed for the 100-K-93 verification samples. The hexavalent chromium concentrations were 6.54 mg/kg and 8.12 mg/kg for the main and duplicate soil samples, respectively. Hexavalent chromium is not a 100-K-93 waste site contaminant of potential concern, and verification sampling results for hexavalent chromium were comparable to the concentrations observed in the vicinity at the 100-K-111 waste site. It was, therefore, determined that the residual contamination observed within the 100-K-93 waste site will be consolidated and dispositioned with the 100-K-111 waste site.
