100 & 300 AREA UNIT MANAGER MEETING MINUTES

Groundwater and Source Operable Units; Facility Deactivation, Decontamination, Decommission, and Demolition (D4); Interim Safe Storage (ISS); Field Remediation (FR); and Mission Completion

September 13, 2012

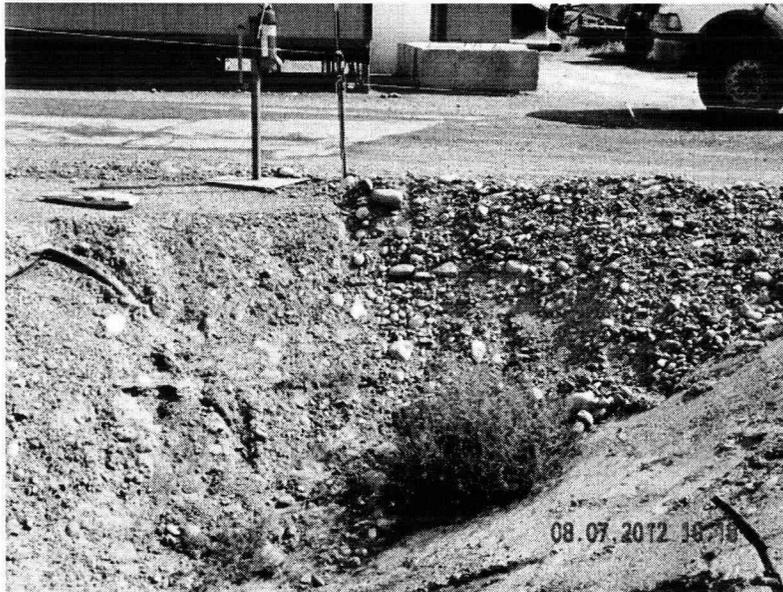
Figure 1. UPR-100-N-6 Waste Site, EXC-3 New Location.

During the UPR-100-N-6 waste site verification sampling activities, two sample locations EXC-3 and EXC-4 were found to be under an active land bridge utilized by D4 activities. Unfortunately, due to limited availability of sampling resources at the time of sampling, a rapid decision had to be made to relocate sample locations EXC-3 and EXC-4 to the west and east of the land bridge, respectively. The sampling locations were focused to the nearest possible original location, immediately outside of the land bridge limits (Figure 1 and 2). A map in Figure 3 shows original locations and the new sampling locations for EXC-3 and EXC-4. New sample coordinates for EXC-3 and EXC-4 are indicated in Table 1.

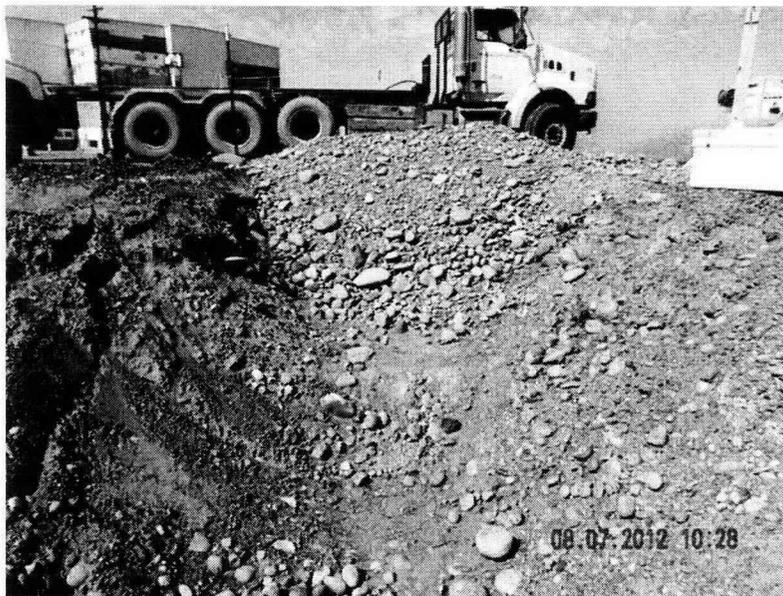
Figure 2. UPR-100-N-6 Waste Site, EXC-4 New Location.
