**Washington Department of Ecology
Nuclear Waste Program
Compliance Report**

Site:	B Plant Complex	RCRA Site ID:	WA7890008967
Inspection Date:	August 19, 2014		
Site Contacts:	Joel Williams Jr., CH2M Hill Plateau Remediation Company (CHPRC), Regulatory Inspection Lead		
Phone:	(509) 376-4782	FAX:	N/A
Site Location:	Hanford Site		
At This Site Since:	March 2, 1943	NAICS #:	56221, 924110, 54171
Current Site Status:	Treatment, Storage, Disposal Facility / Closure Unit Group # 24		
Compliance Index #:	14.502

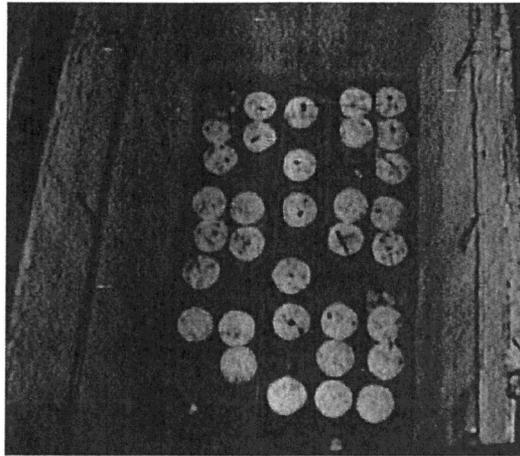
Excerpt 1: Part A Application, from Page 12

the Preclosure Work Plan, Cell 4 is a concrete cell in 221-B that is covered with a concrete block. The block can only be removed by a crane within the canyon that is not operational for the S&M phase. Mr. Dixon also said the 221-B canyon cannot be accessed due to concerns of radiation exposure to personnel. Areas of radiation contamination within the canyon can be found in HNF-3208, Table 2.

221-B Building, Cell 4, Container Storage
94040656-5CN Photo Taken 1994

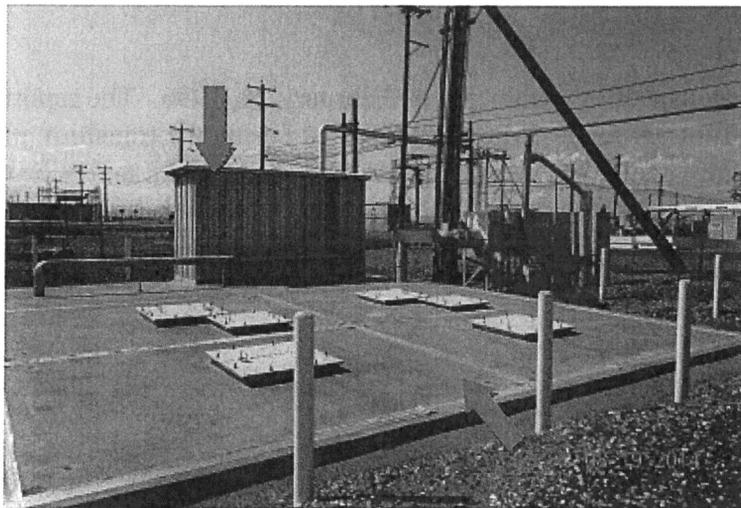
Photo 1: Building 221-BF (~Southwest corner of B Plant Complex)

After reviewing documents Ms. Ware, Ms. Conaway, Ms. Schleif, and I conducted a walkthrough of the B Plant Complex. The first location is one of four structures that make up the DWMUs. According to the Part A Application, 221-BF consists of two below grade tanks, 221-BF-A and 221-BF-B. The tanks are accessible through a structure adjacent to the concrete blocks that cover the tanks. According to the CHPRC NCO that accompanied us during our walkthrough, the above ground structure facilitates access for sampling the two tanks. According to Table 4-2 of the Preclosure Work Plan the 221-BF-A tank has a tank heel volume of 235 liters, no residue, and is "Empty and below minimum heel." 221-BF-B tank has a tank heel volume of 235 liters, no residue, and is "Empty and below minimum heel."

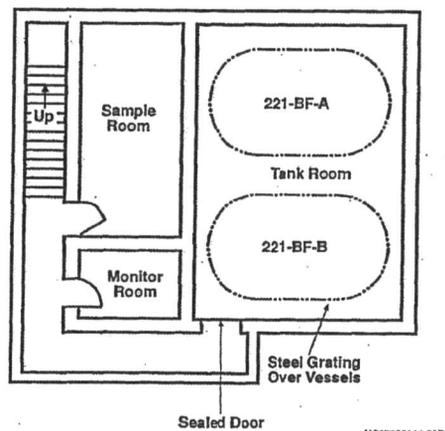
Excerpt 5: Preclosure Work Plan, from Page F2-6

Figure 2-6. 221-BF Condensate Effluent Discharge Facility.

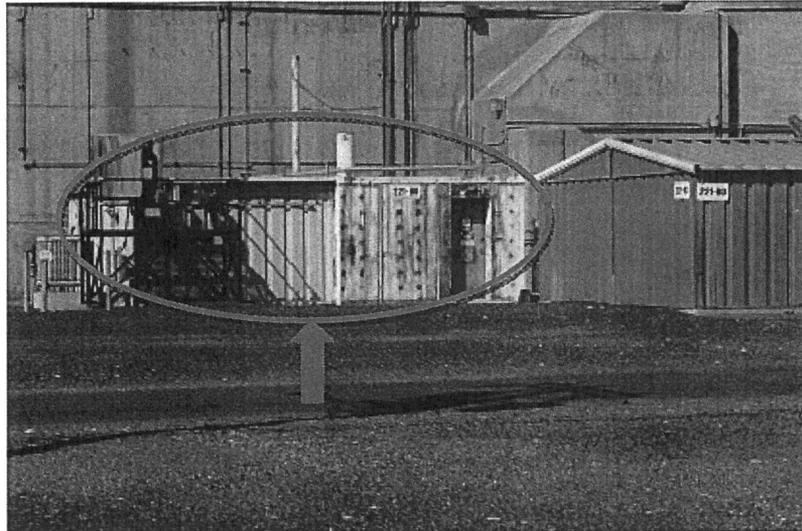
Photo 2: Building 221-BB (Adjacent to South side of 221-B Building)

Our next location is the second of four structures that make up the DWMUs. According to the Part A Application, 221-BB consists of two below grade tanks BCP and BCS. The tanks are accessible through a sheet metal structure, which sits above a condensate pit, where the tanks are located. According to Table 4-2 of the Preclosure Work Plan the BCP tank has a tank heel volume of less than 189 liters, no residue, and is "Empty and below minimum heel." The BCS tank has a tank heel volume of less than 189 liters, no residue, and is "Empty and below minimum heel."

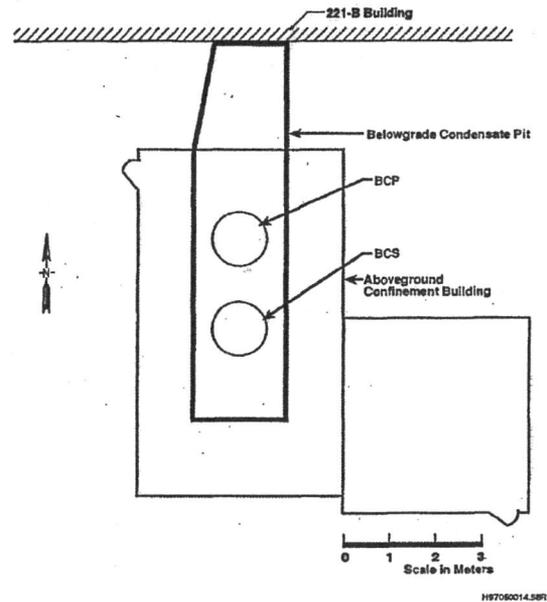
Excerpt 6: Preclosure Work Plan, from Page F2-5

Figure 2-5. 221-BB Process and Steam Condensate Building.

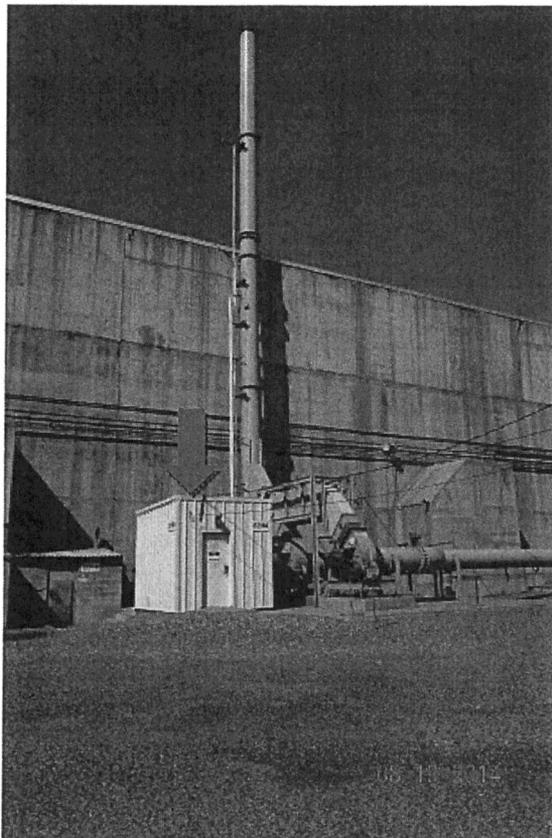
Photo 4: Building 221-BK (Houses PLC Equipment)

The next location houses the programmable logic controller (PLC) in building 221-BK. According to the S&M Plan, the PLC “provides data acquisition for monitoring data controls for the ventilation system exhaust fans, stack flow, and sampling system.” The PLC also monitors TK-10-1 liquid level, which accumulates liquid from 221-B canyon’s liquid in-leakage.

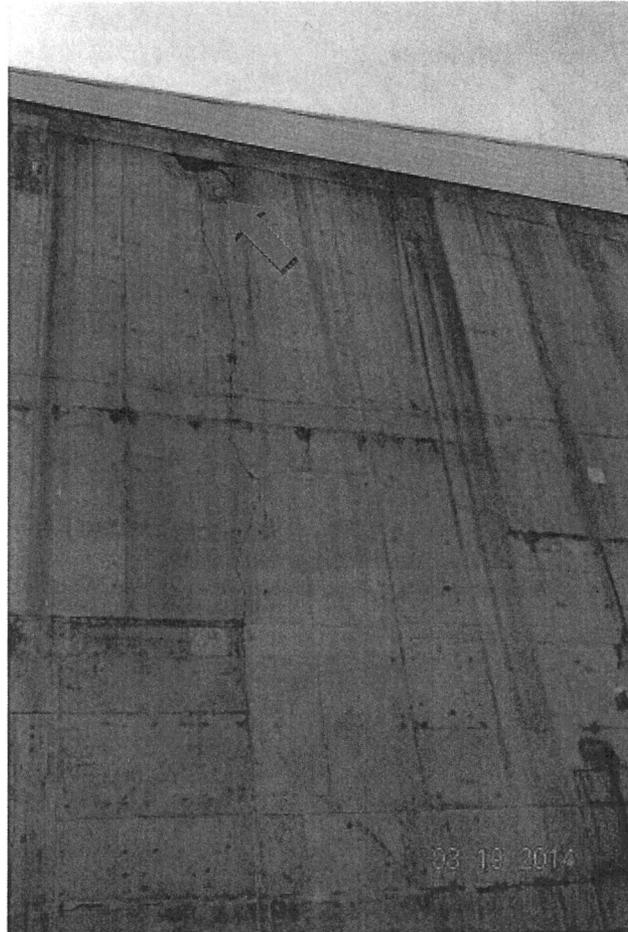
Photo 5: East side 221-B Canyon Building

The next location is the third of four structures that make up the DWMUs. According to the Part A Application, the 221-B consists of the Containment Building, Cell 4 and the majority of the five tank systems that make up the DWMUs. I observed the East wall, where Ray Stevens (CHPRC Design Authority Engineer) showed us a crack. Mr. Stevens said the crack is under an ongoing monitoring effort. I observed the crack nearly runs from the top to the bottom of 221-B. Mr. Stevens said there were no immediate actions necessary to repair the wall and despite the crack, the wall is structurally intact.

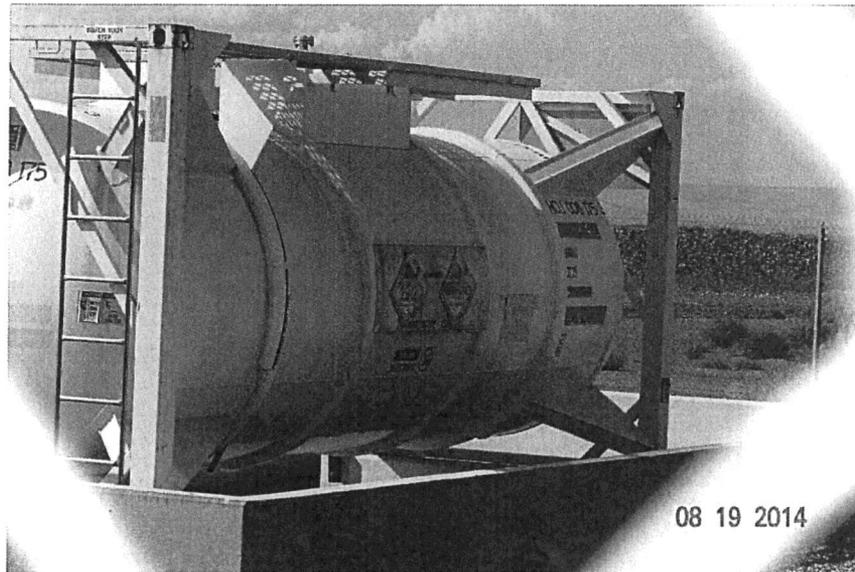
Photo 6: 276-BA (Secondary containment housing the ISO East Tank)

The final location is the fourth of four structures that make up the DWMUs. According to the Part A Application, 276-BA currently consists of one above ground tank and a concrete secondary containment structure that previously housed two tanks (ISO East and ISO West). The ISO-East tank is part of the organic MW tank storage system and has no walls and roofing. According to Table 4-2 of the Preclosure Work Plan the ISO East tank has no tank heel, no residue, and is "Empty and below minimum heel." I did not observe any labels or signs indicating that the tank is storing DW, MW, or major risk labels.

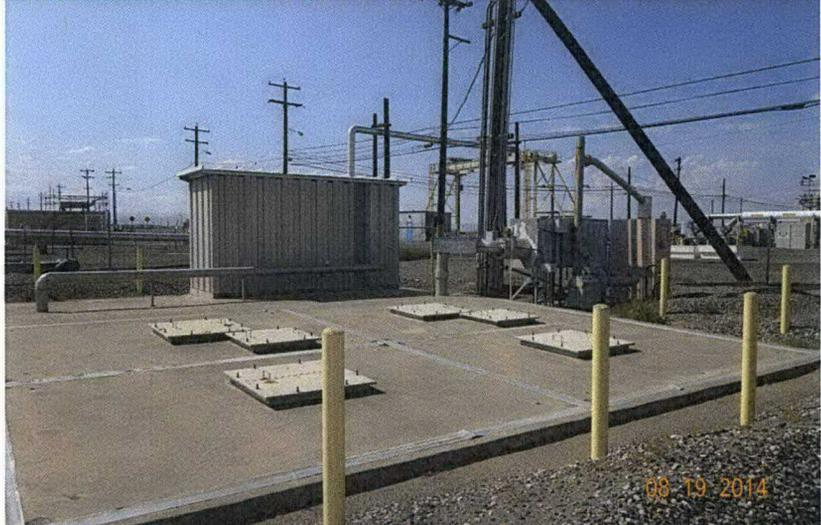
No.	Location	Activity Description or Other Comment	Photo
1.	221-BF Below Grade Tanks	<p>DSC00123 (3:25 p.m.)</p> <p>Two below grade process condensate tanks, covered with concrete blocks. The tanks are a part of the miscellaneous tank system. The shed behind the concrete pad is used for accessing the below grade tanks for sampling activities. See the Part A Application for more details.</p>

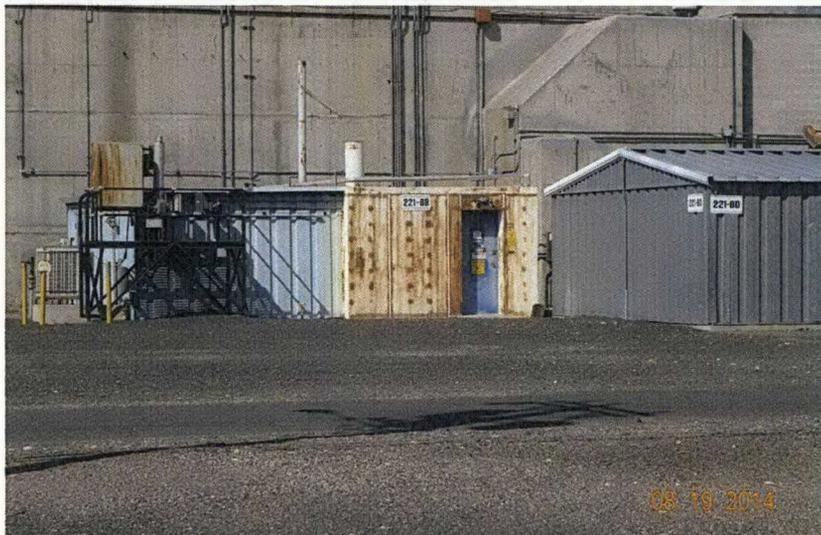
2.	Southside 221-BB and 221-BD	<p>DSC00124 (3:30 p.m.)</p> <p>The 221-BB building has tanks that are a part of the miscellaneous tank system. There are two tanks accessible by the building. See the Part A Application for more details.</p>

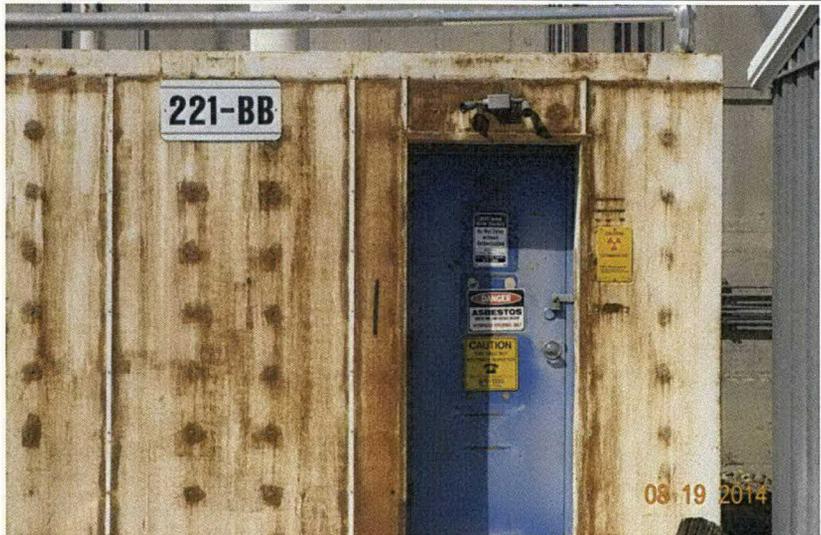
3.	Southside 221-BB	<p>DSC00125 (3:32 p.m.)</p> <p>Close up of the 221-BB building entrance. The entrance has a padlock and signs regarding entrance, asbestos, radioactivity and contact information.</p>

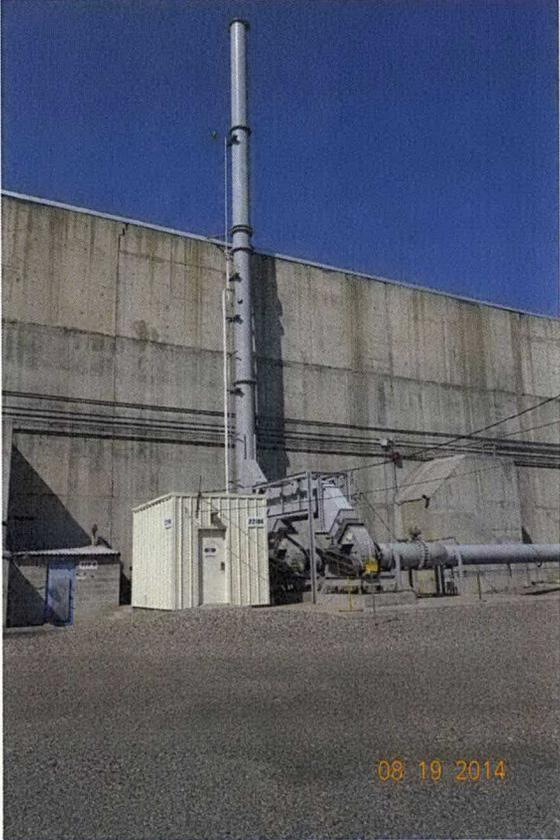
No.	Location	Activity Description or Other Comment	Photo
4.	221-BK and 2711-B	<p>DSC00126 (3:34 p.m.)</p> <p>221-BK is the monitoring and control room for the HEPA filter-air system, which is for the 221-B Canyon.</p>

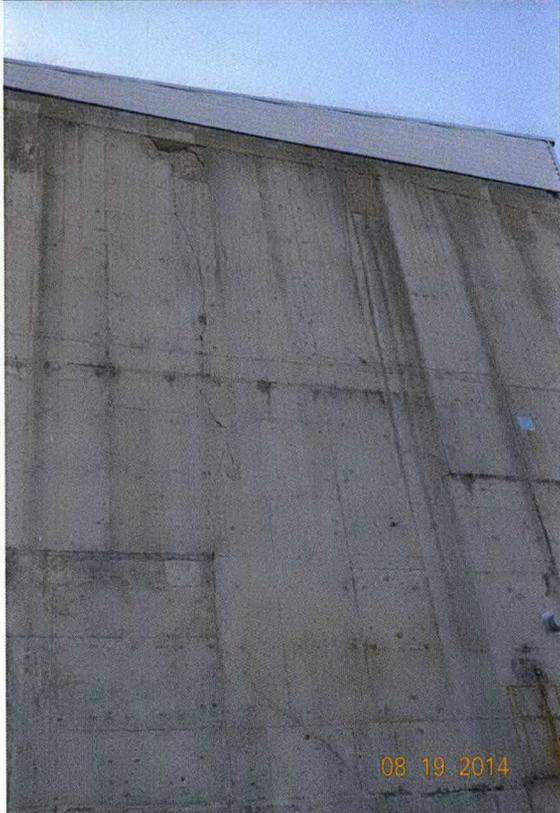
5.	221-B Canyon Eastside	<p>DSC00127 (3:40 p.m.)</p> <p>The crack on the east side concrete wall of the 221-B canyon. The crack nearly runs the full length of the wall.</p>

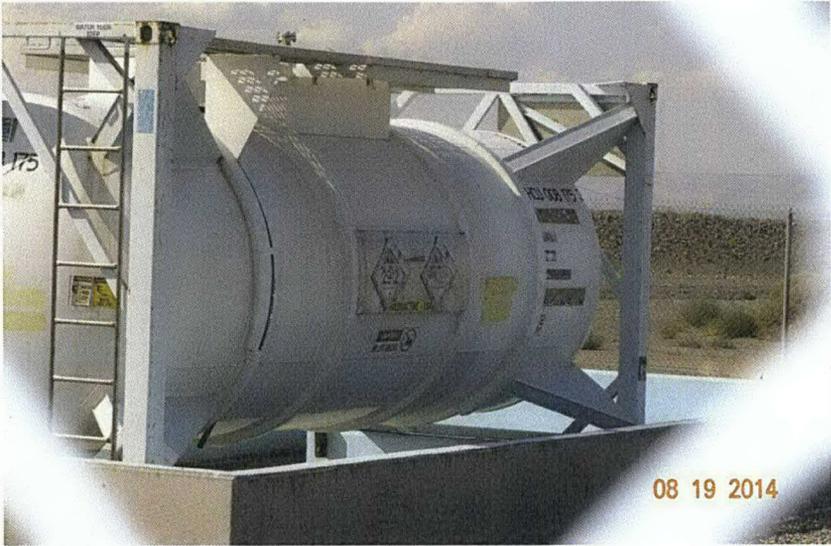
No.	Location	Activity Description or Other Comment	Photo
6.	276-BA ISO East Tank	DSC00128 (3:44 p.m.) The ISO East tank is a part of the Organic Mixed Waste Storage System. The Tank is in the Northwest corner of the B Plant Complex Boundary and has a separate fence enclosing the immediate area surrounding the tank.
