100/300 AREA UNIT MANAGER MEETING ATTENDANCE AND DISTRIBUTION

100 & 300 AREA UNIT MANAGER MEETING MINUTES

Groundwater and Source Operable Units; Facility Deactivation, Decontamination, Decommission, and Demolition (D4); Interim Safe Storage (ISS); Field Remediation (FR); and Mission Completion

July 12, 2012

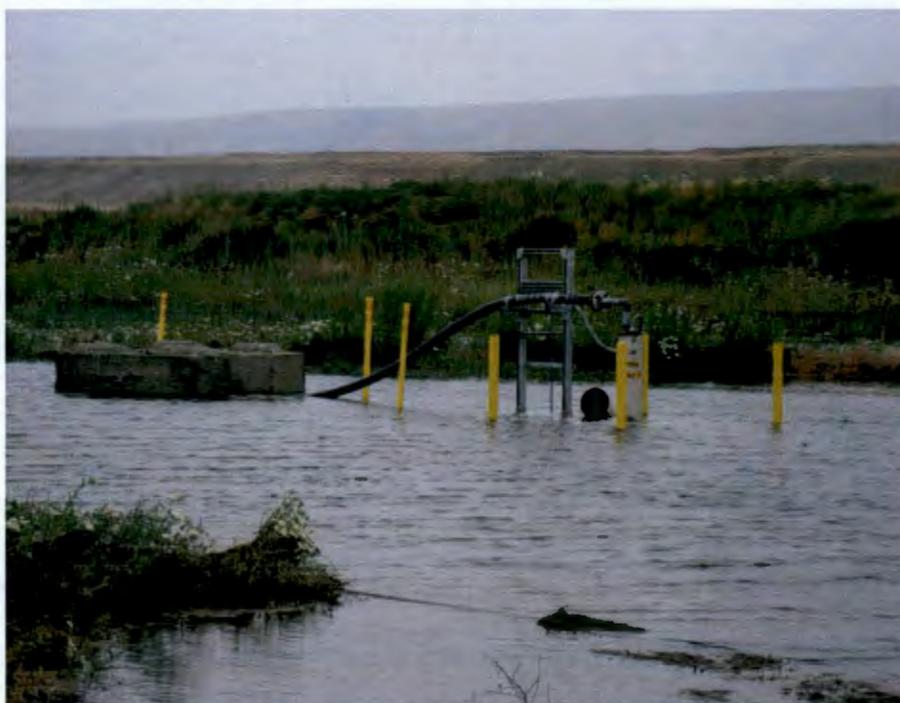
- Monitoring & Reporting: Concentrations of hexavalent chromium continue to drop in the Horn Area along the Columbia River north of 100-H Area as a result of HX pumping. Well 199-H1-35 is representative of wells in this area where a zone of the groundwater plume that had concentrations of 40-100 $\mu\text{g/L}$ or greater is being cleaned up to below the aquatic standard. Well 199-H1-35 is on the north edge of this zone.
