FACILITY STATUS CHANGE FORM

Date Submitted: June 14, 2012	Area: 300 Area	Control #: D4-300-058
Originator: John Harrie	Facility ID: 307 Retention Basins	
Phone: 509.308.9935	Action Memorandum: Action Memorandum #3

The 307 Retention Basins were part of the 340 Complex – Waste Neutralization Facility located north of the 308 Building on the eastern portion of the 300 Area.

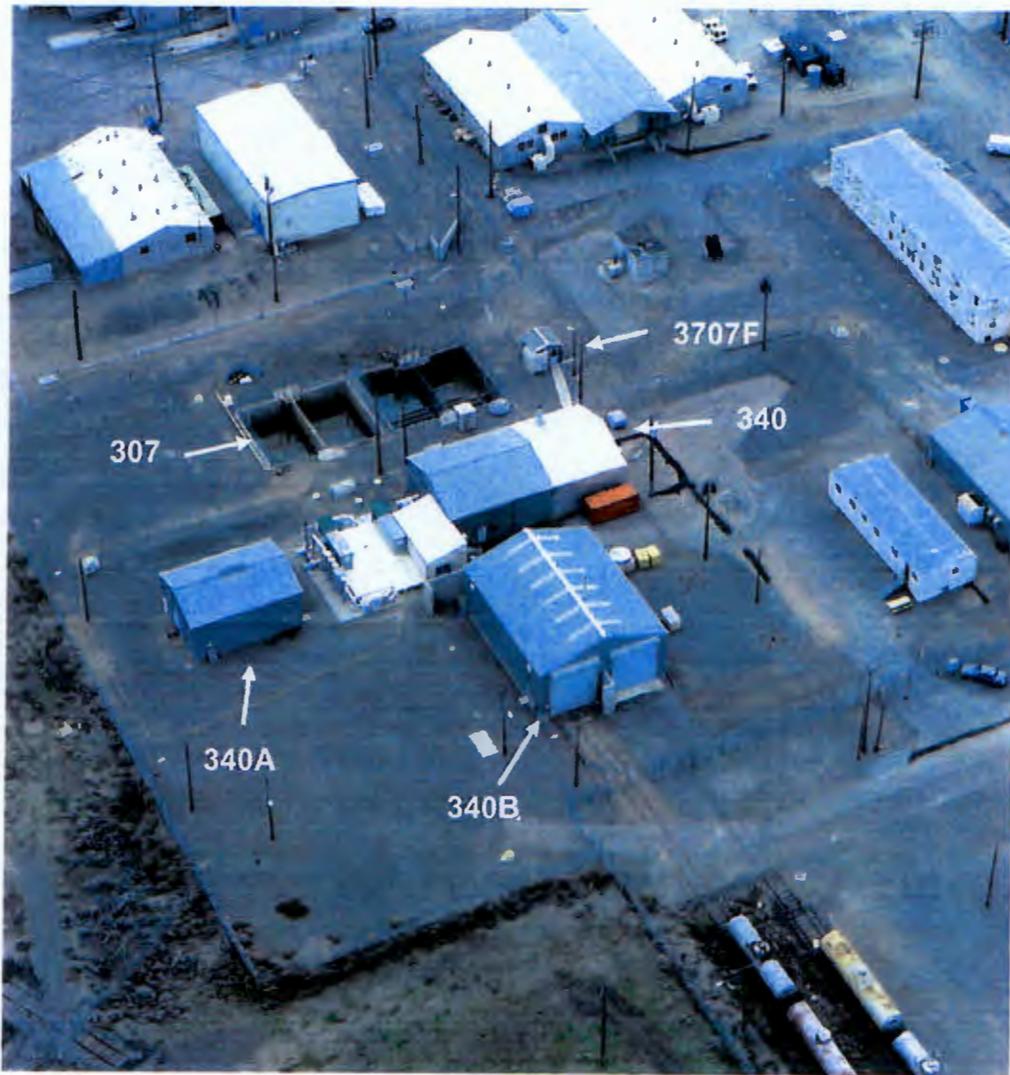
Figure 1: 340 Complex in March of 1993 (looking southeast)

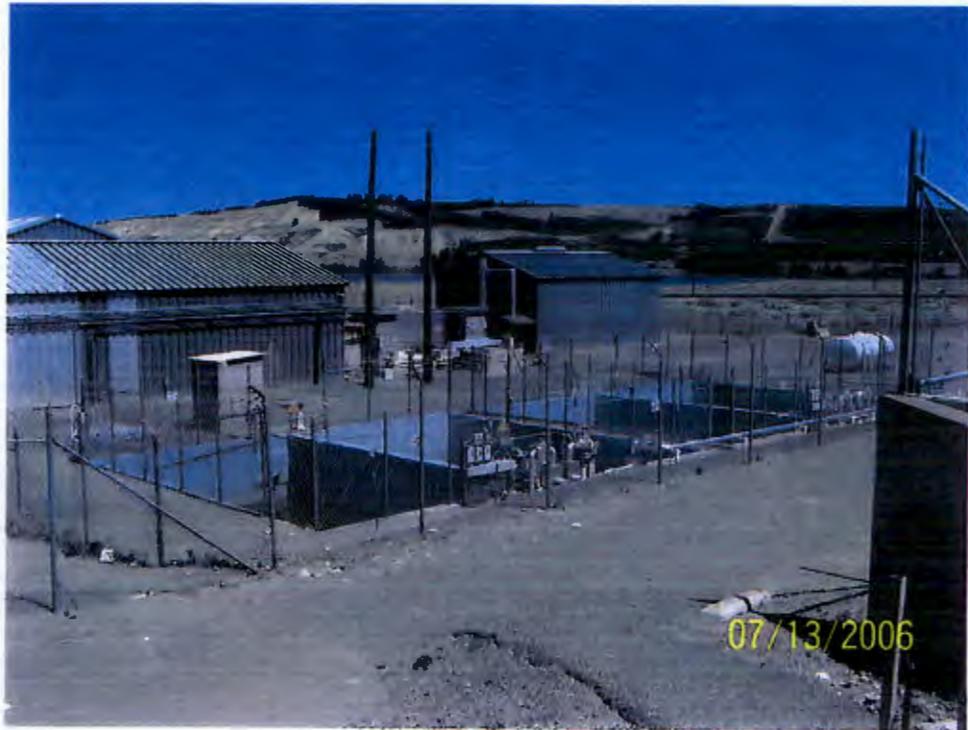
Figure 2. Looking northeast at the 307 Basins on July 13, 2006.

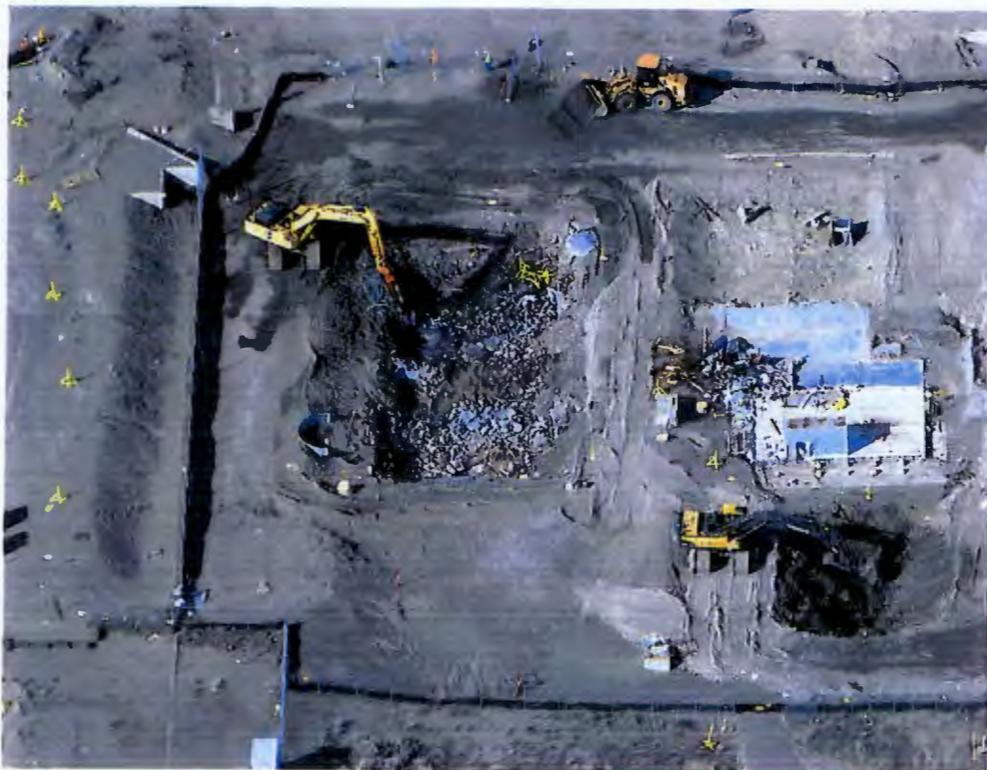
Figure 3. Looking west at the 307 Basins during demolition on March 8, 2012.

Demolition: Demolition of the 307 Retention Basins was completed in June of 2012. The basins debris were removed and disposed of at ERDF. The demolition was performed with Radiological and Industrial Hygiene controls.

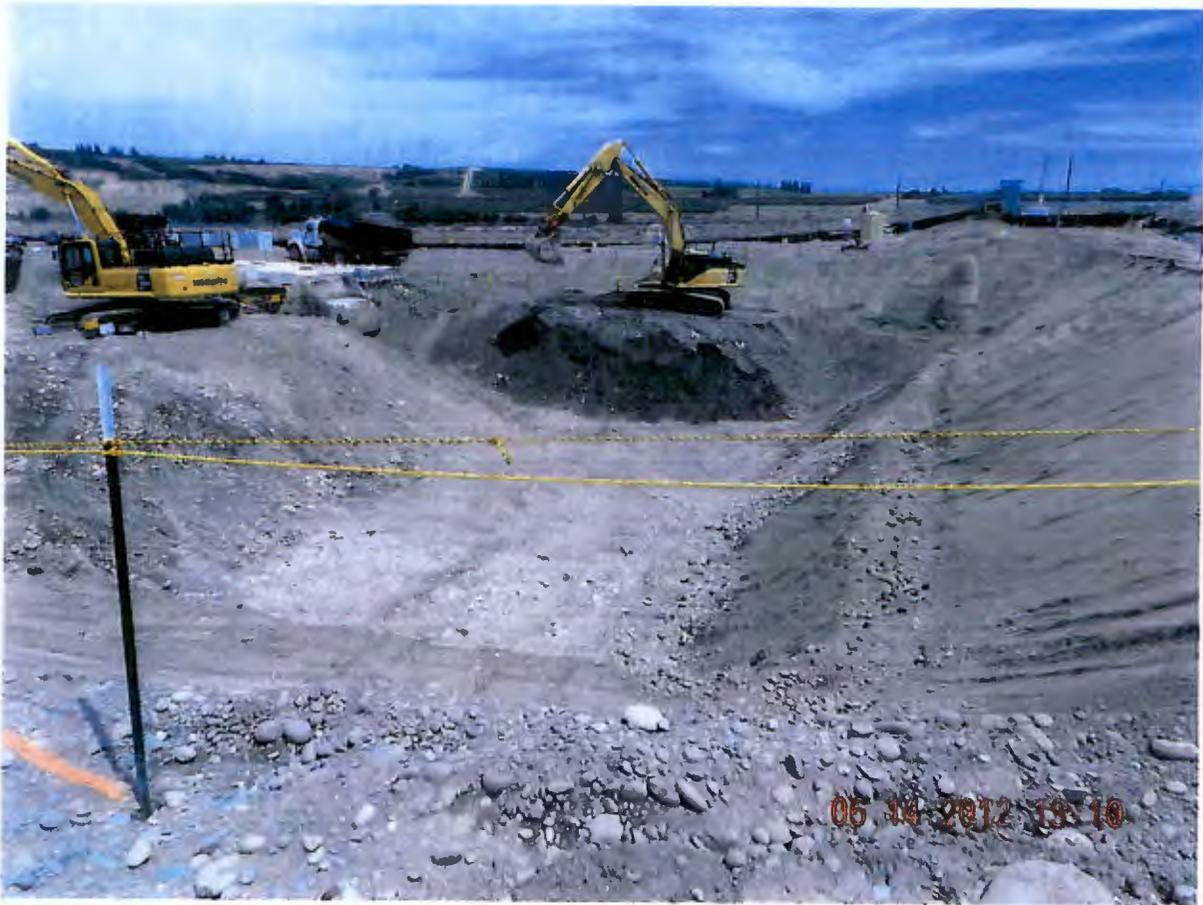
Figure 4. Looking east at the 307 Basins Excavation following demolition and load-out on June 14, 2012.

The 307 Basins were removed in June of 2012. The excavation remains open.
