HNF-EP-0182
Revision 363

Waste Tank Summary Report for Month Ending March 31, 2018

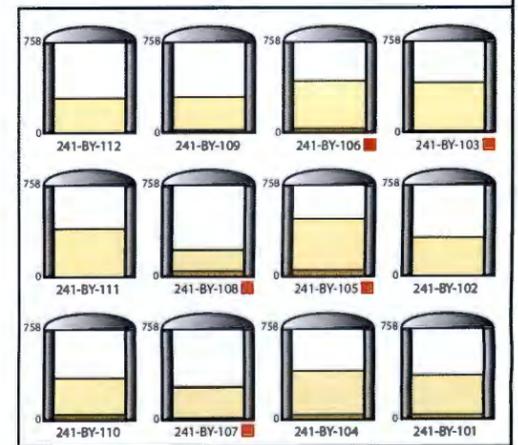
BY-Tank Farm- Constructed 1948-1949
12 @ 758 Kgal Tank Capacity, Single-Shell

Tank	Kgal		
	Sludge	Saltcake	Supernatant
241-BY-101	37	328	0
241-BY-102	0	316	0
241-BY-103	9	403	0
241-BY-104	43	358	0
241-BY-105	48	429	0
241-BY-106	30	399	0
241-BY-107	16	258	0
241-BY-108	44	177	0
241-BY-109	23	273	0
241-BY-110	44	304	0
241-BY-111	0	399	0
241-BY-112	2	285	0

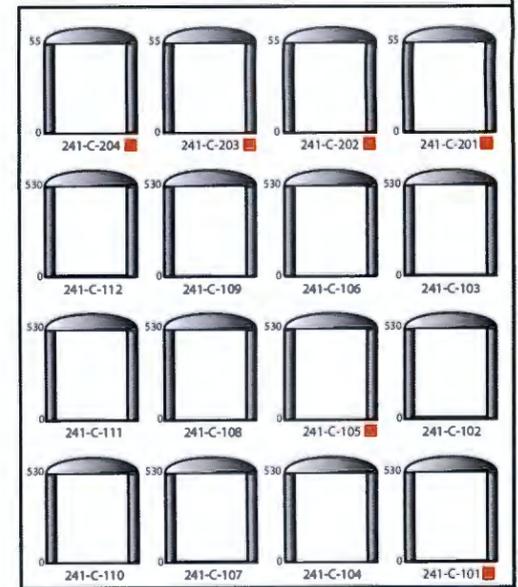
C-Tank Farm- Constructed 1943-1944
12 @ 530 Kgal Tank Capacity, Single-Shell
4 @ 55 Kgal Tank Capacity, Single-Shell

Tank	Kgal		
	Sludge	Saltcake	Supernatant
241-C-101	5.5	0	0
241-C-102	15.5	0	0
241-C-103	2.3	0	0.2
241-C-104	1.8	0	0
241-C-105	1.5	0	0
241-C-106	2.7	0	0.1
241-C-107	10	0	0
241-C-108	3.3	0	0
241-C-109	1.9	0	0
241-C-110	2	0	0
241-C-111	4.9	0	0
241-C-112	10	0	0
241-C-201	0.1	0	0
241-C-202	0.1	0	0
241-C-203	0.1	0	0
241-C-204	0.1	0	0
